Analecta of Structures Formed During the 28 June 1992 Landers-Big Bear, California Earthquake Sequence

Including Maps of Shear Zones, Belts of Shear Zones, Tectonic Ridge, Duplex En Echelon Fault, Fault Elements, and Thrusts in Restraining Steps

U.S. Geological Survey
Open File Report 97-94
Denver, Colorado 80225
1997

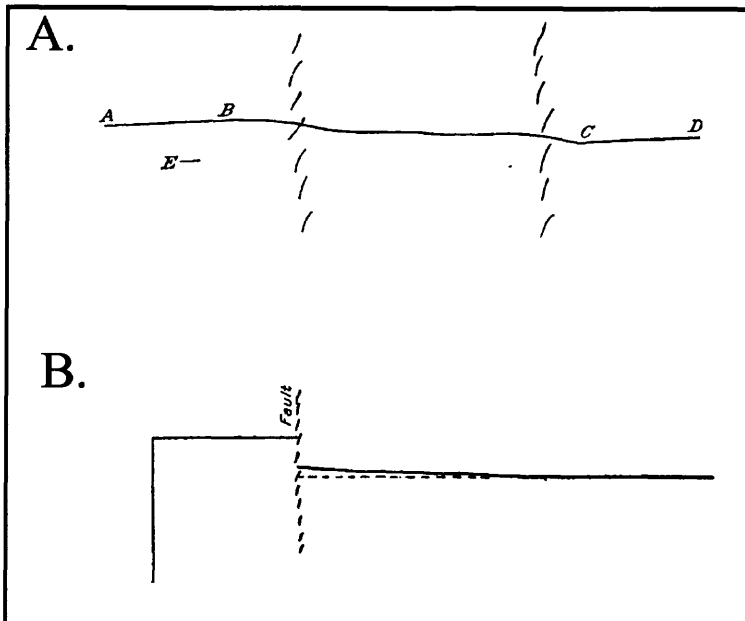
Figure 4. Deformed fences on farm of E.R. Strain, near Woodville, California. 1906 earthquake ruptures (from G.K. Gilbert, in Lawson, 1908, p. 71). The upper diagram shows two zones of concentrated shearing and an intervening zone of more diffuse shearing. The lower diagram, somewhat north of the one described above, shows the continuation of the shear zone shown near B. The fence is broken and offset 8.5 feet (2.6 m). On one side of the fault the fence is straight. The other the fence is deformed as it approaches the trace.

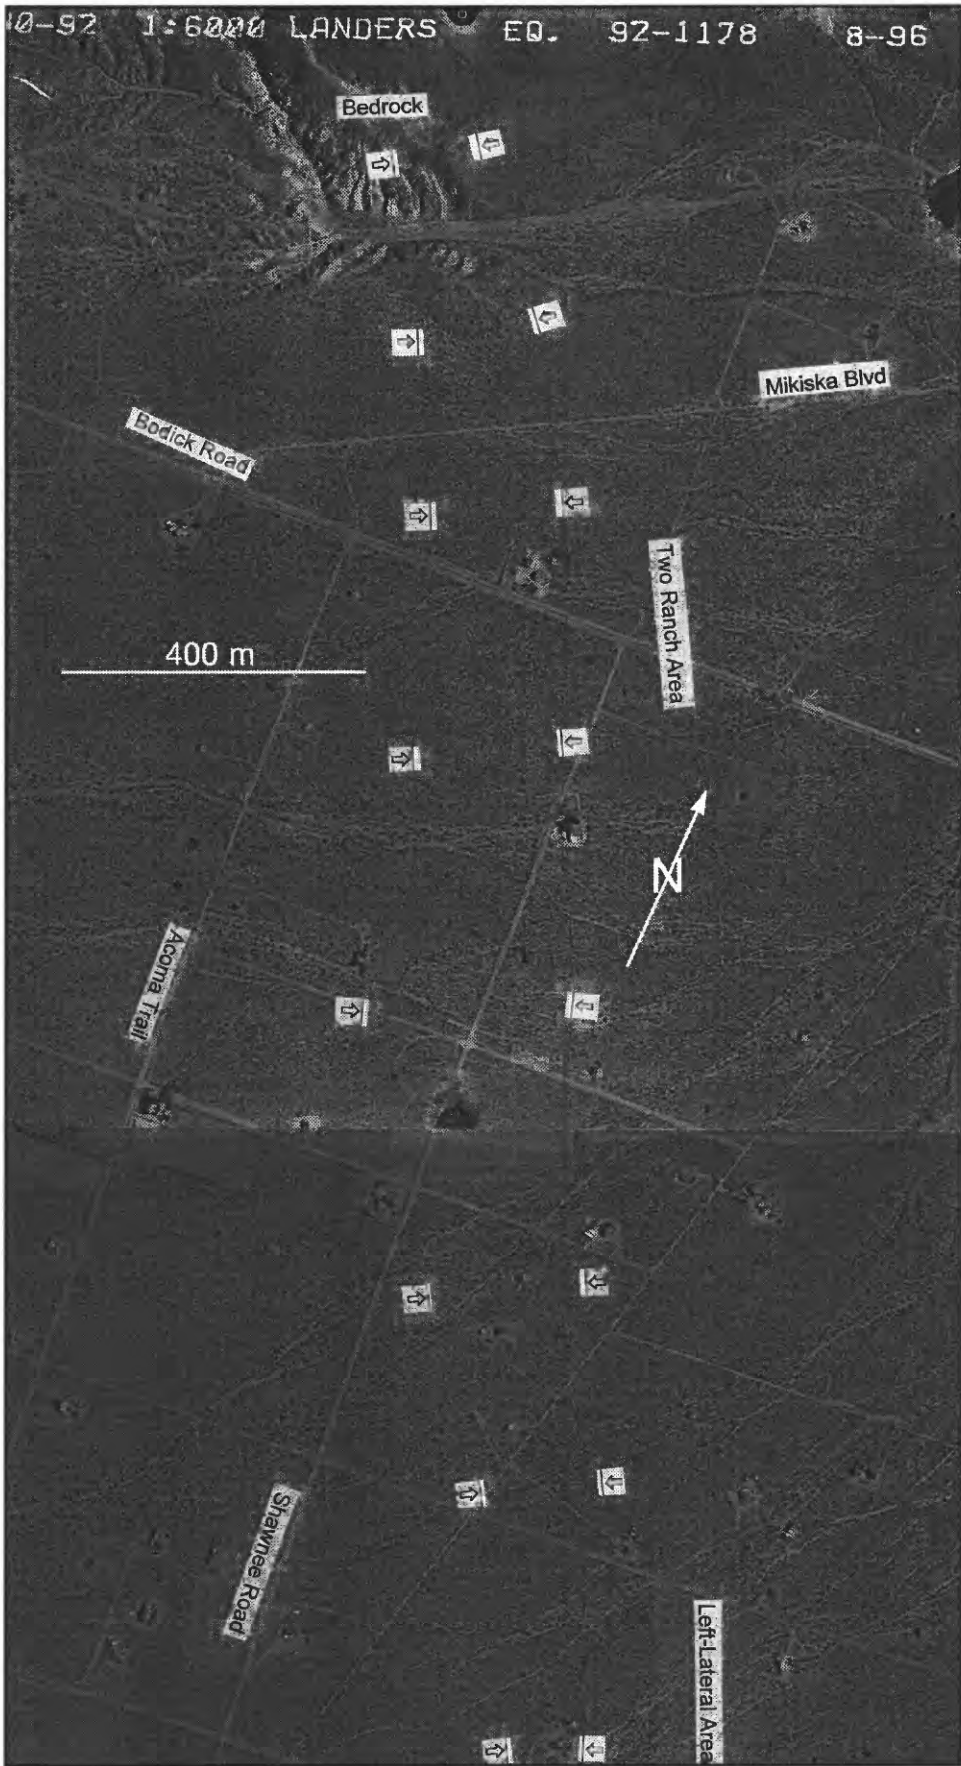
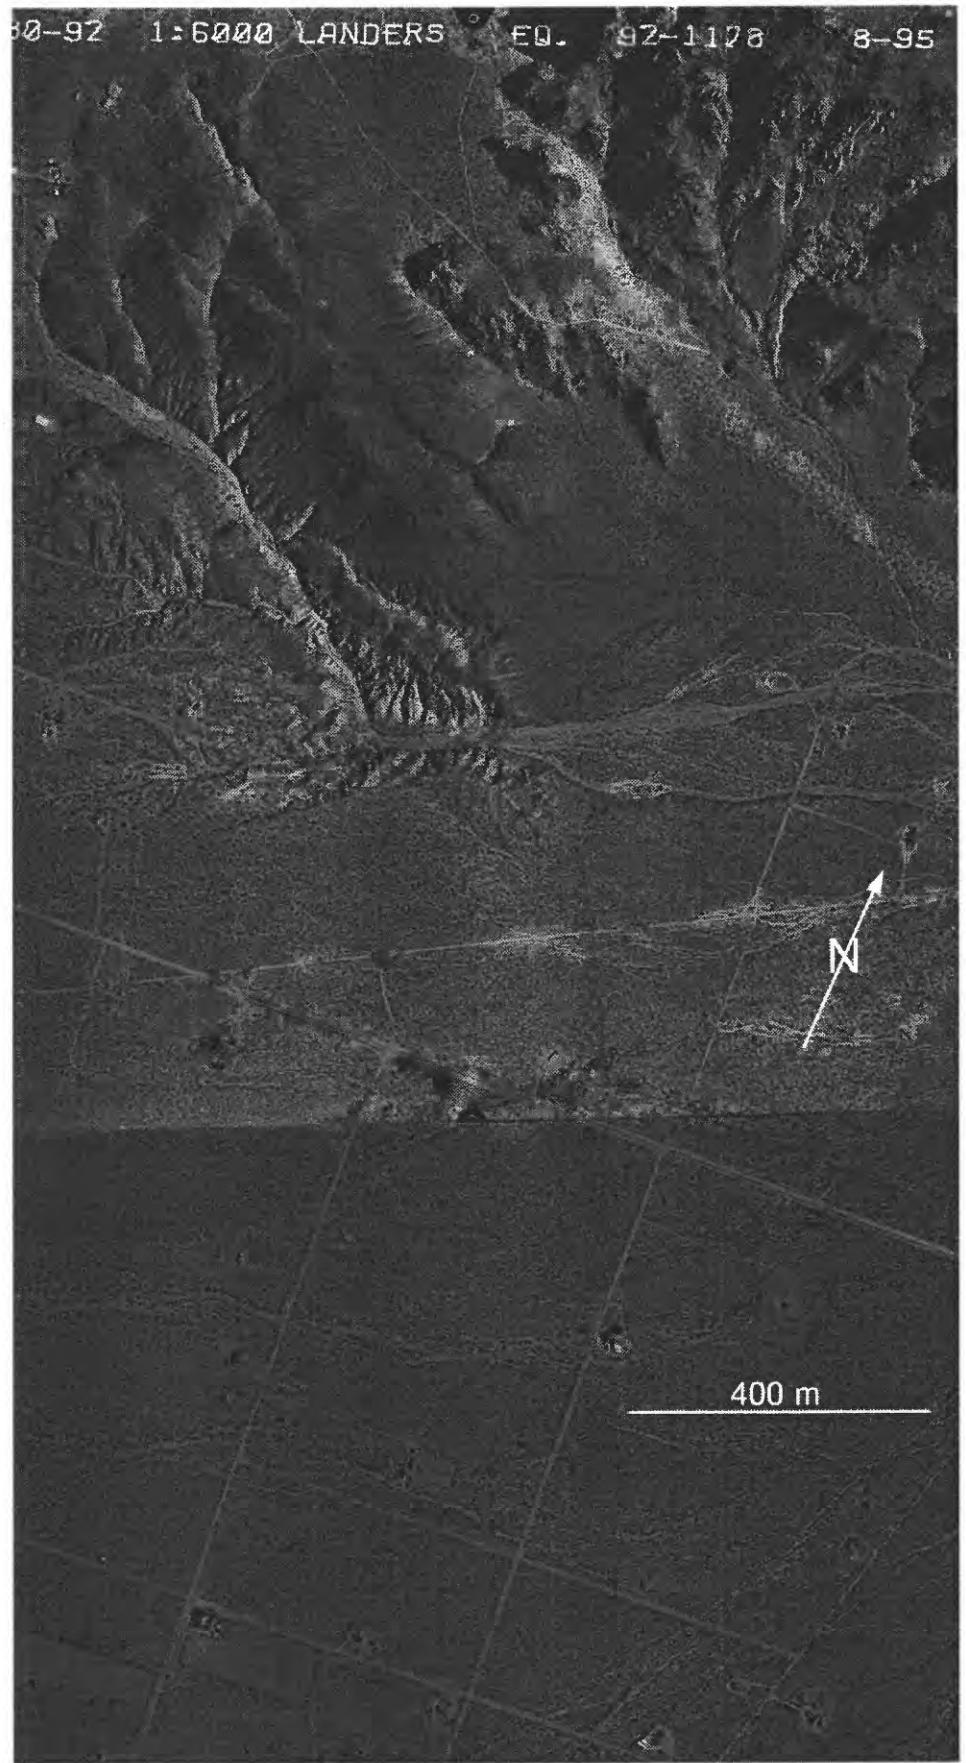
Figure 6. Aerial photographs of part of 1992 Landers rupture along the Homestead Valley fault zone.

→ B. View of rupture zone from Two Ranches area into exposed bedrock of Goatsucker Hill ridge in north. Arrows mark boundaries of belt of shear zones, which passes from consolidated alluvium in southern half of area into bedrock in northern part of area.

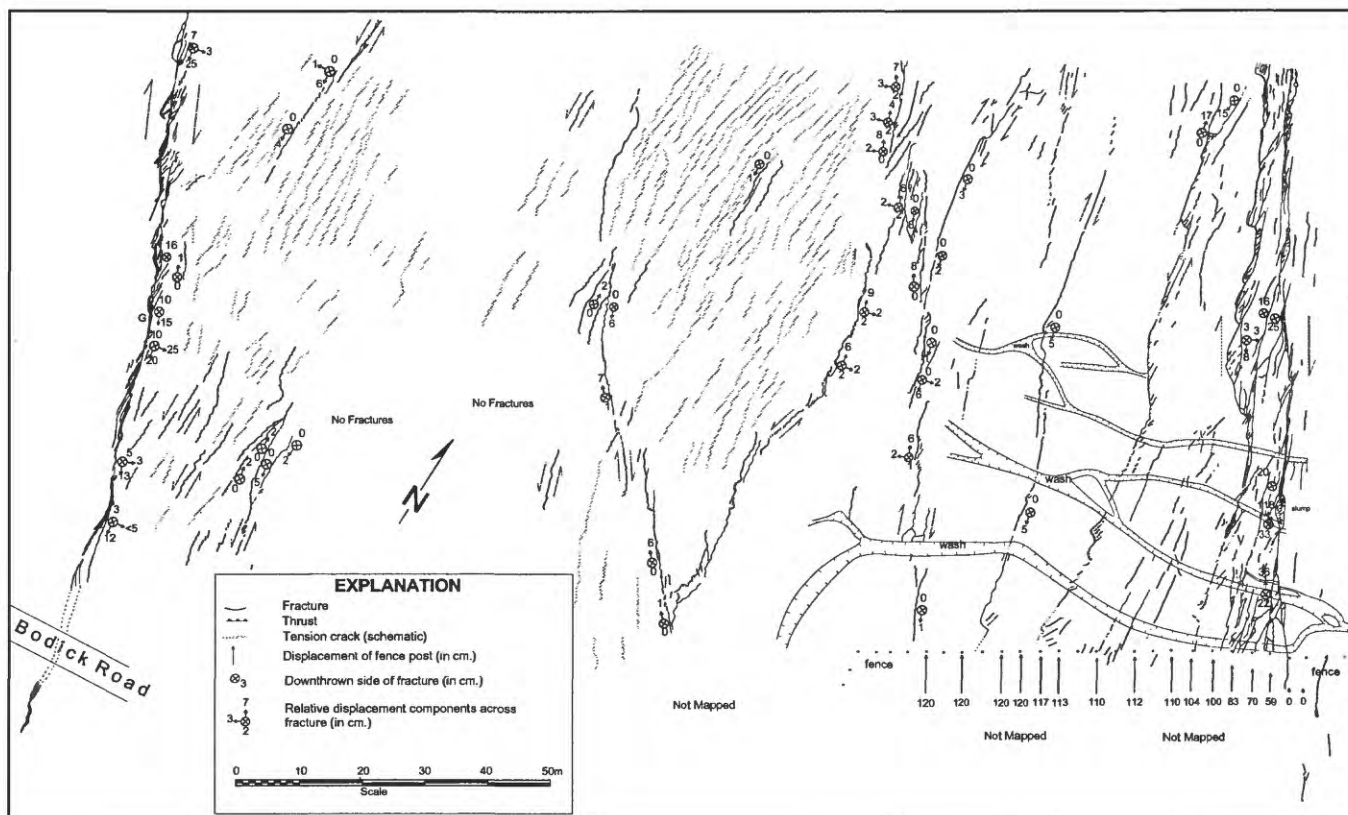
Figure 7. Detailed map of tension cracks, small faults, and right- and left-lateral narrow shear zones along the Homestead Valley fault zone, north of Bodick Road and its intersection with Shawnee Trail. Shapes of individual tension fractures shown schematically with gray lines, but lengths, distributions and orientations are accurate. Some of the fractures that formed as tension cracks subsequently slipped to produce the characteristic open and closed fracture segments that reflect right- or left-lateral shearing. At southwest wall is a shear zone up to 5 m wide that has accommodated 1.5 to 3 dm of right-lateral shift. The band of tension cracks within the broad zone, adjacent to the southwest wall, is about 30 m wide. Much of central third of the belt of shear zones is also characterized by tension cracks oriented roughly north-south. At the northeast wall of the belt is a shear zone that accommodated more than half of the right-lateral shearing of the entire belt. This shear zone is complex and is up to 12 m wide, generally widening from northwest to southeast. Its east side is marked by a scarp, up to 3 dm high, and its west side is marked by thrusts. Within the zone are tension cracks and left-lateral fractures oriented north-south, and right-lateral fractures generally oriented about N30°W. Components of differential displacement normal to fence line shown along base of diagram. Measurements of offset were from alignment of fence posts.

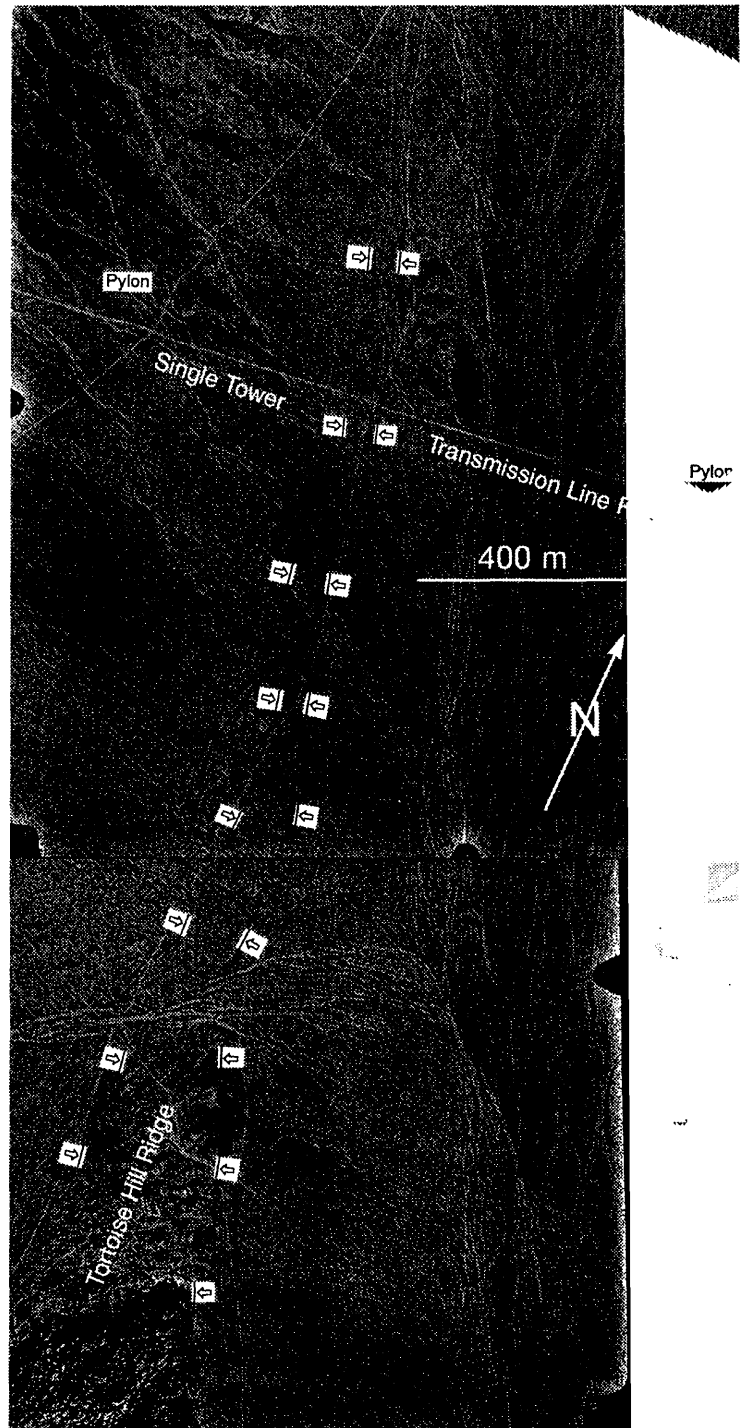
Figure 10. Vertical aerial photograph showing belt of shear zones along Emerson fault zone about 6 km north of Bessemer Mine Road. Road in upper part of area is along Single-Tower Transmission Line. At south end of photo is north end of Tortoise Hill ridge. Edges of belt shown with arrows. East (right) side of belt is defined by the main fault in this area. The belt is about 70 m wide at Transmission Line road and 400 m wide in part of ridge shown.

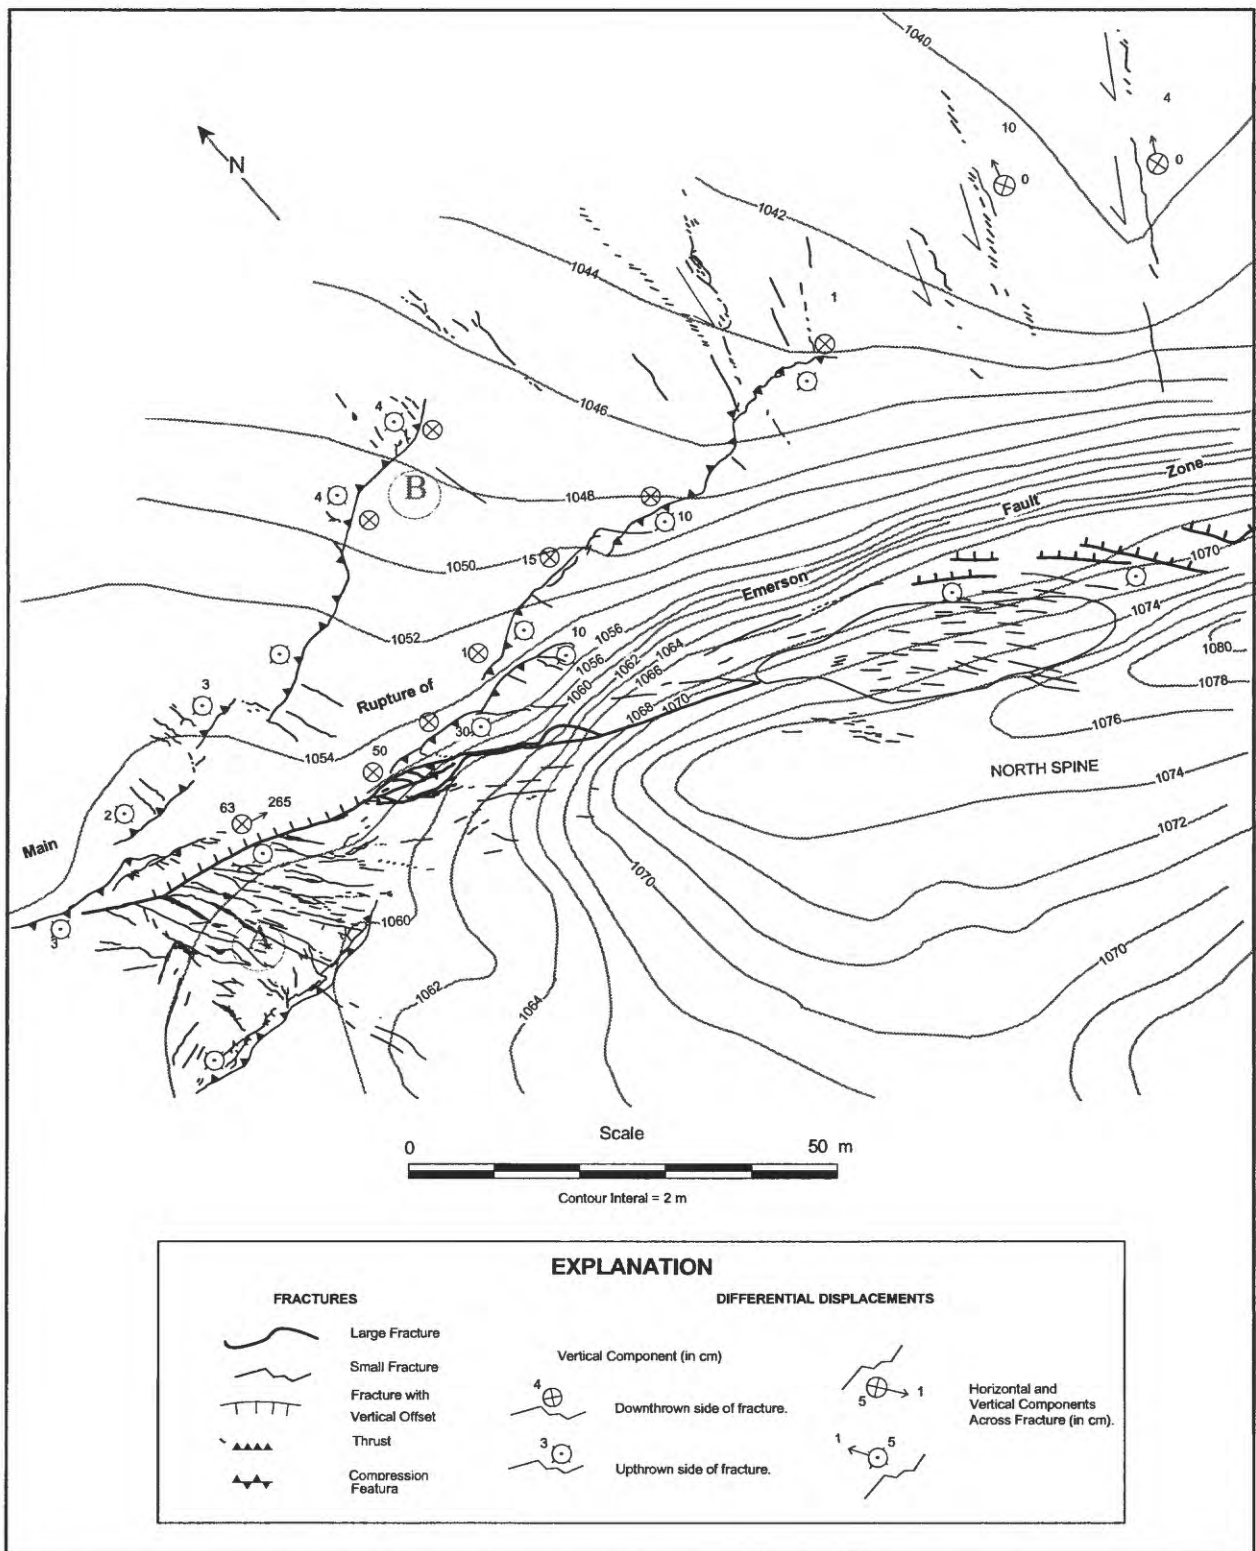
Figure 18. Fractures at left jog in Emerson fault zone at brow of Tortoise Hill, showing compression features on both sides of the jog. The main rupture of the Emerson fault had a scarp about 65 cm high near center of area shown and right-lateral slip was about 265 cm here. The main rupture trends southeast over the east edge of the elongated dome of North Spine. To the north of the rupture are opposite-facing thrusts, dipping north or south, indicating north-south compression and creating low brows that are up to 10 or 15 cm high. To the south there is a welt marked by numerous tension cracks oriented north-south and bounded on the south by a thrust dipping northward.

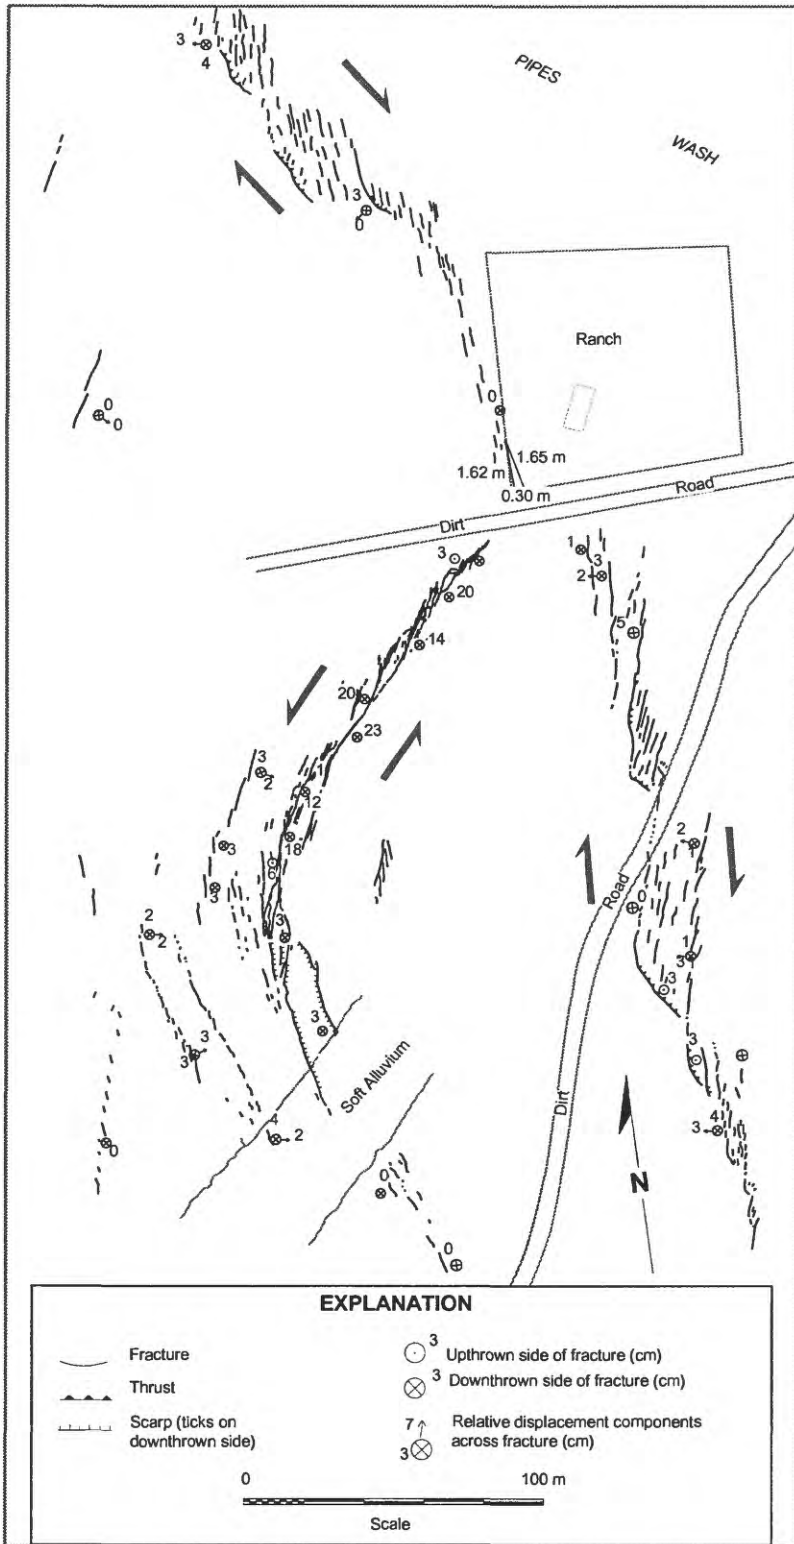
Figure 20. Fractures in Pipes Wash stepover in Homestead Valley fault zone as mapped 1 year after Landers earthquake. The main rupture of the Homestead Valley fault zone is defined by an echelon swarms of tension cracks oriented north-south and thrusts at the southwest ends of individual swarms. As indicated in Plate 1, the main trace turns clockwise near the ranch, so most of rupture shown here is within the stepover. The stepping segment to the south is out of view. Within the stepover is the left-lateral/normal rupture zone shown near the center of the figure. It extends from near the ranch southwestward about 150 m to right-lateral/normal faults. Details of the left-lateral rupture are shown in Plate 7.

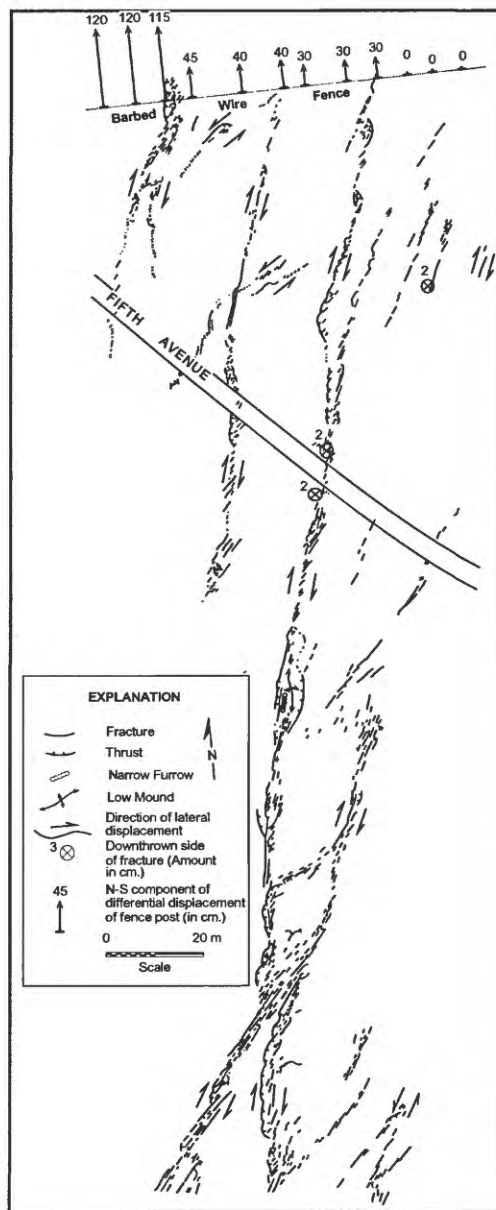
Figure 21. *En echelon* shear zones in the two-bikers area along the western side of the Kickapoo fault zone near intersection of Kickapoo Trail and Fifth Avenue. Each longer element of the zone consists of several smaller elements in a restraining orientation with respect to the longer element. Thrusts reflect the restraining steps or bends. Shift on the longest element nearly dies out before the element reaches the fence line at the northern end of the area. The element offsets the fence about 30 cm. Total shift recorded by the fence line for the *en echelon* shear zones is 120 cm. Another right-lateral rupture zone enters the south end of the map area with an orientation of N30°E, crosses the longest element of the north-south rupture, and then turns roughly north-south on the east side of the longest element. The two rupture zones seem to share tension cracks.

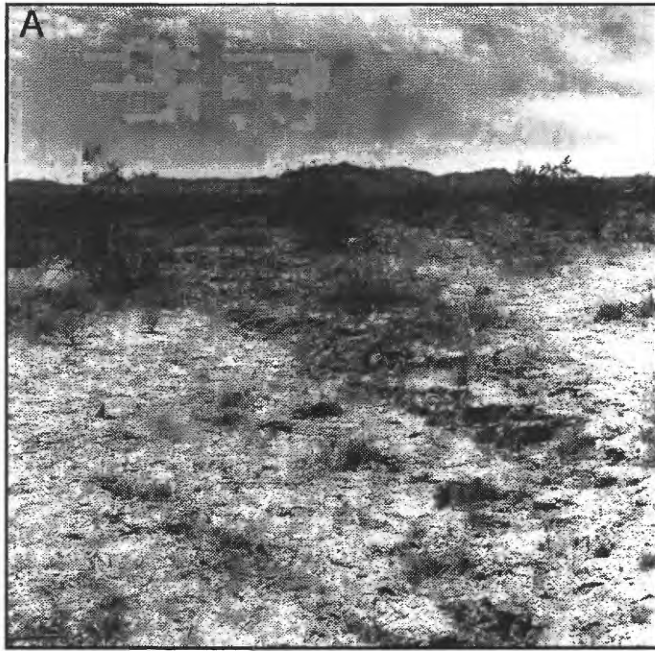
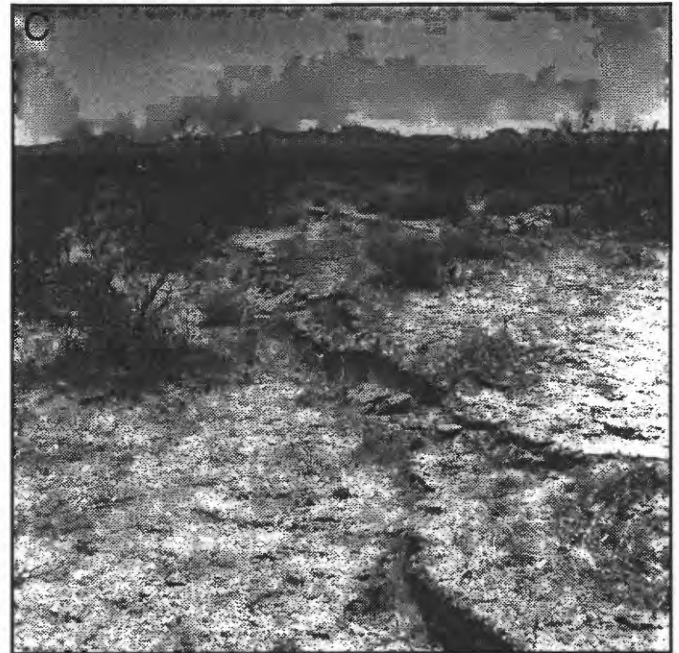
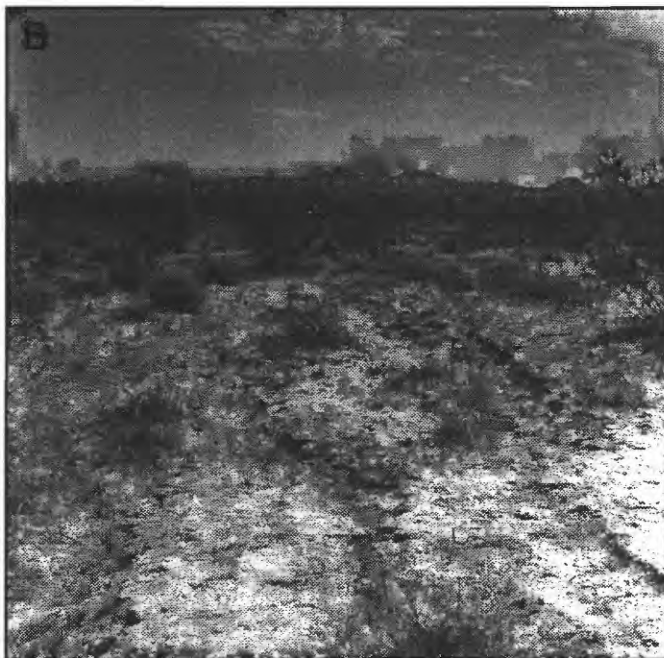
Figure 22. Views along left-lateral ruptures at Pipes Wash releasing bend. All views to the southwest. A. Belt of closely-spaced ruptures trends away from observer whereas individual ruptures trend obliquely across view. Downthrown side of most ruptures is toward camera. Ramps are the tilted blocks that connect the downthrown side of the left-lateral rupture zone on the left with the upthrown side on the right. B. More widely spaced ruptures and wider ramps farther southwest than in A. C. Most widely spaced ruptures, and widest ramps, near southwest end of left-lateral rupture. Because of their breadth, only two members of the en echelon belt are visible.
