Mass Movements

Rainfall February 1996

Impact in Washington State

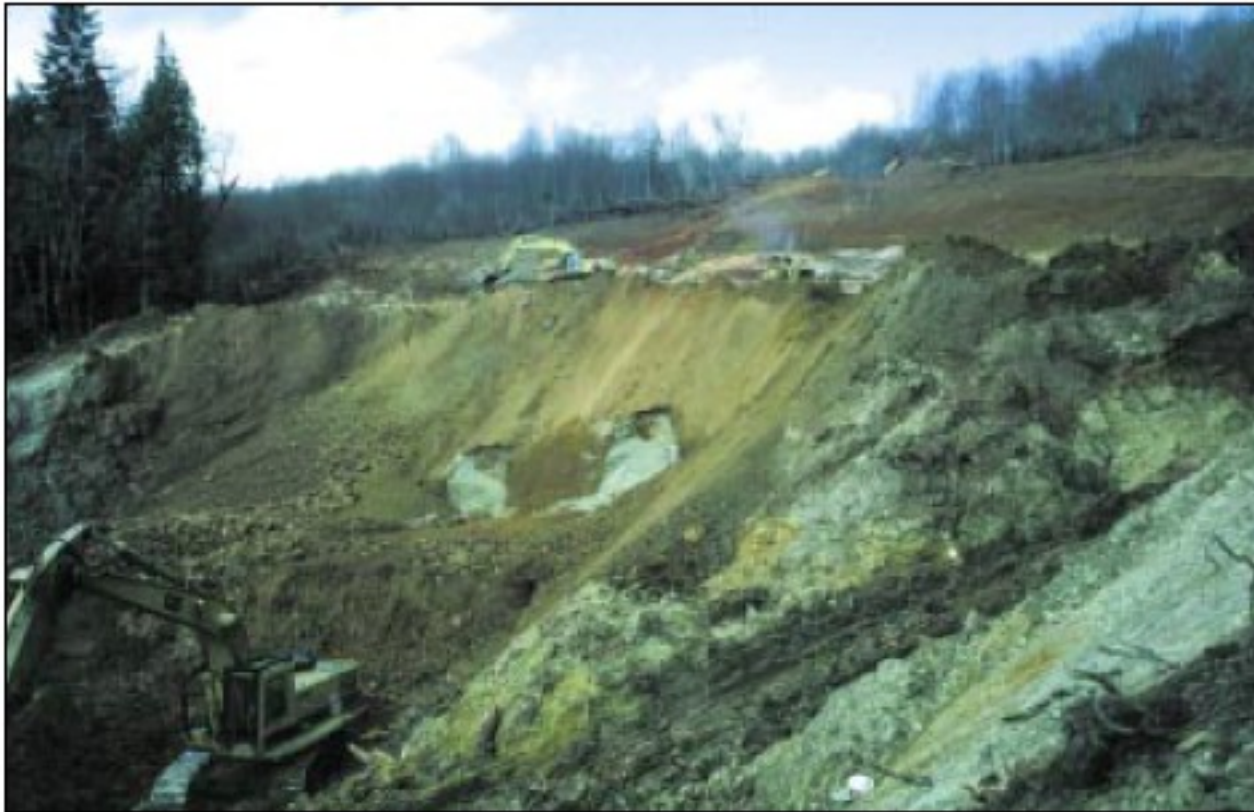
Figure 10 Head-scar area of slump-debris flow shown in figure 9

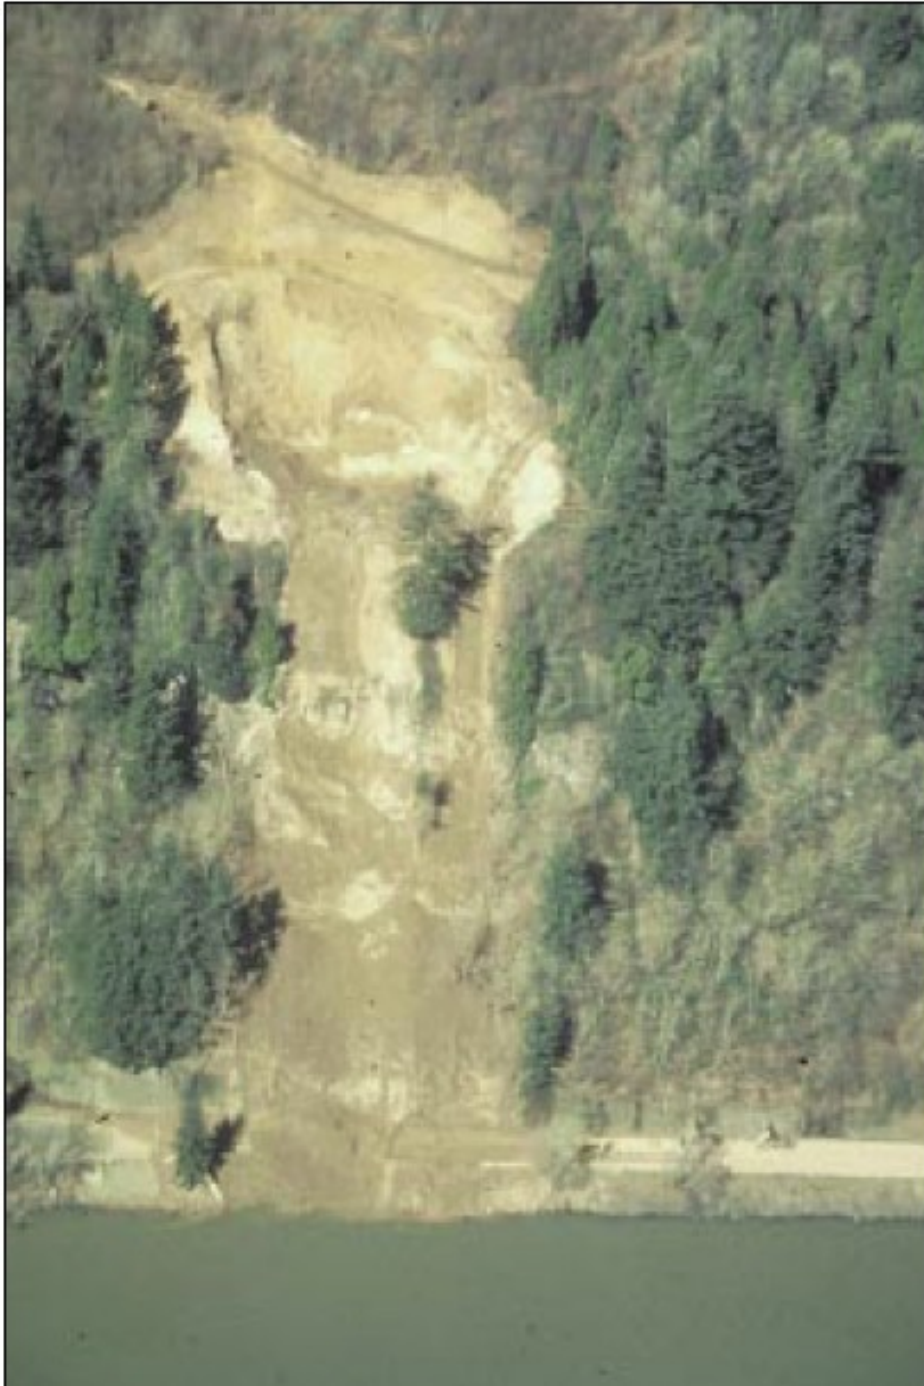
Figure 9. Large slump-debris flow located about 5 mi west of Stella, Washington on SH-4.

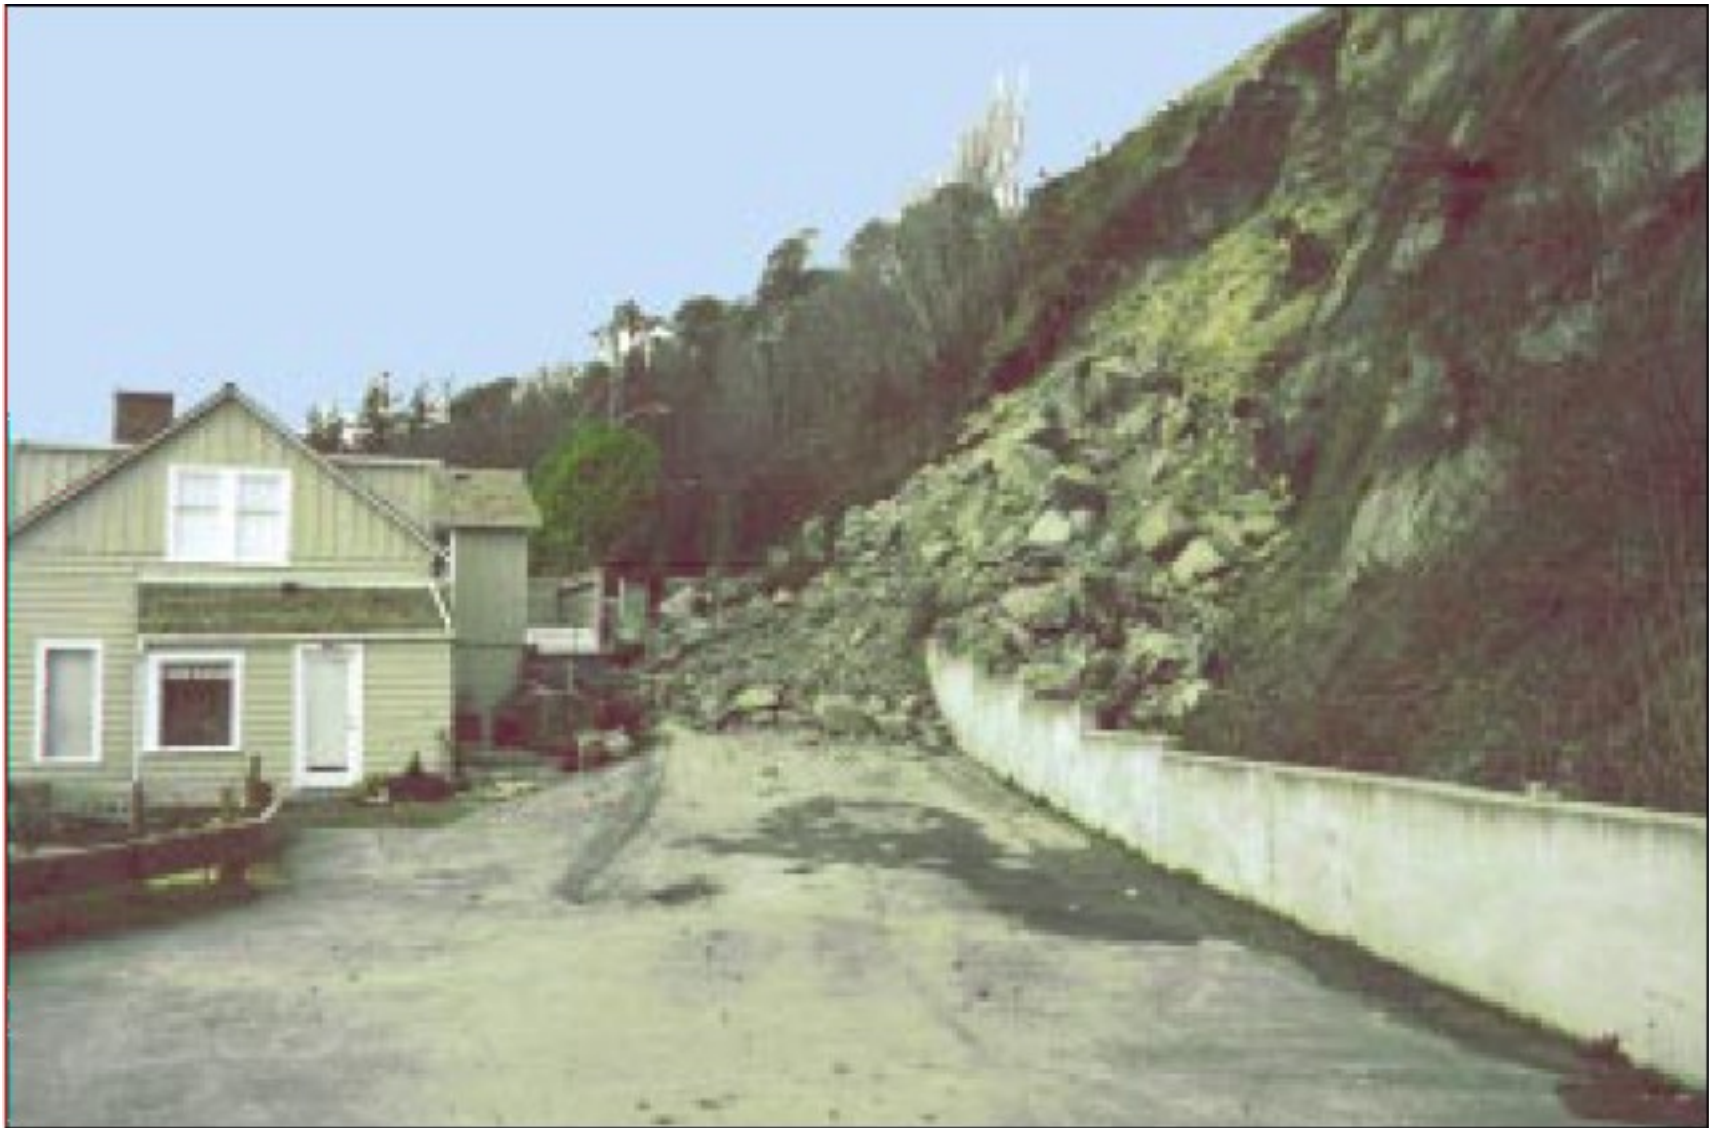
Figure 11. Rock fall next to a house on Perkins Way in northern Seattle. Rock fall is a secondary failure on a larger rotational slump whose failure surface projects beneath the house and Perkins Way.

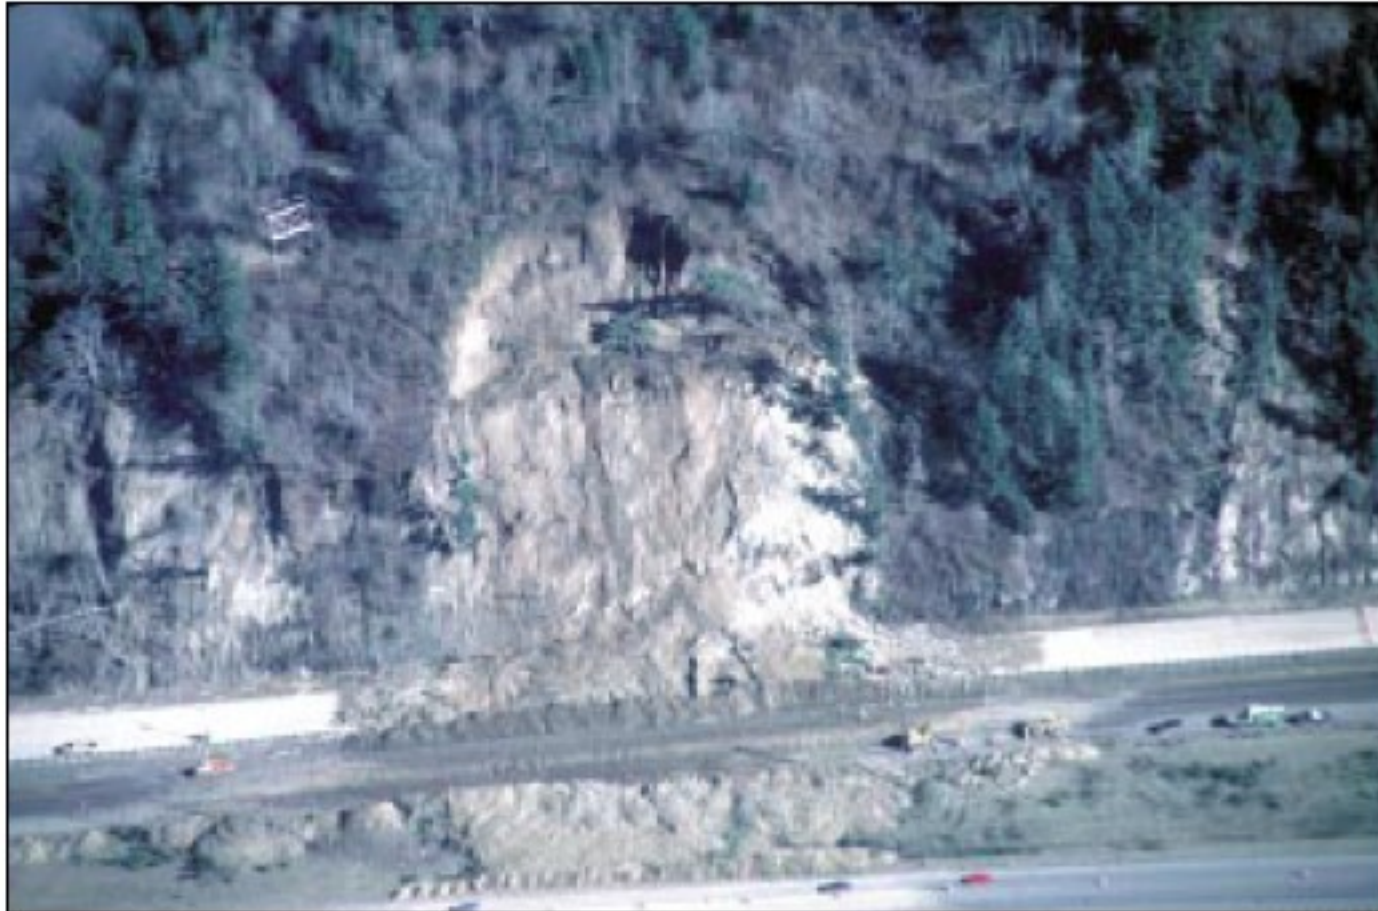
Figure 18. Slump north of Woodland, Washington that covered I-5 and the Burlington Northern-Santa Fe rail line.

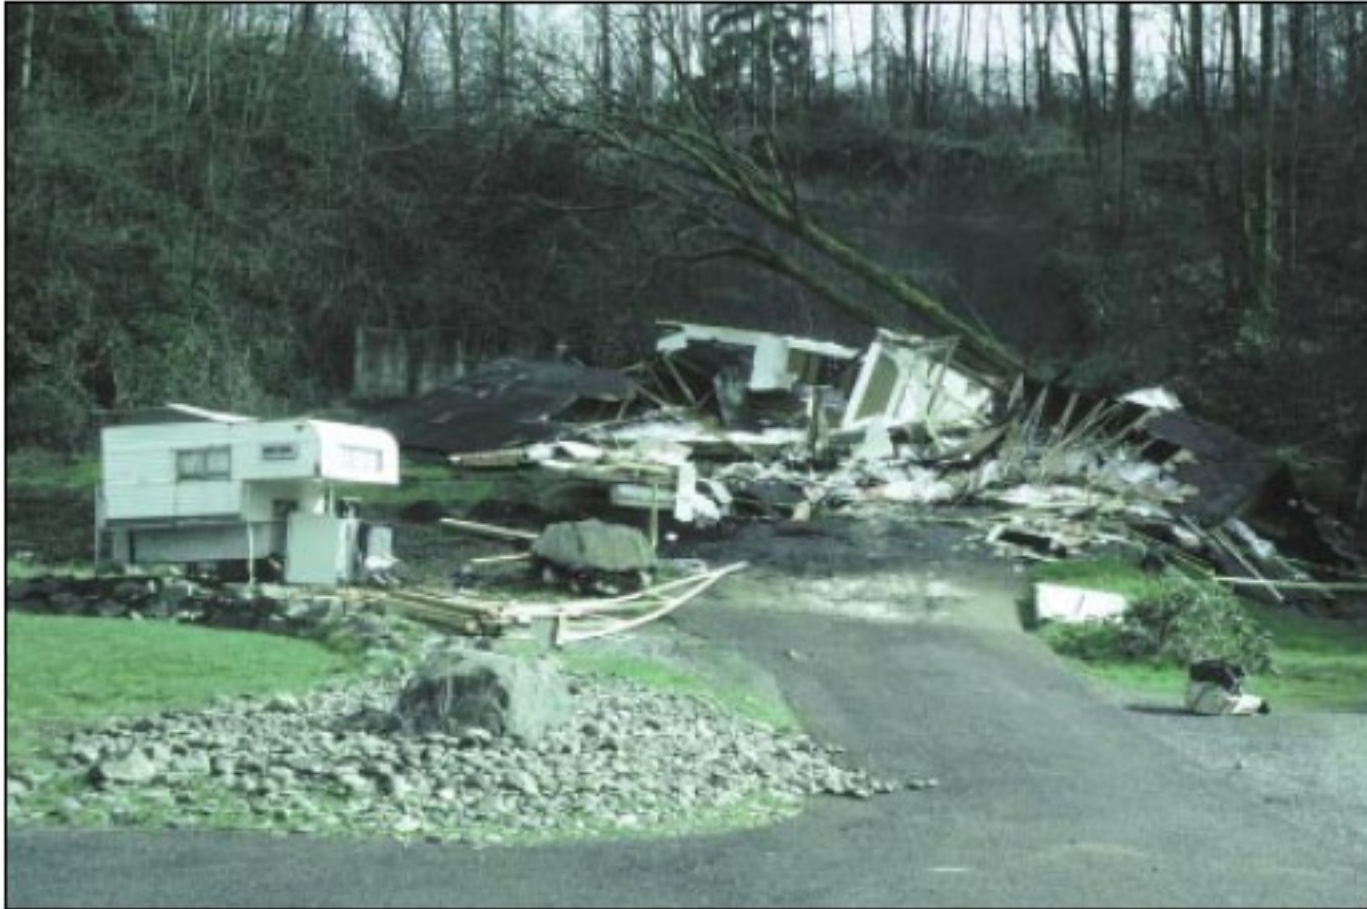
Figure 19. Small slump in northwest Vancouver that destroyed a residence located next to a steep slope bordering an old river terrace.

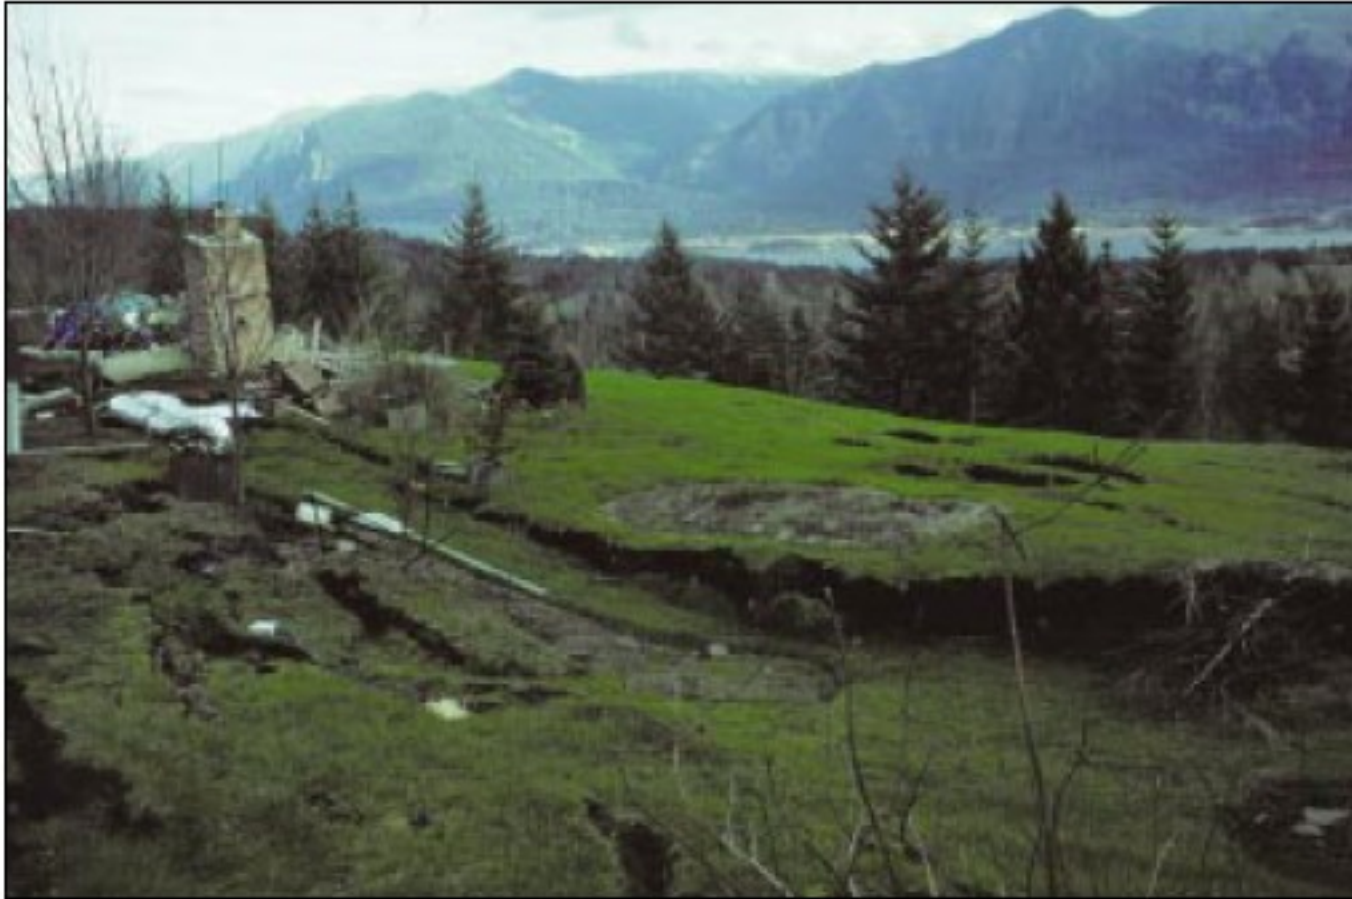
Figure 20. Headscarp area of deep-seated, complex rotational slump-earth-flow in subdivision in Stevenson, Washington. Landslide has resulted in removal of three houses and has threatened six or seven additional residences.

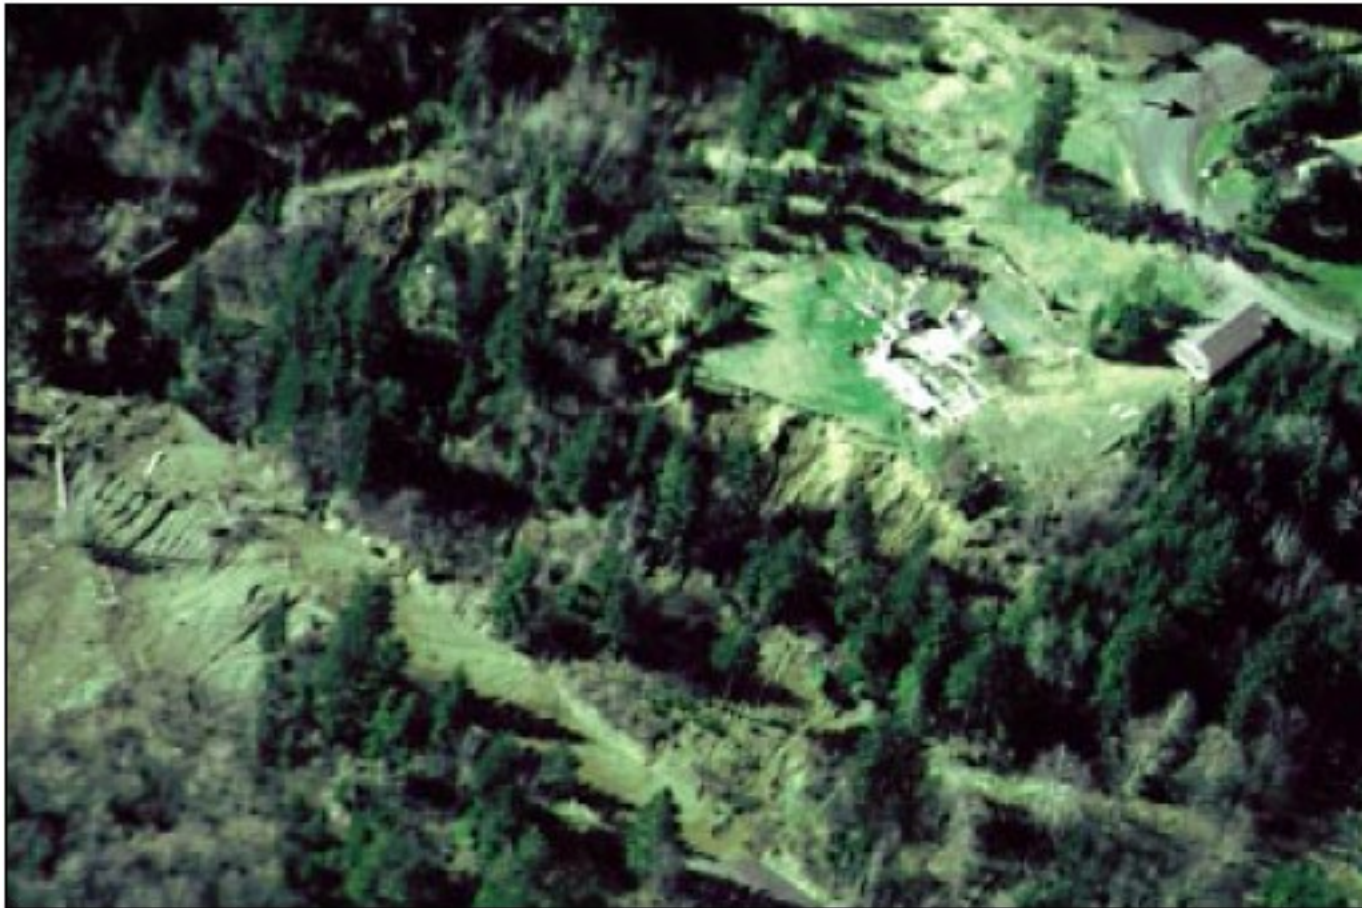
Figure 22. Aerial oblique view of Stevenson landslide. At center right is foundation shown in figure 21. Arrows denote additional extension fractures up-slope from fractures shown in figures 20 and 21.

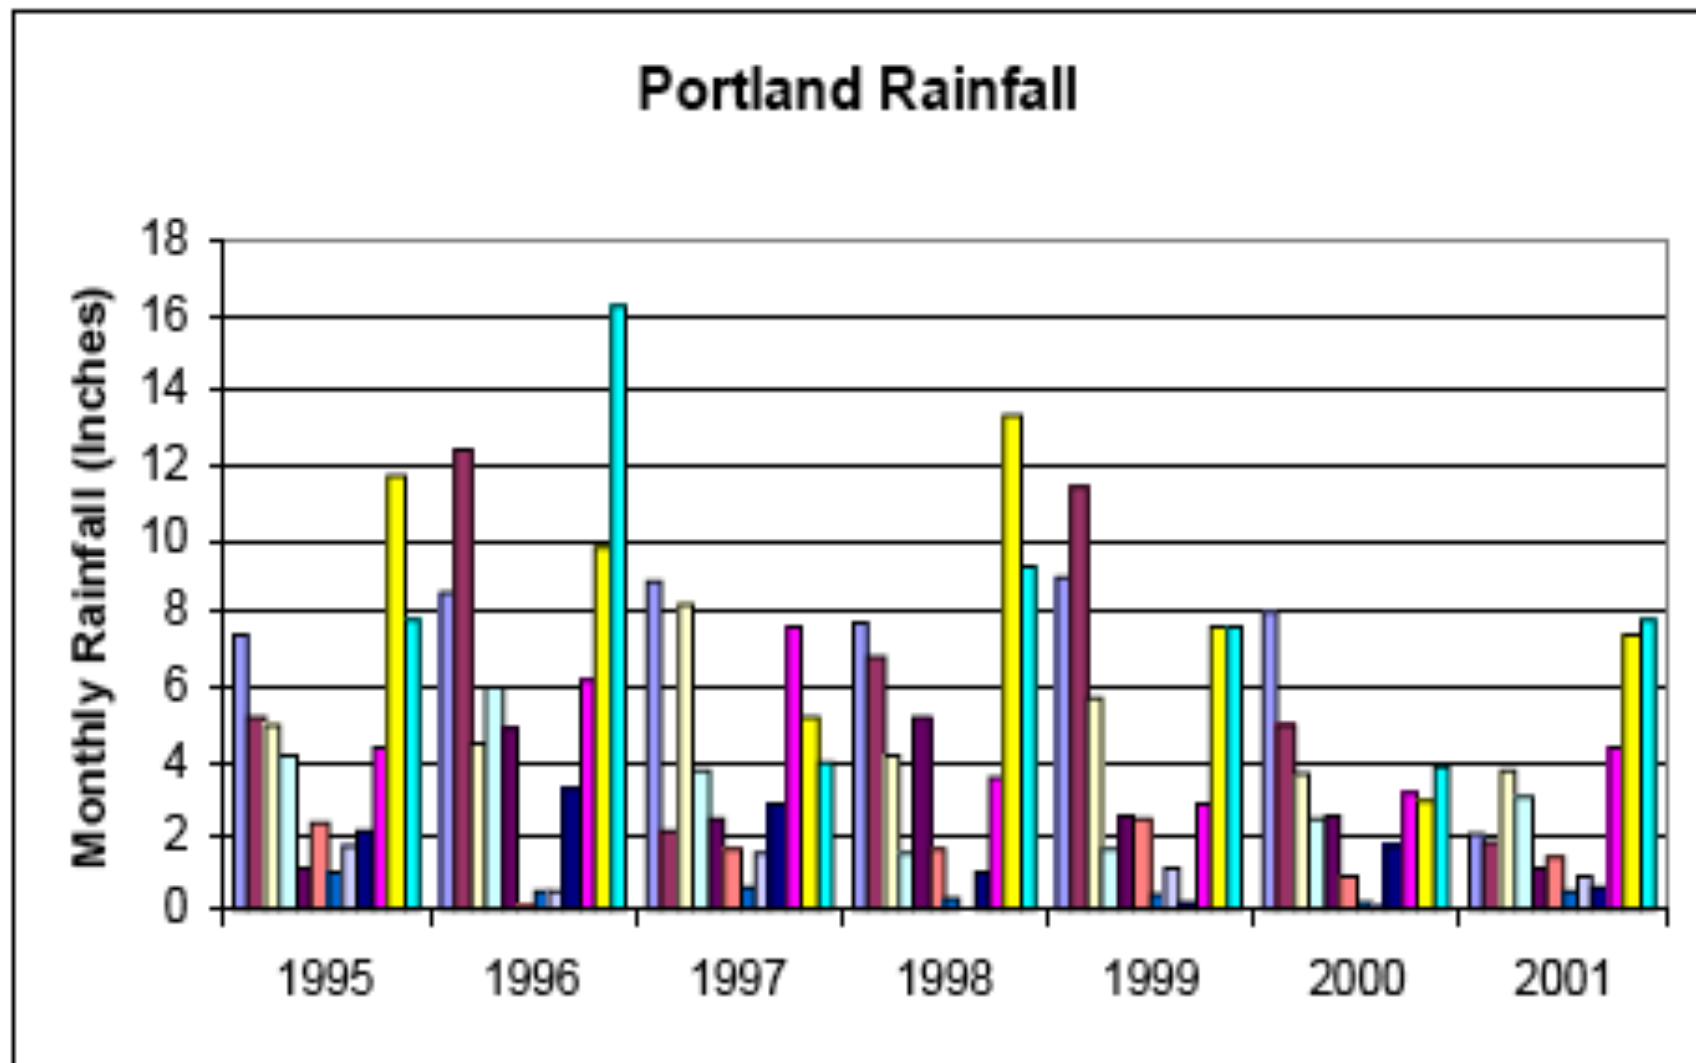
Figure 3. Seven years of monthly rainfall data in Portland, Oregon. This graph shows the variability in rainfall pattern, which directly affects landslide occurrences.

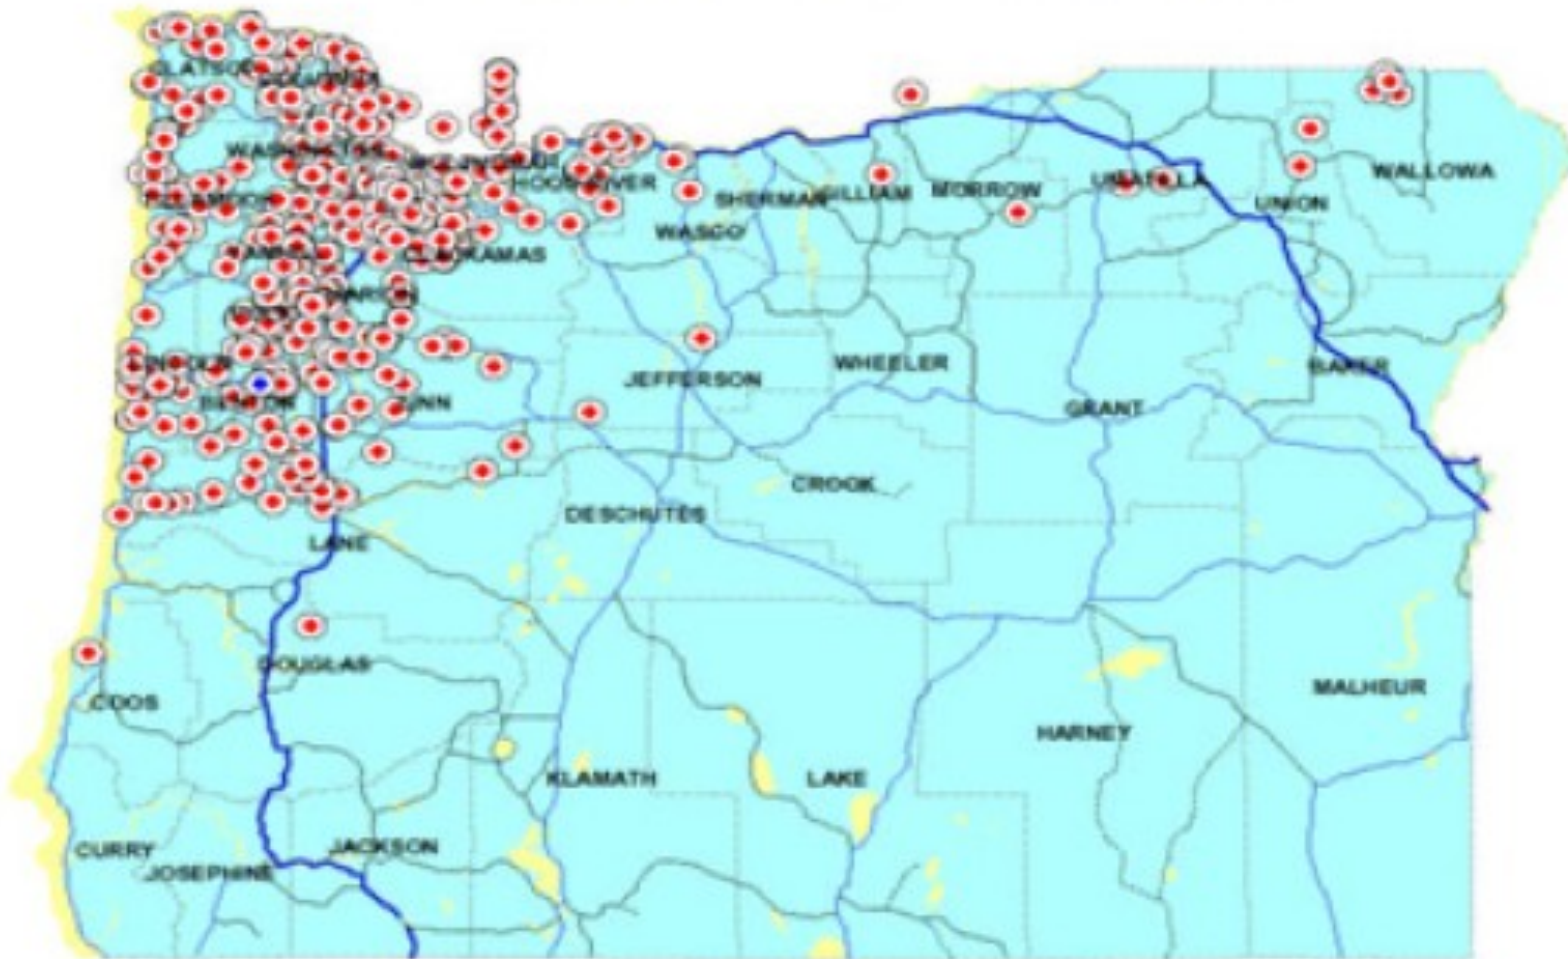
- Landslide, flow, or ground failure reported by Public Assistance, DR-1099
- Landslide, flow, or ground failure reported by Public Assistance, DR-1107

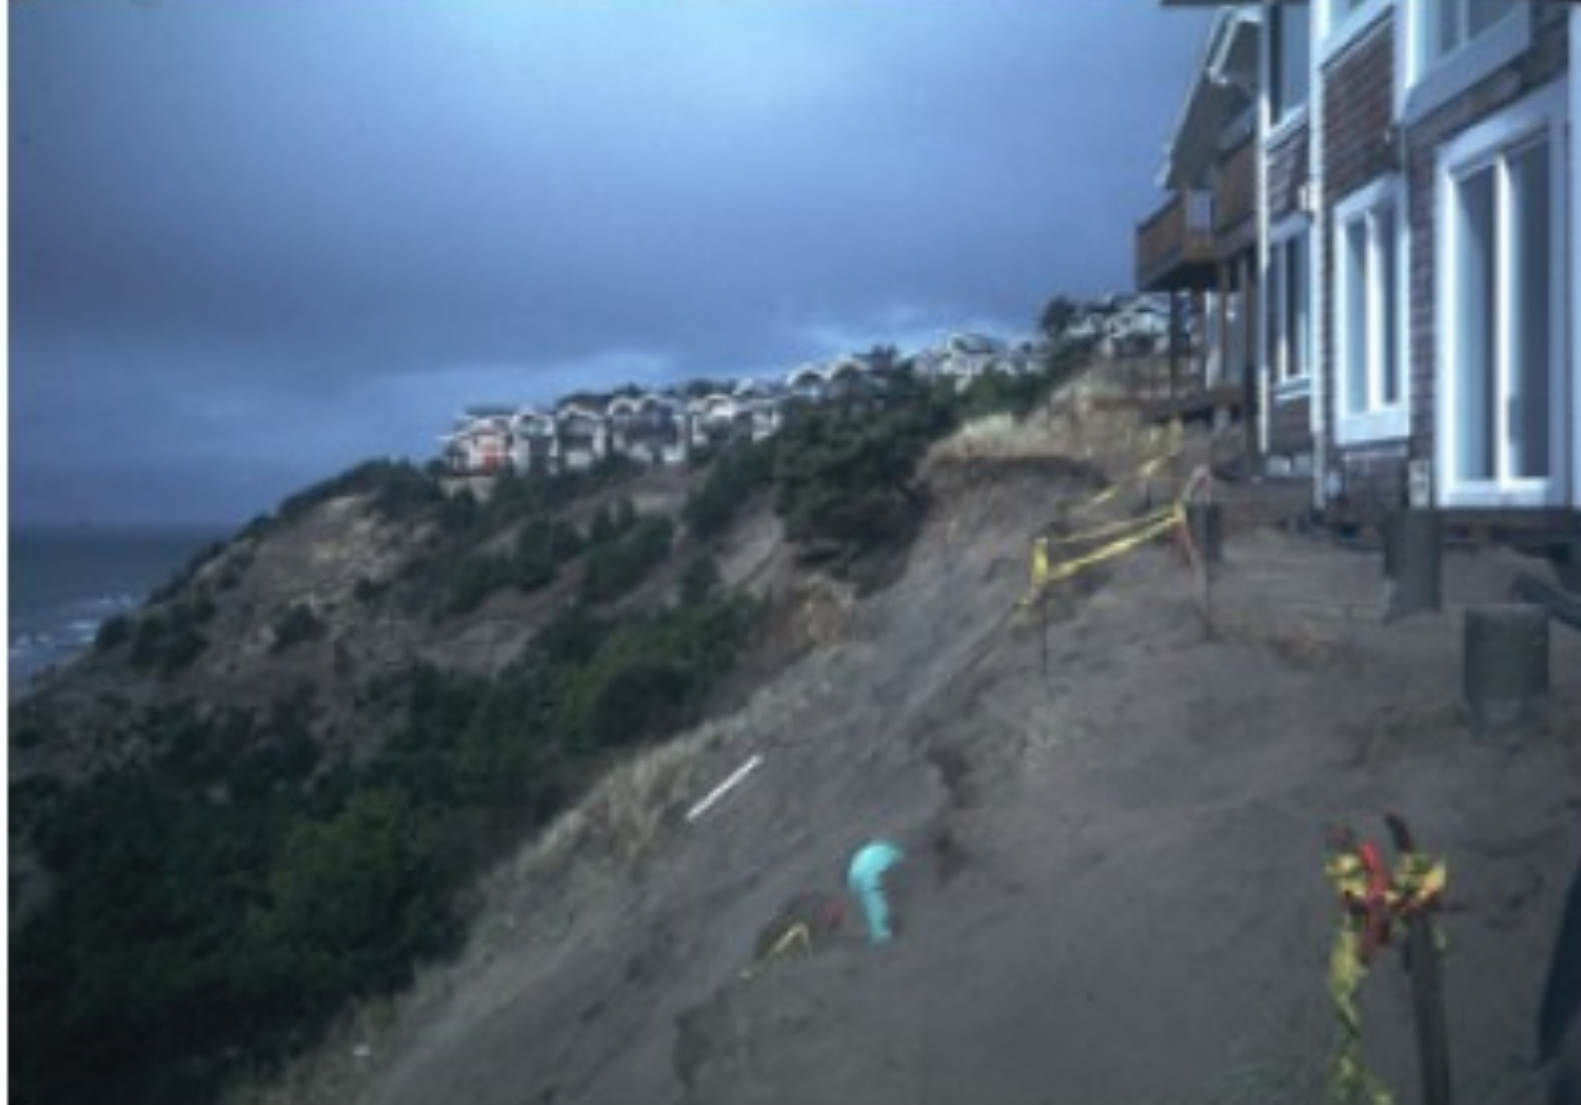
Figure 1. The Capes private housing community experienced landslide and coastal erosion damage associated with the 1997-8 El Nino event. Residents were evacuated and short-term mitigation was implemented. Long-term mitigation options, which need to accommodate coastal building regulations, are still being evaluated. Photo: Paul Komar

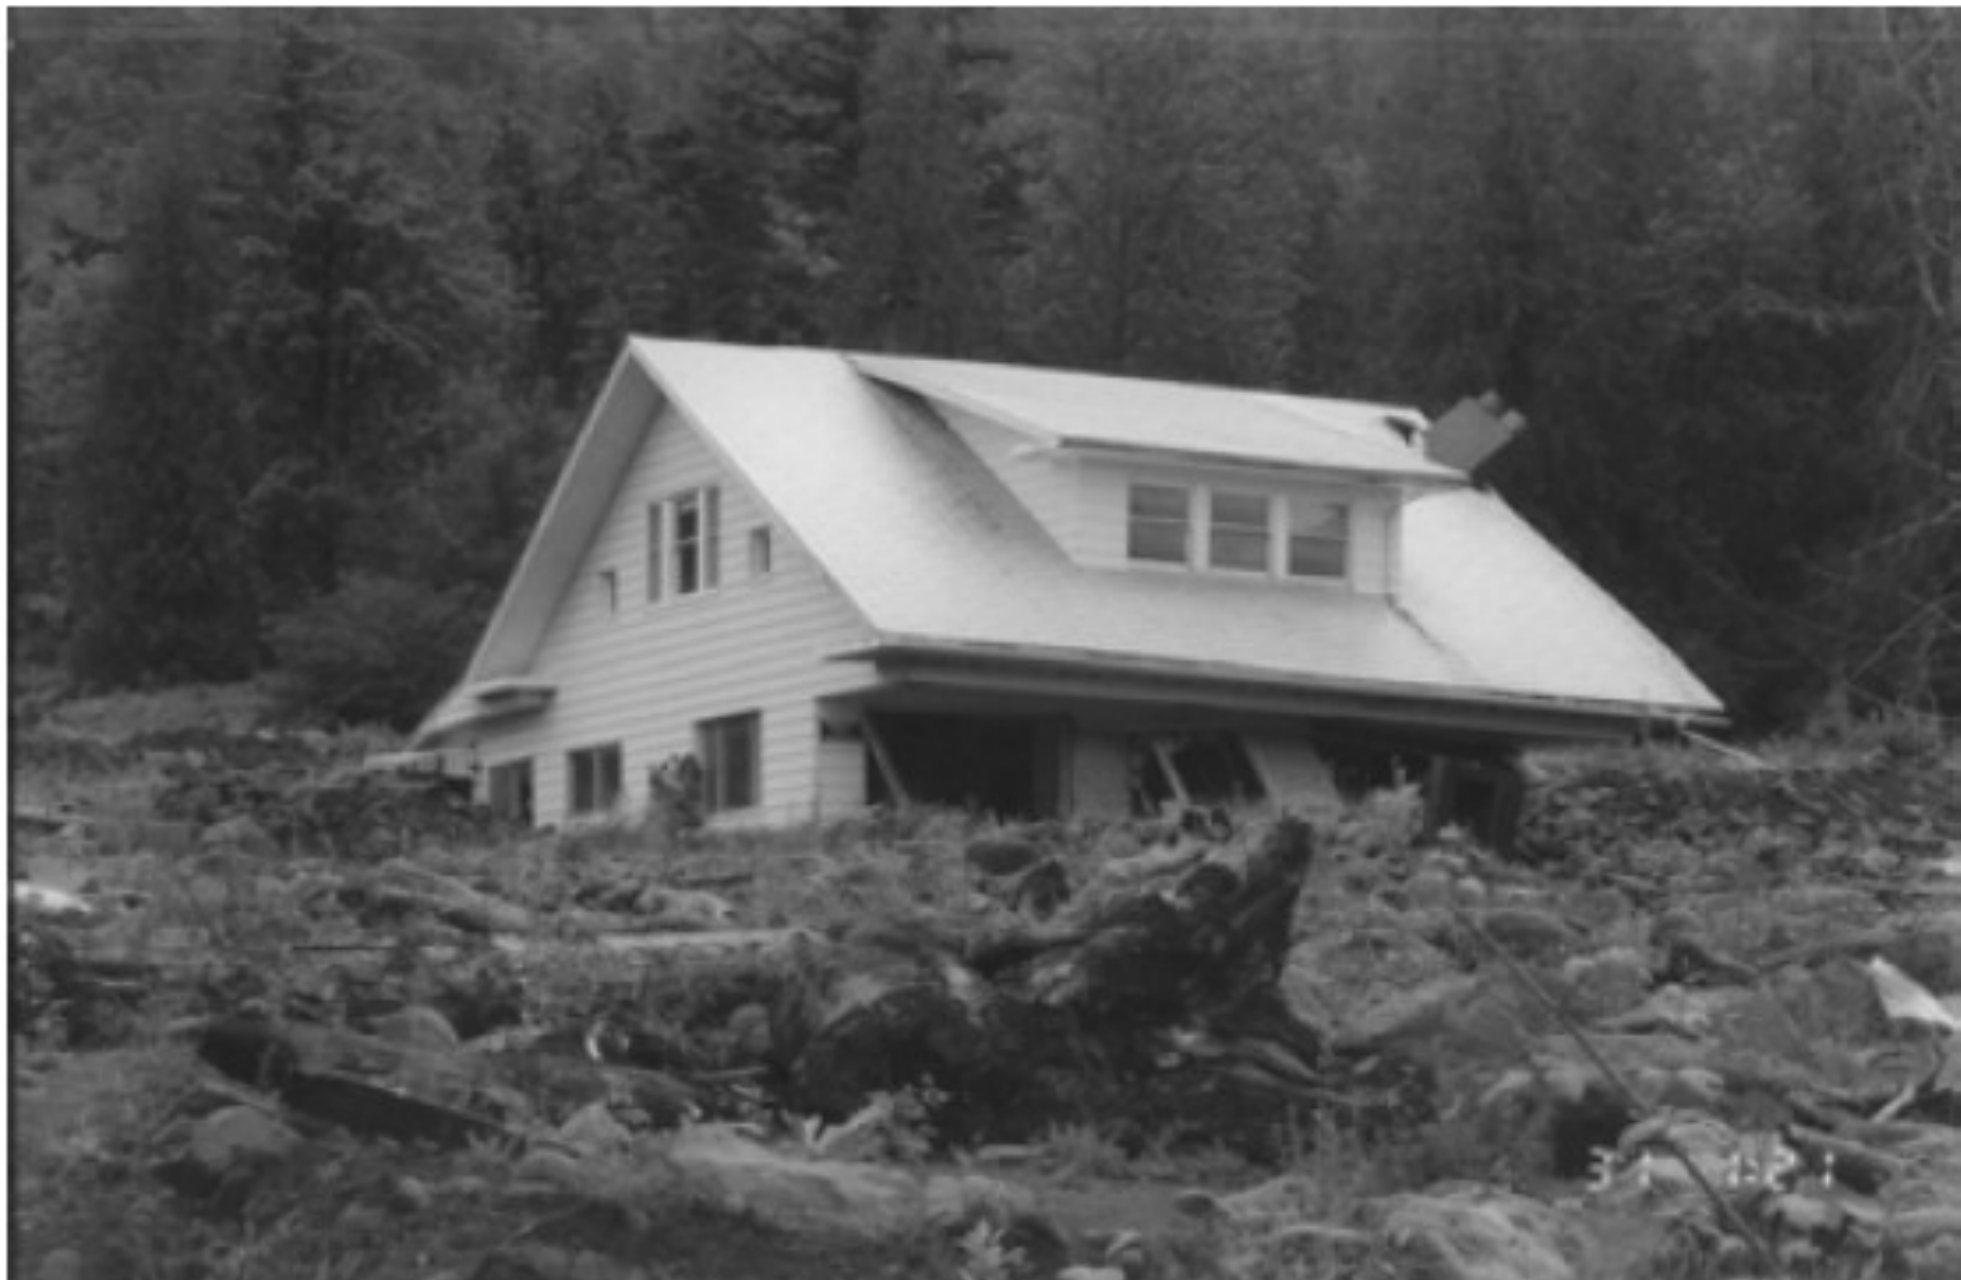
Figure 5. A debris flow destroyed this 2-story residence in Dodson, Oregon in the February 1996 FEMA-OR-1099-OR disaster.

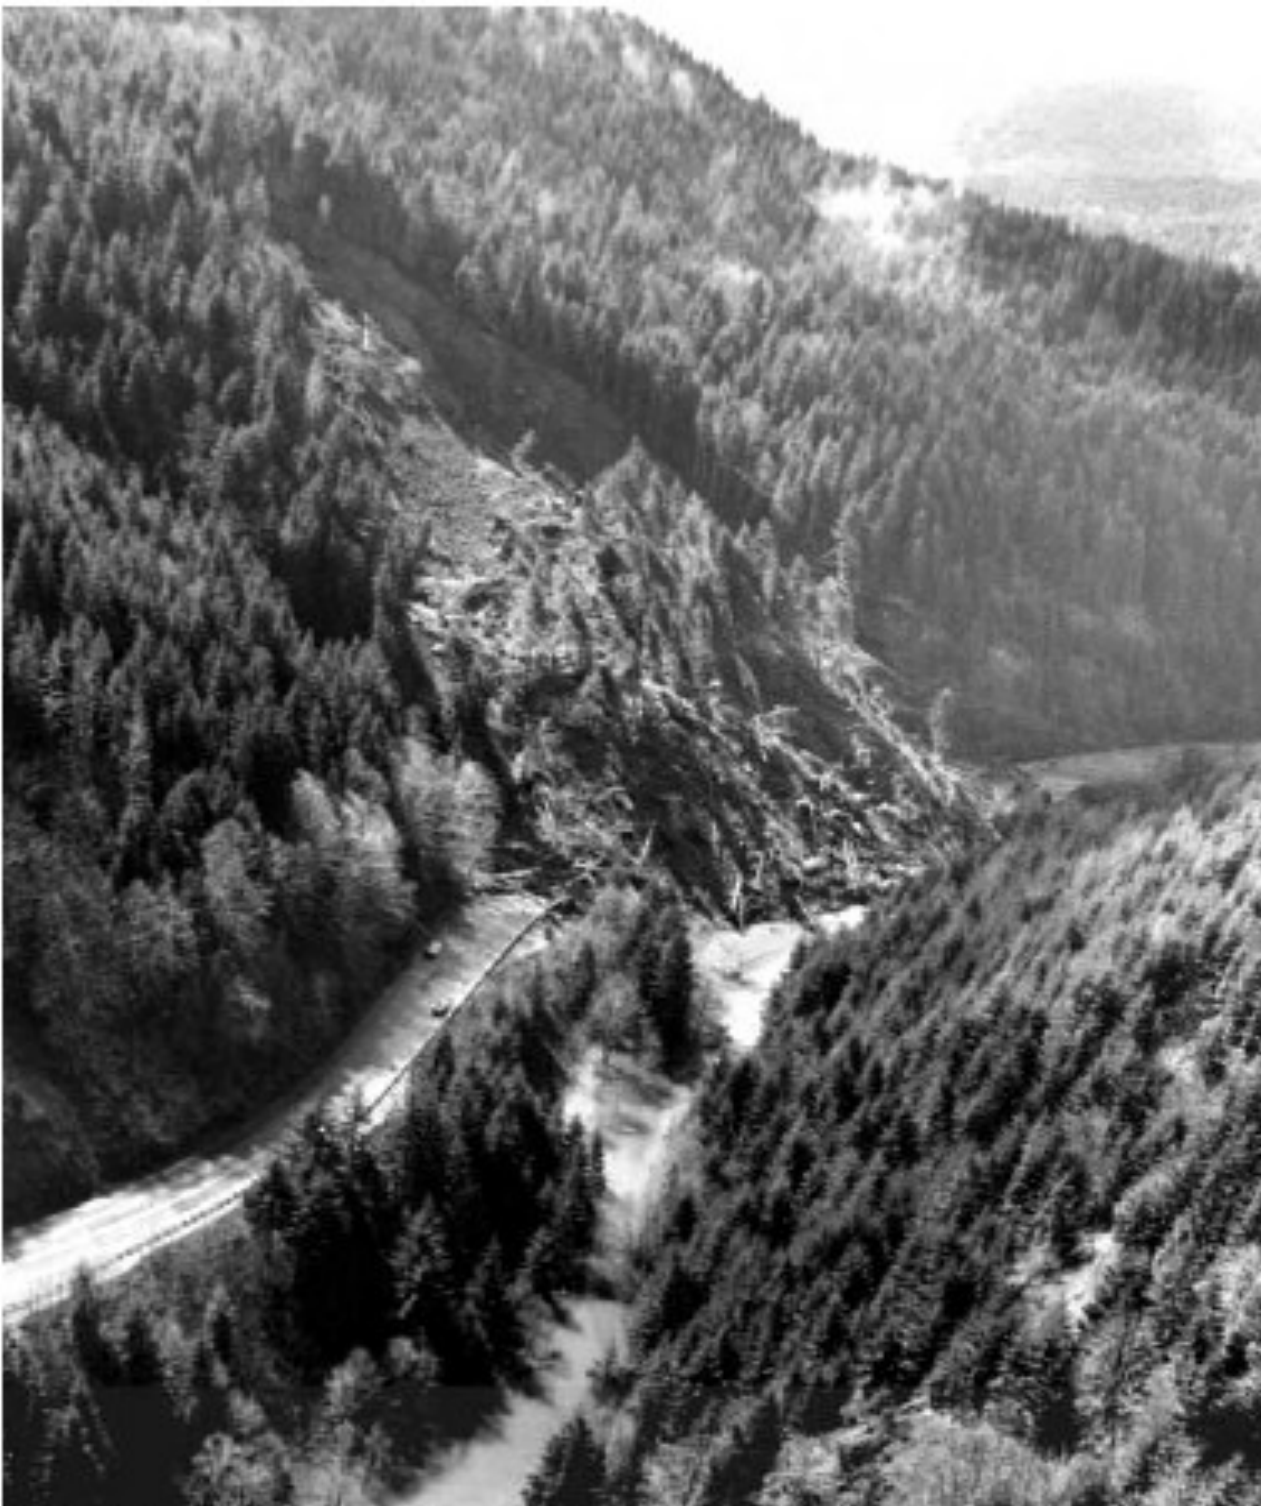
Figure 4. Rockslide that occurred along the Wilson River Highway (Hwy 6) in 1991. Though not a debris flow, this hazardous area is identified by the Further Review Area model. (Photo courtesy of Susanne L. D'Agnesse, Oregon Department of Transportation)

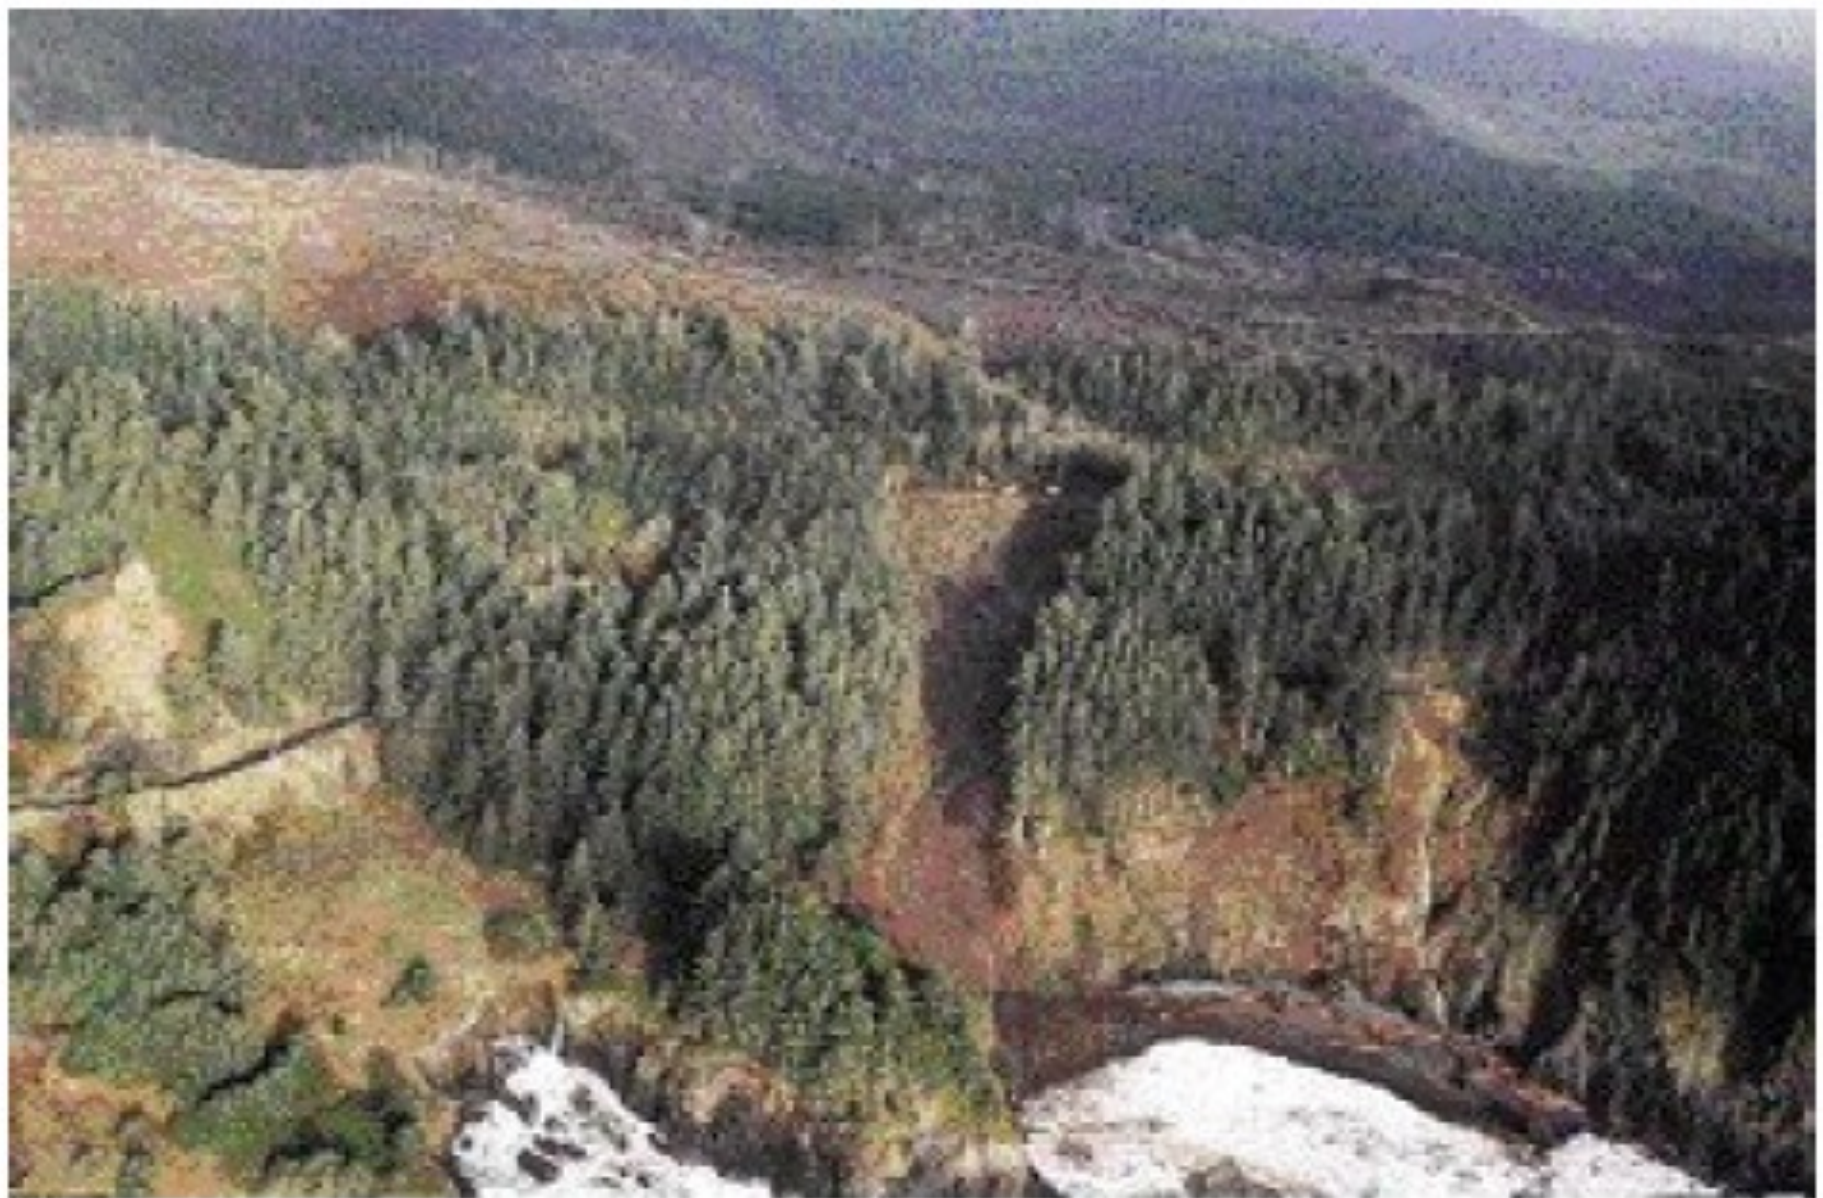
Figure 10. Cape Foulweather landslide. The downslope lanes of coastal US Highway 101 was damaged from a fill slope failure in December 1999. Repair work lasted about one month. (ODOI³³ photo)

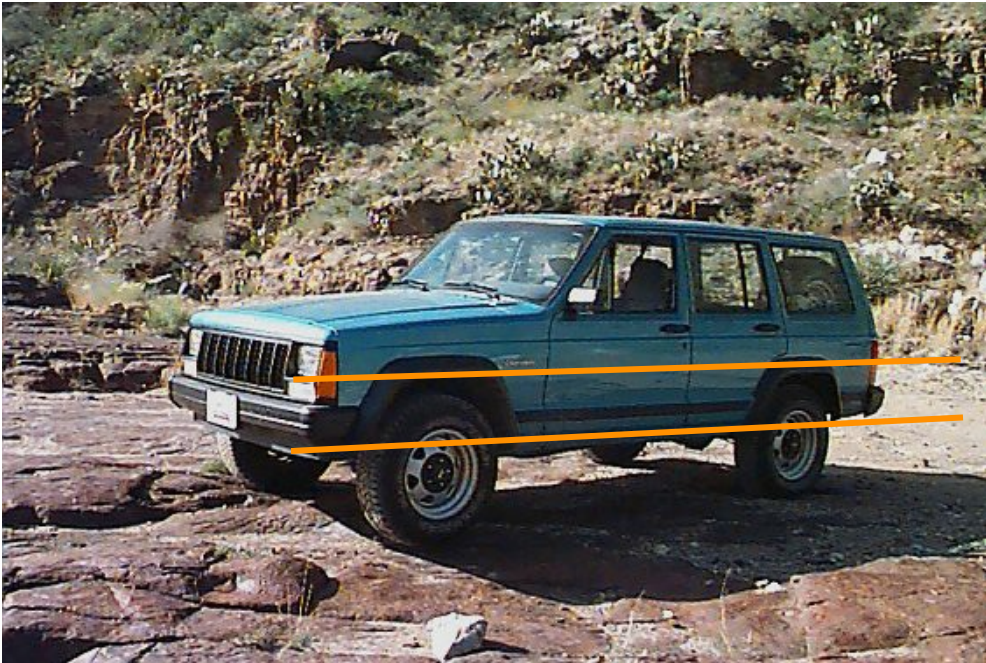
- Width: 5.5 feet
- Length: 14 feet
- Ground Clearance: 10 inches
- Weight: 3,400 pounds

However, 1 foot of water displaced by this vehicle weighs:
(5.5' x 14' x 1' x 62.4 lbs./cu.ft.) = 4,805 pounds

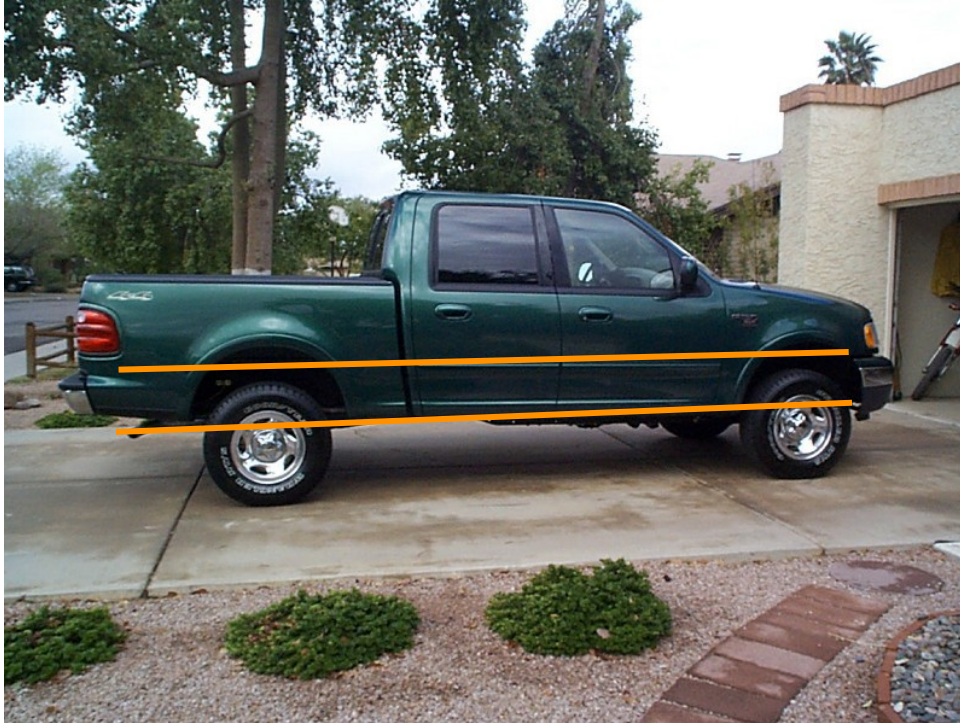
- Width: 6 feet
- Length: 18 feet
- Ground Clearance: 18 inches
- Weight: 5,040 pounds

1 foot of water displaced by this vehicle weighs:
(6' x 18' x 1' x 62.4 lbs./cu.ft.) = 6,739 pounds
