Mass Movements

Rainfall February 1996

Impact in Washington State

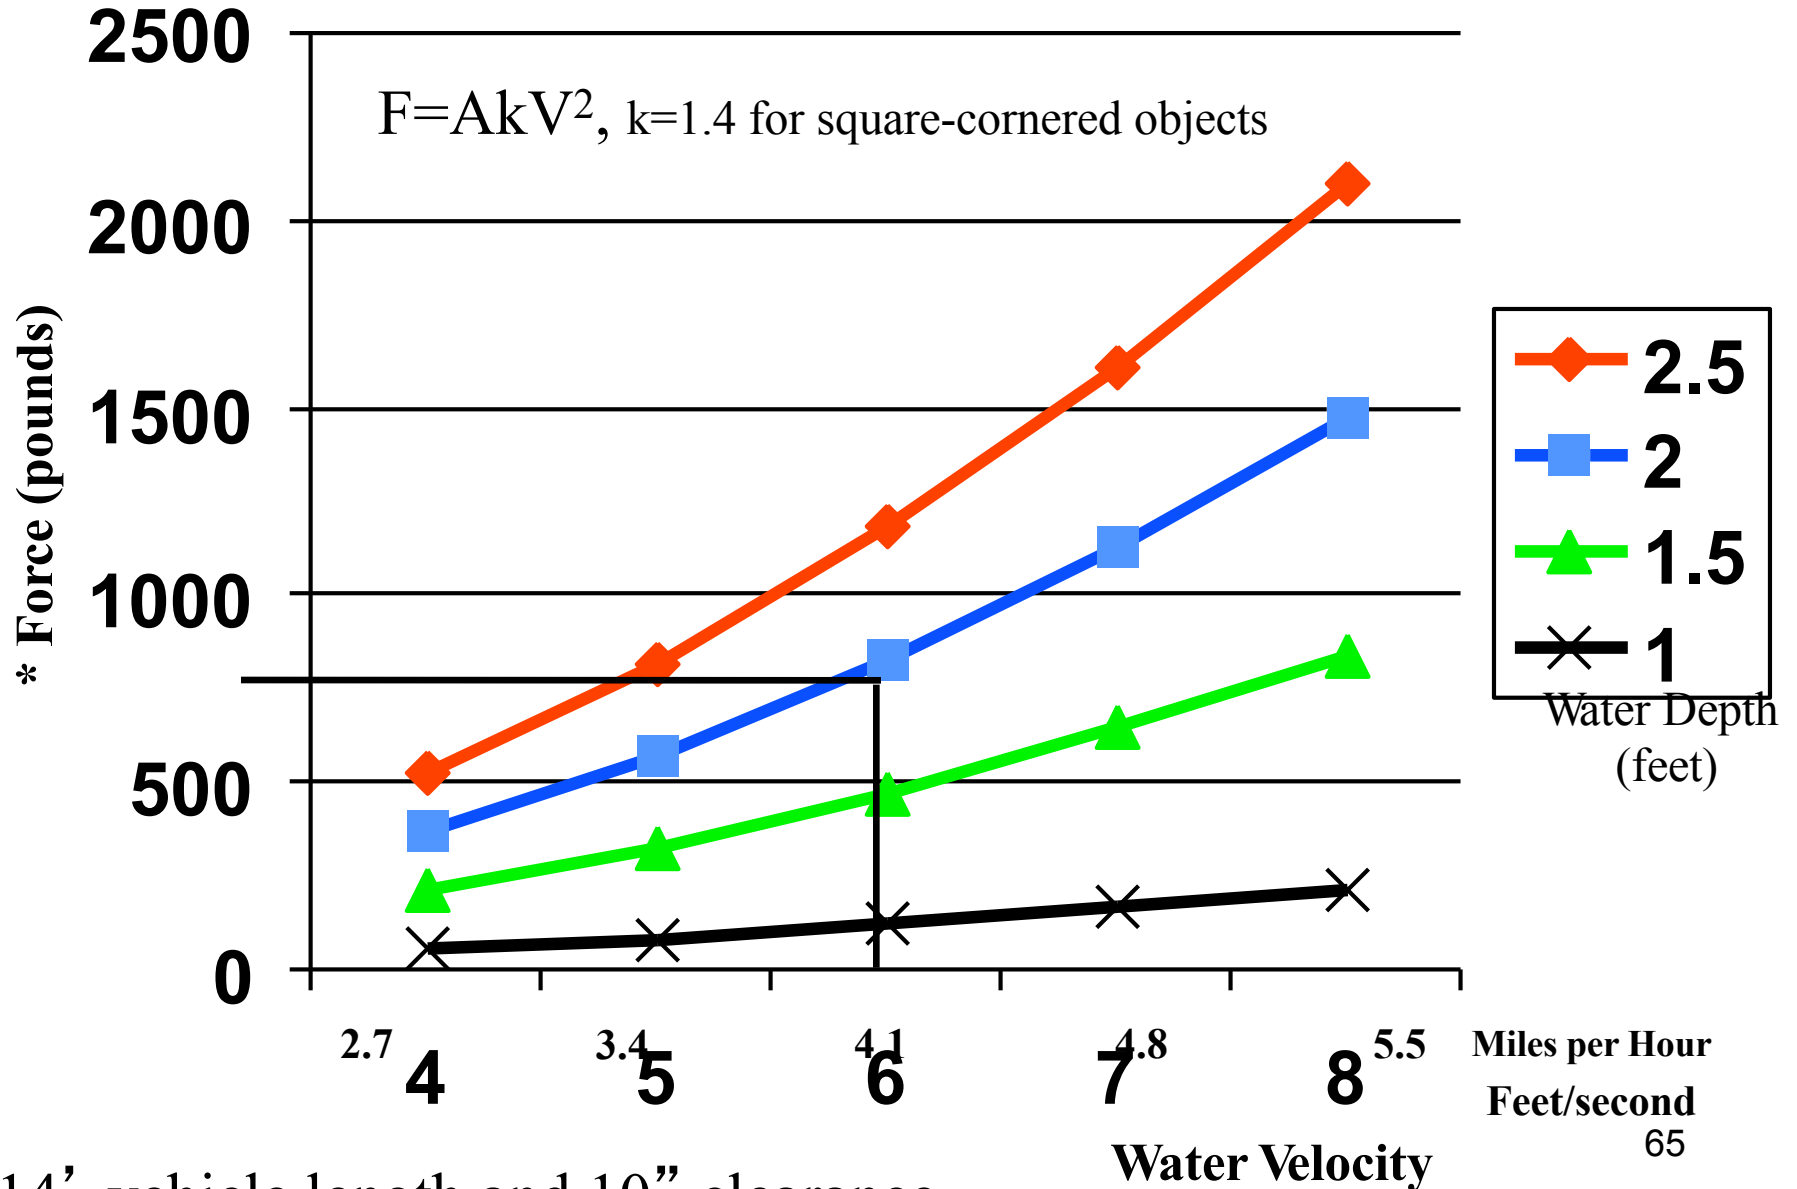
Stream Forces on Vehicles

* 14' vehicle length and 10" clearance
