Using Archived Data to Measure Operational Benefits of ITS Investments

**Analysis and Validation of Loop Detector Data
In the I-5 Corridor**

Research Report PSU-CE-TRG-02-03

May, 2002

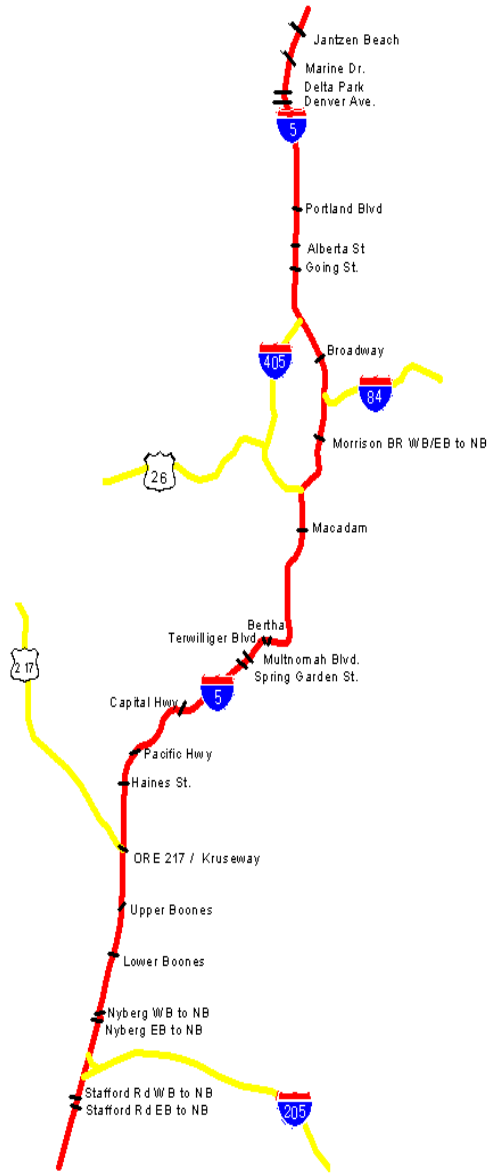
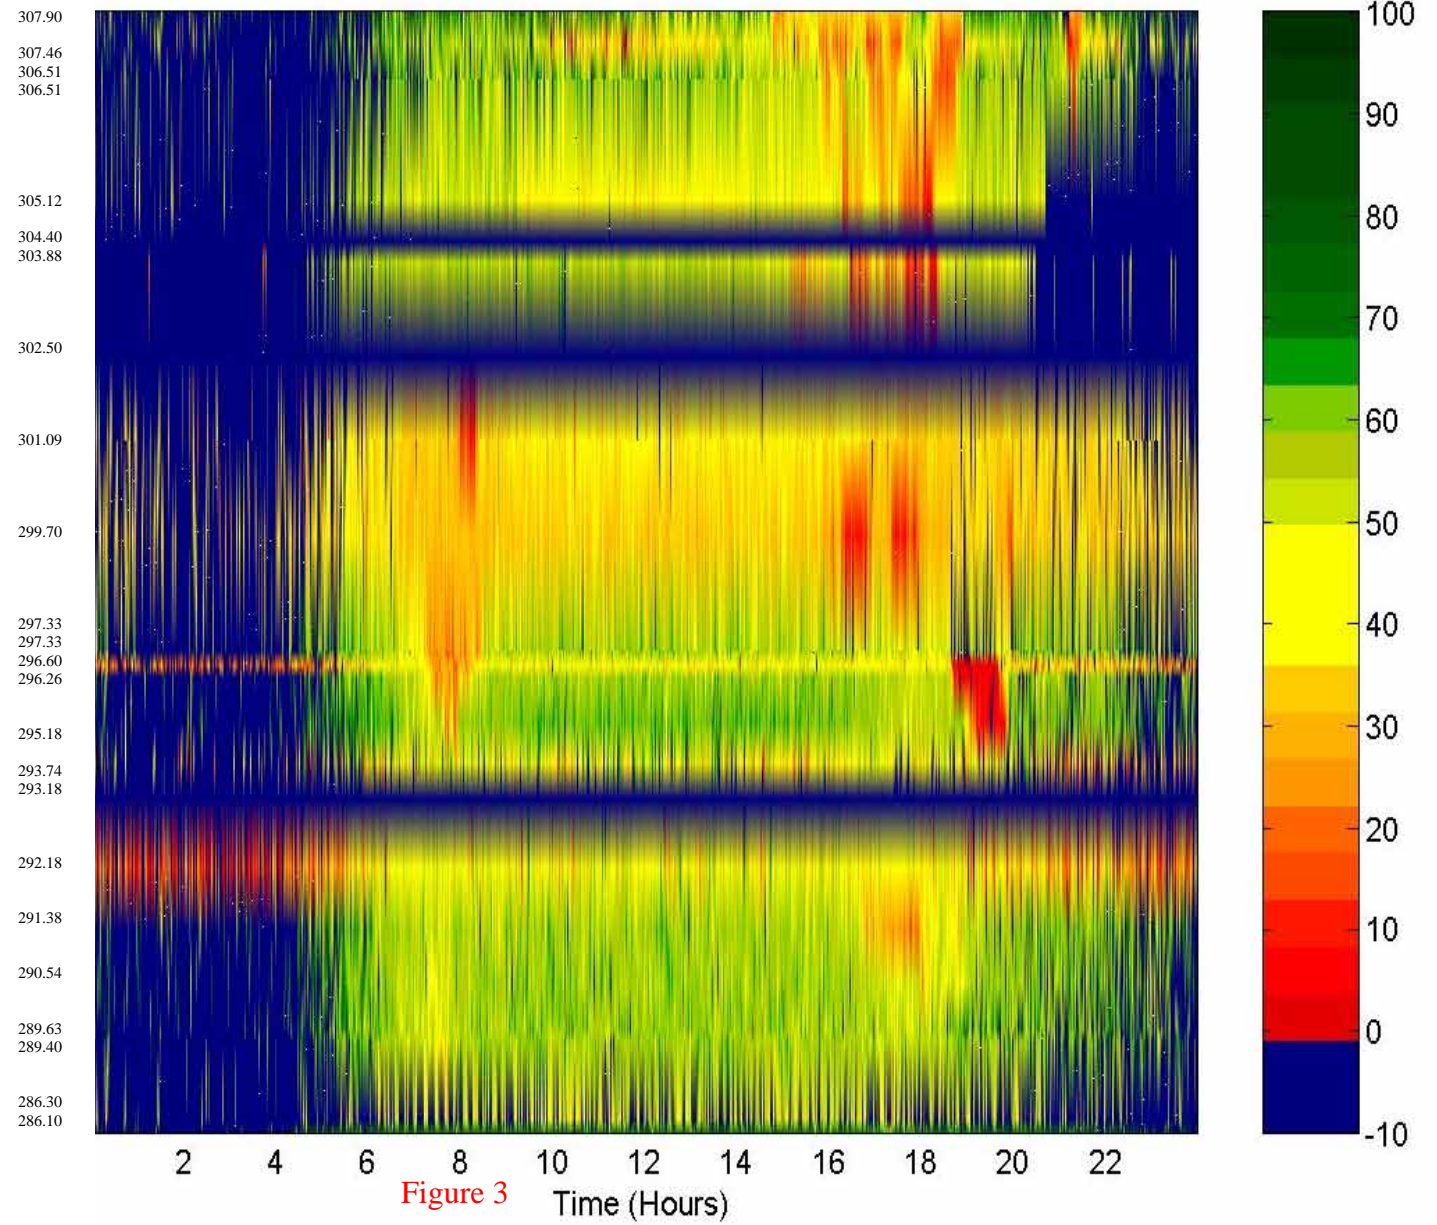
FIGURE 2

Different plotting techniques were used to assist in visualizing the data, including a speed contour diagram shown in Figures 2 and 3 for the northbound and southbound corridor respectively. In the figures the horizontal axis is time, the vertical axis is distance (loop detector stations) and the colors represent speed. In these plots the negative values are shown in blue. To improve visualization, data with -999 or -1 were replaced by -10. On this day, one southbound station (Wheeler, MP 302.17) reported values of 0.

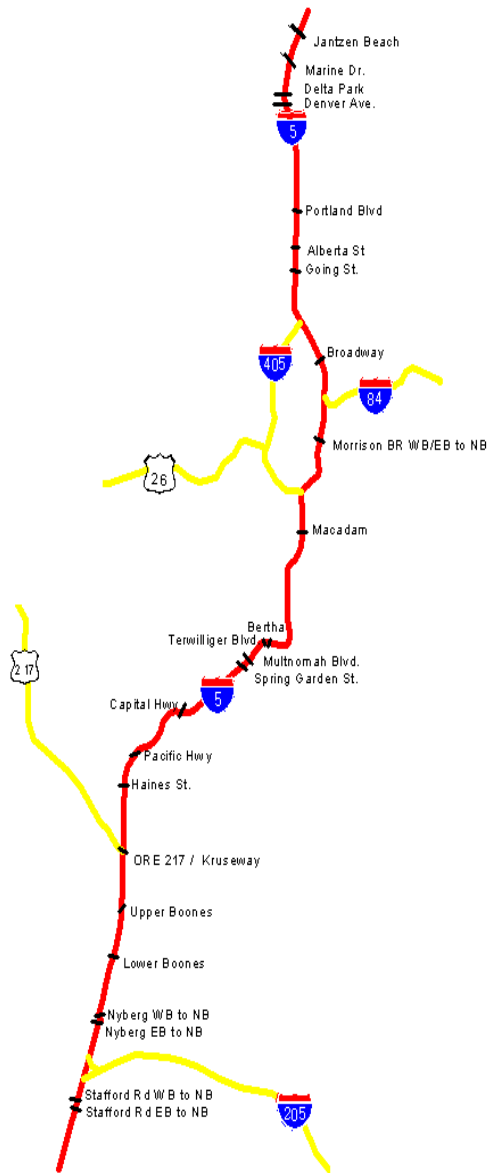
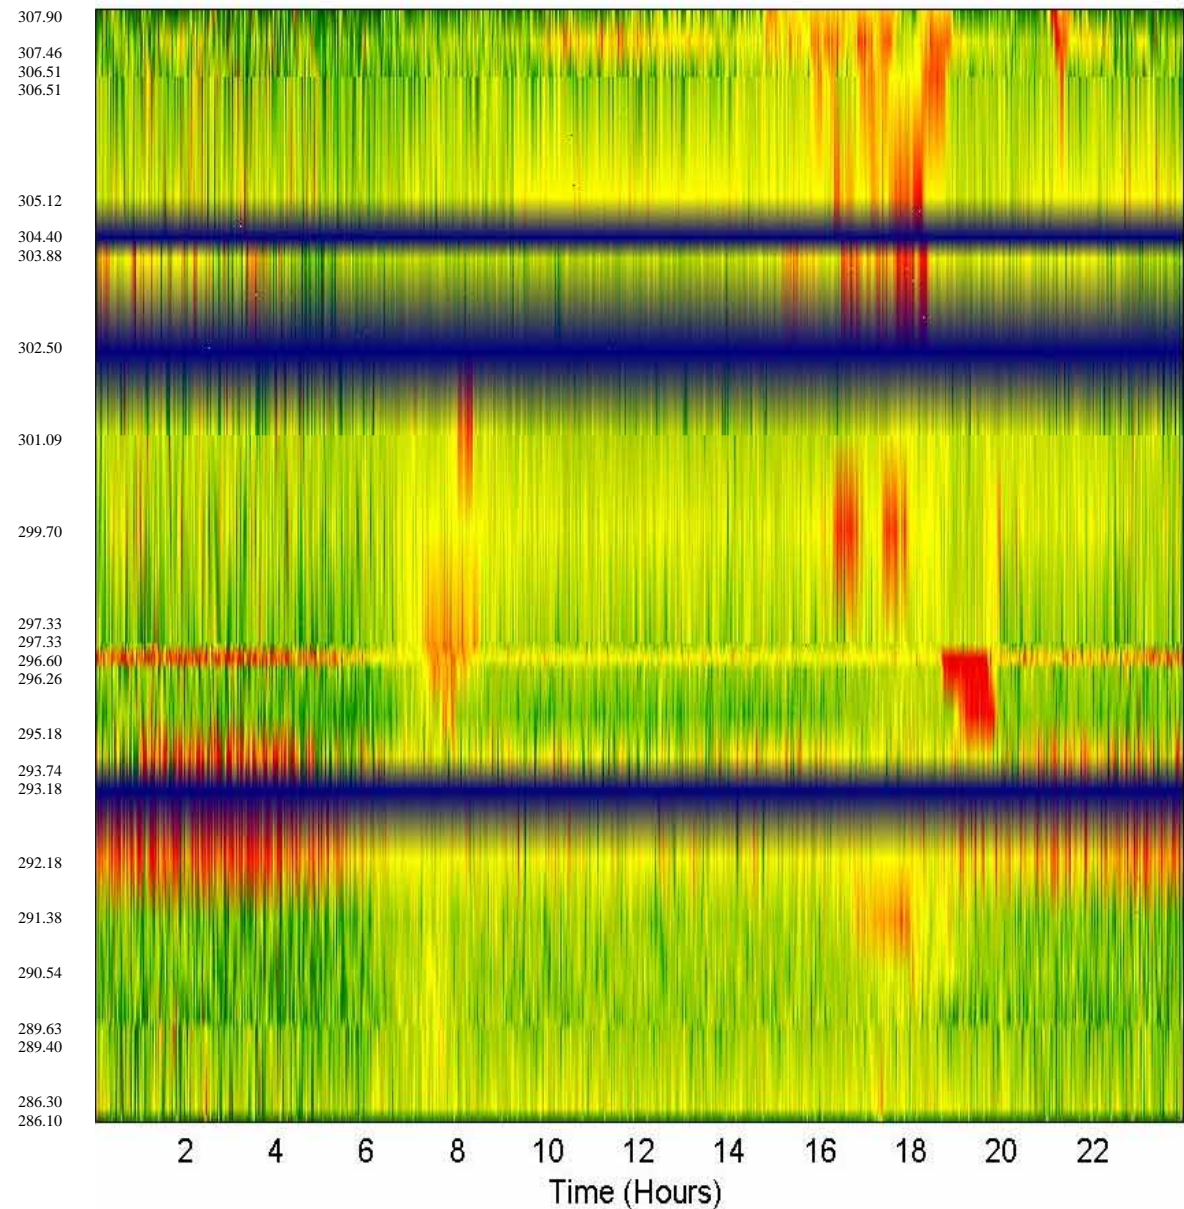
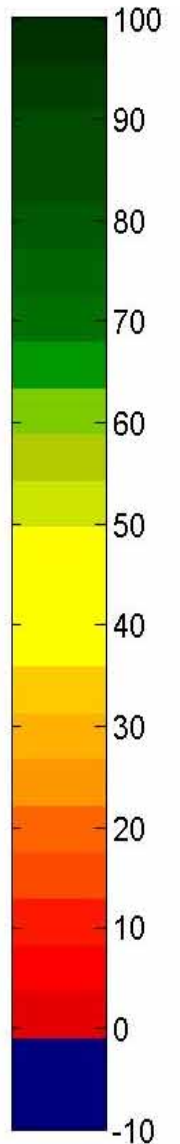
FIGURE 4

In order to further clarify the visualizations, a filter was applied to remove the negative values, as shown in Figure 4 and 5. The filter used simple averaging techniques to account for a negative value in one lane. If there was a negative reading in one of the lanes, the average speed was calculated using the other lanes. Locations where all lanes included -1, -999 or 0 readings were given the color blue and marked as “No information.”

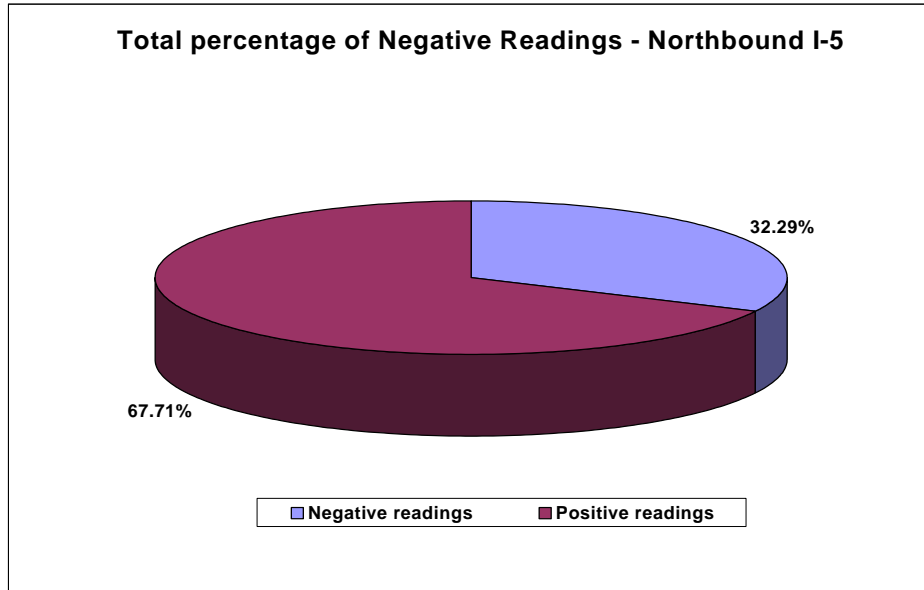
FIGURE 6

In order to understand the sources and impacts of loop detector negative readings, a detailed analysis was performed for one day. Figures 6 and 7 show the total percentage of negative readings on I-5 on the day studied.

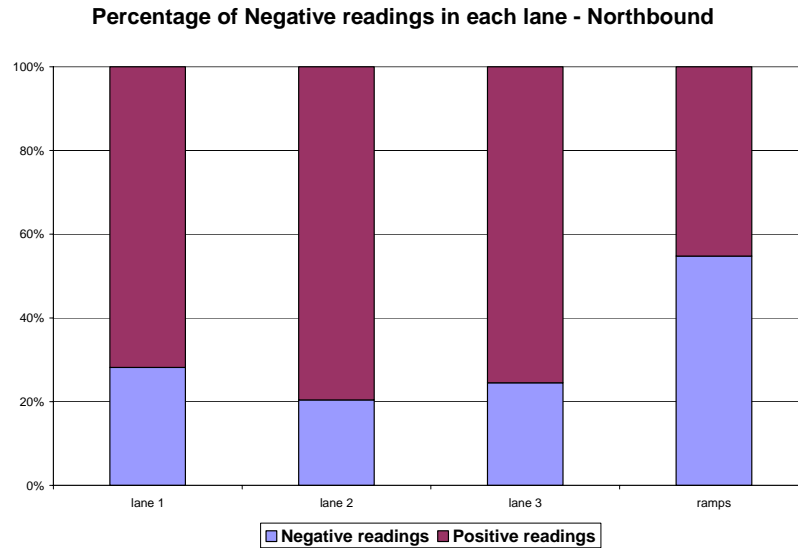
FIGURE 8

There was a great difference in the percentage of negative count values for the ramps and the mainline. Figure 8 and 9 show the distribution of negative readings versus positive readings. For the ramps it can be observed that the negative counts are more than 50% of the total number of counts.

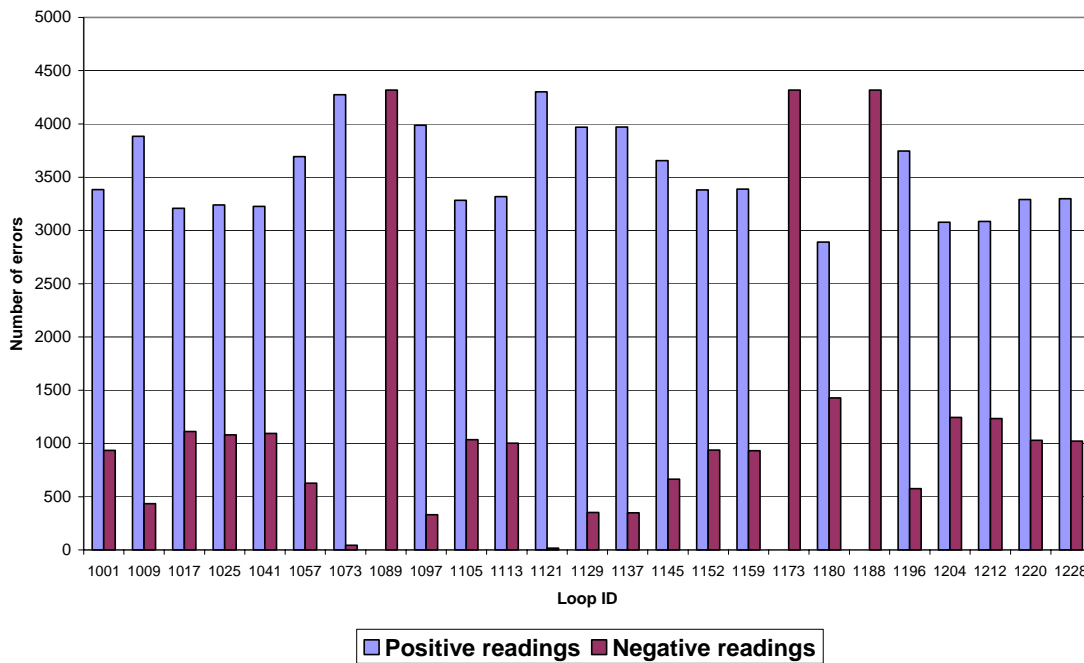
FIGURE 10

Individual lanes were also analyzed. Figures 10, 11, 12 and 13 describe the lane-by-lane analysis for northbound I-5 and Figures 14, 15, 16 and 17 describe the lane-by-lane analysis of southbound I-5. There were some loop detectors that reported negative values all day for the northbound and southbound stations; we assumed that these were not functioning during the studied day due to construction or maintenance.

Lane 1 Negative Readings - Northbound

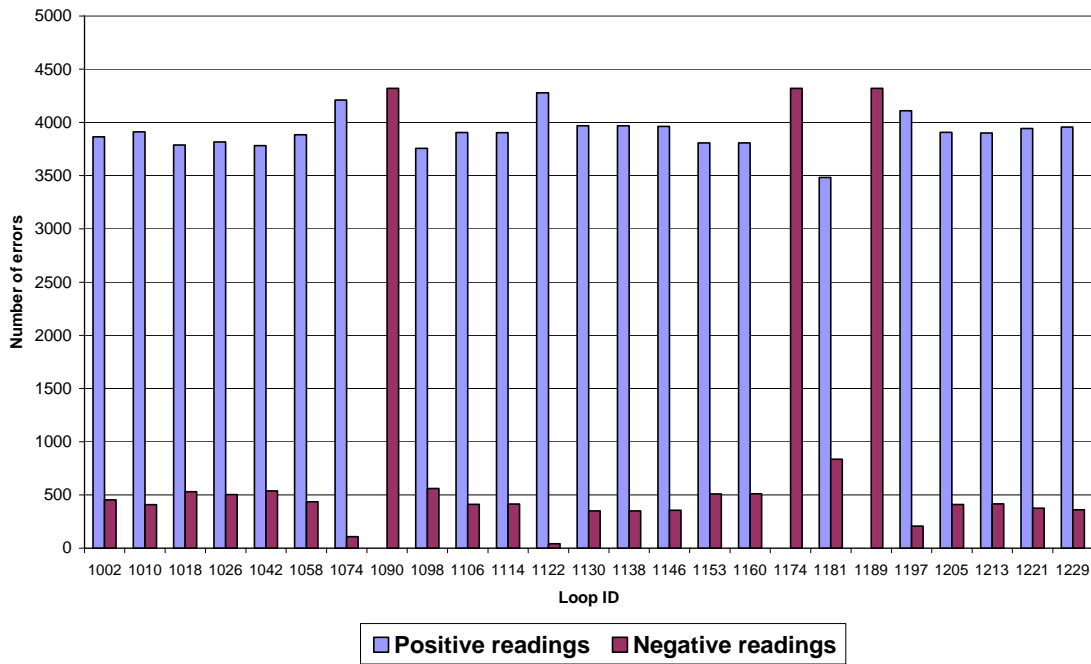
FIGURE 11

Lane 2 Negative Readings - Northbound

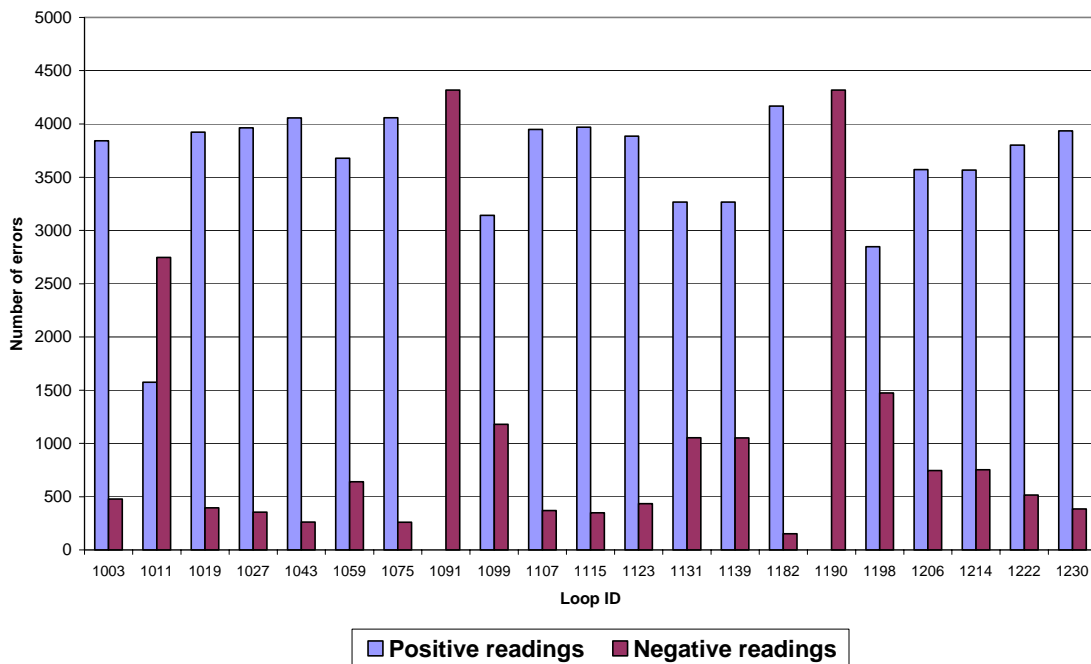
FIGURE 12

Lane 3 Negative Readings - Northbound

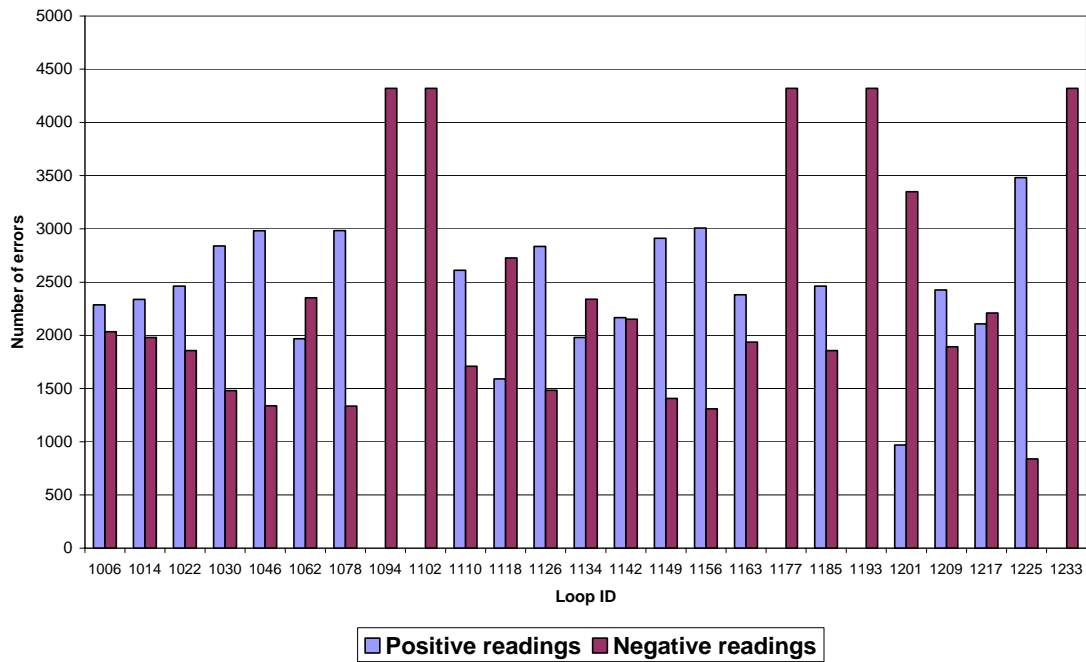
FIGURE 13

Ramps Negative Raedings- Northbound

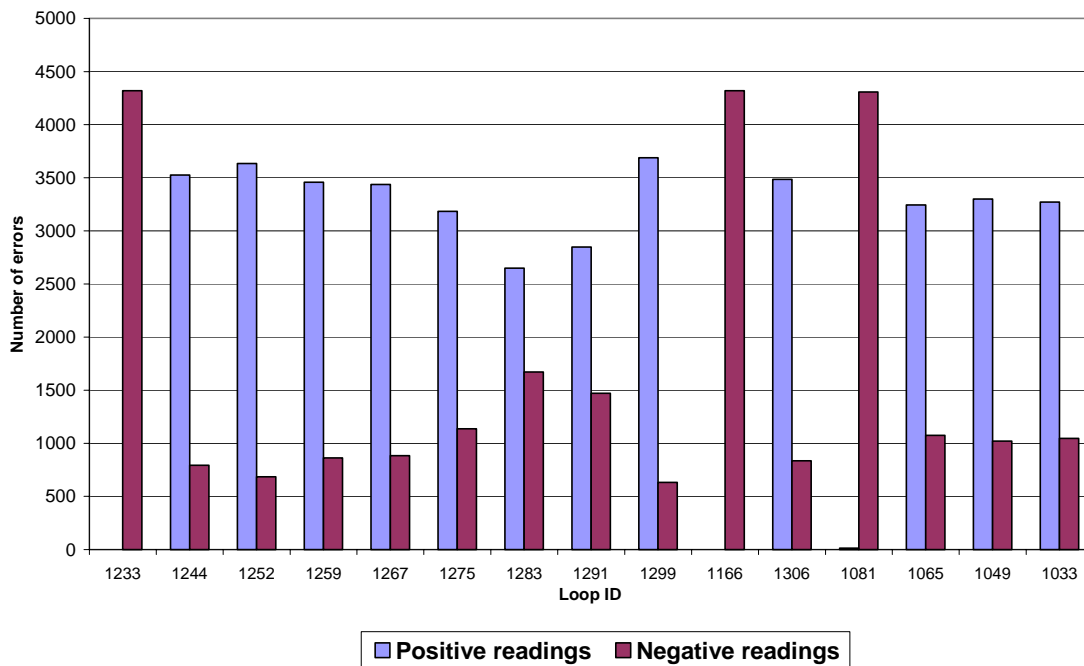
FIGURE 14

Lane 1 Negative Readings - Southbound

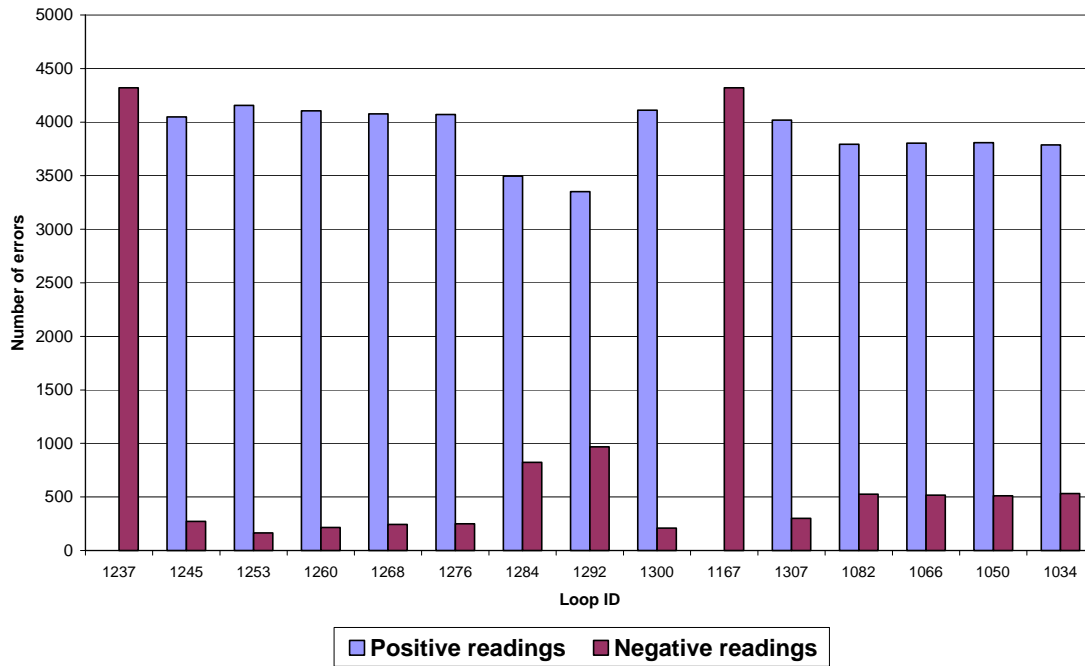
FIGURE 15

Lane 2 Negative Readings - Southbound

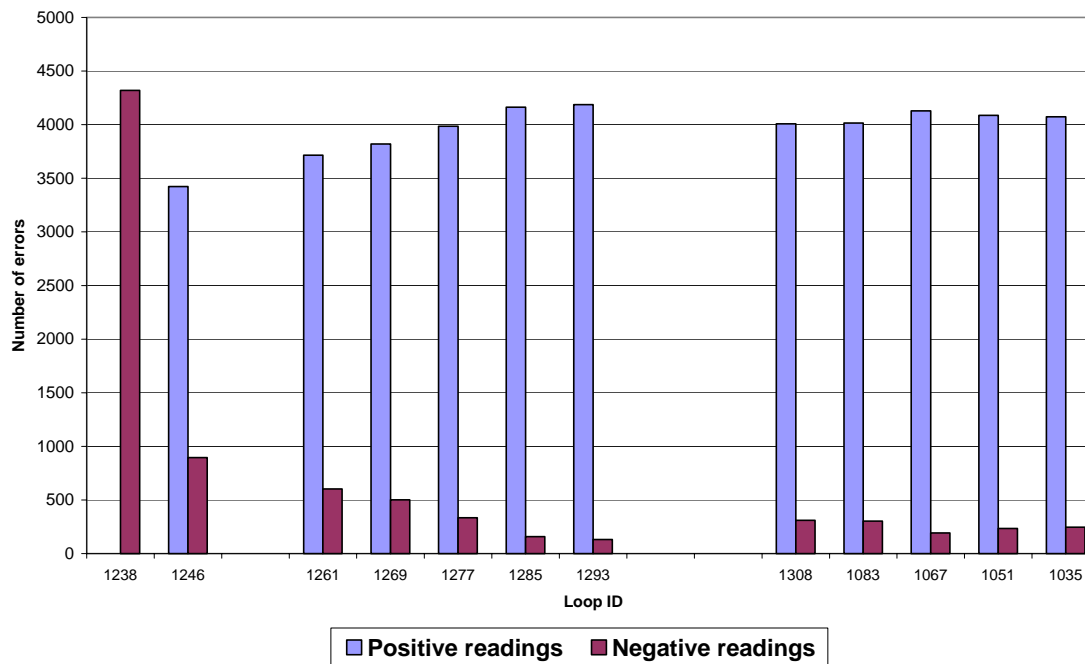
FIGURE 16

Lane 3 Negative Readings - Southbound

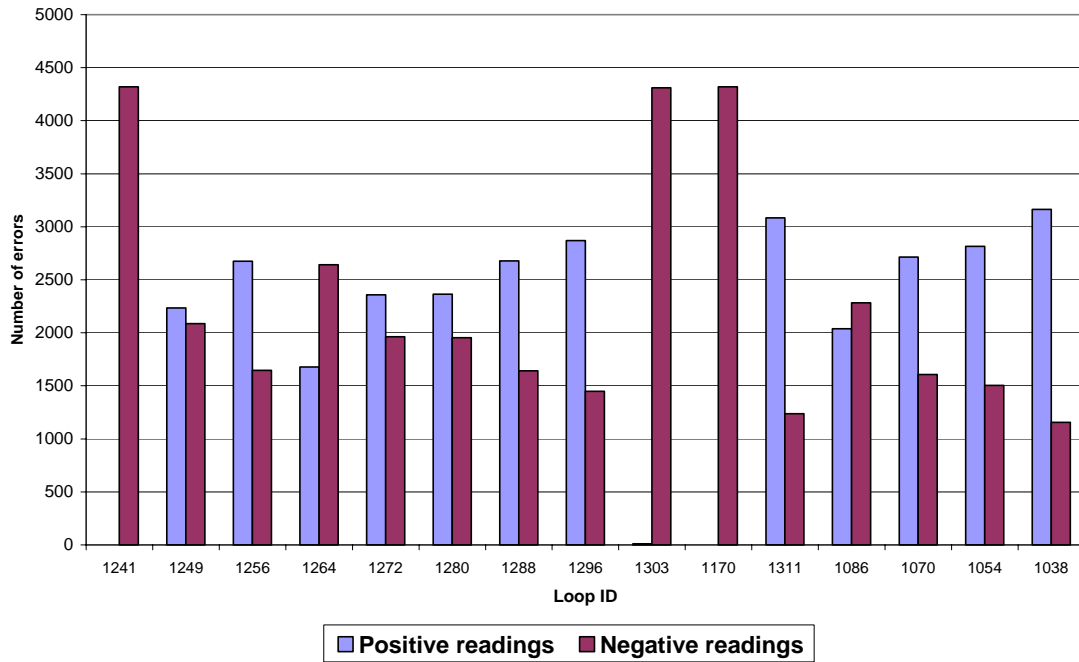
FIGURE 17

Ramps Negative Readings - Southbound

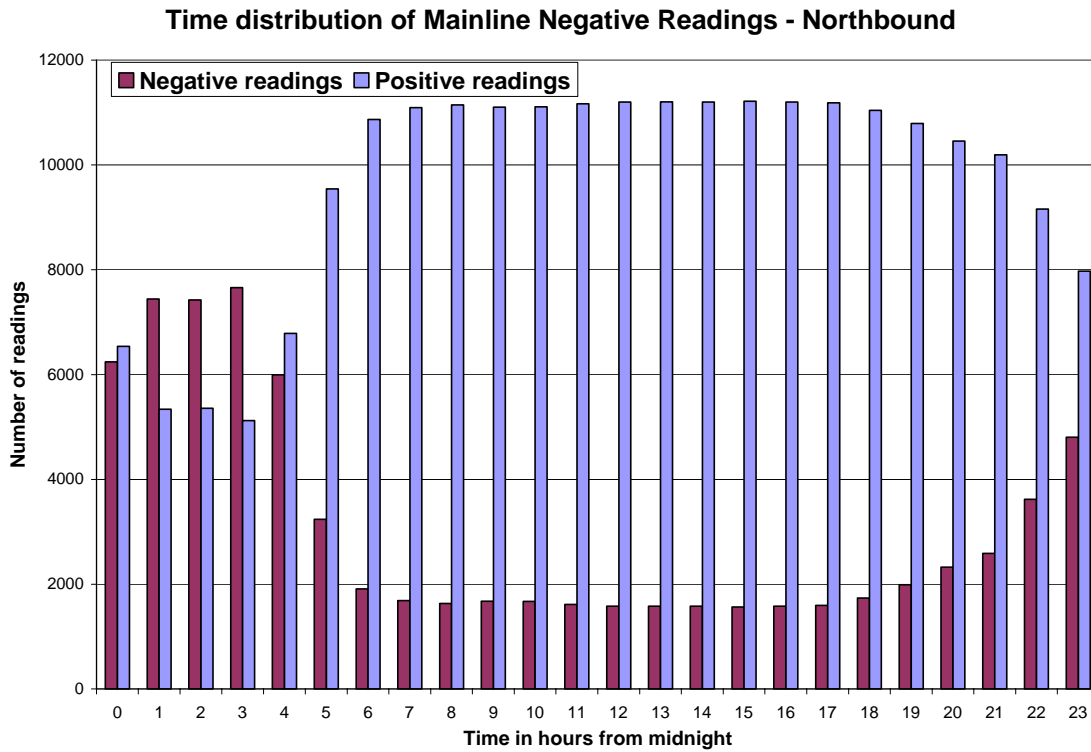
FIGURE 18

Figures 18 and 19 show the distributions of positive and negative readings for northbound I-5 on both the mainline and for the ramps. Similarly, Figures 20 and 21 show the distribution of readings for southbound I-5 on both the mainline and the ramps. It can be observed that the majority of negative values occur during the off-peak hours, approximately from 10:00 pm to 6:00 am.

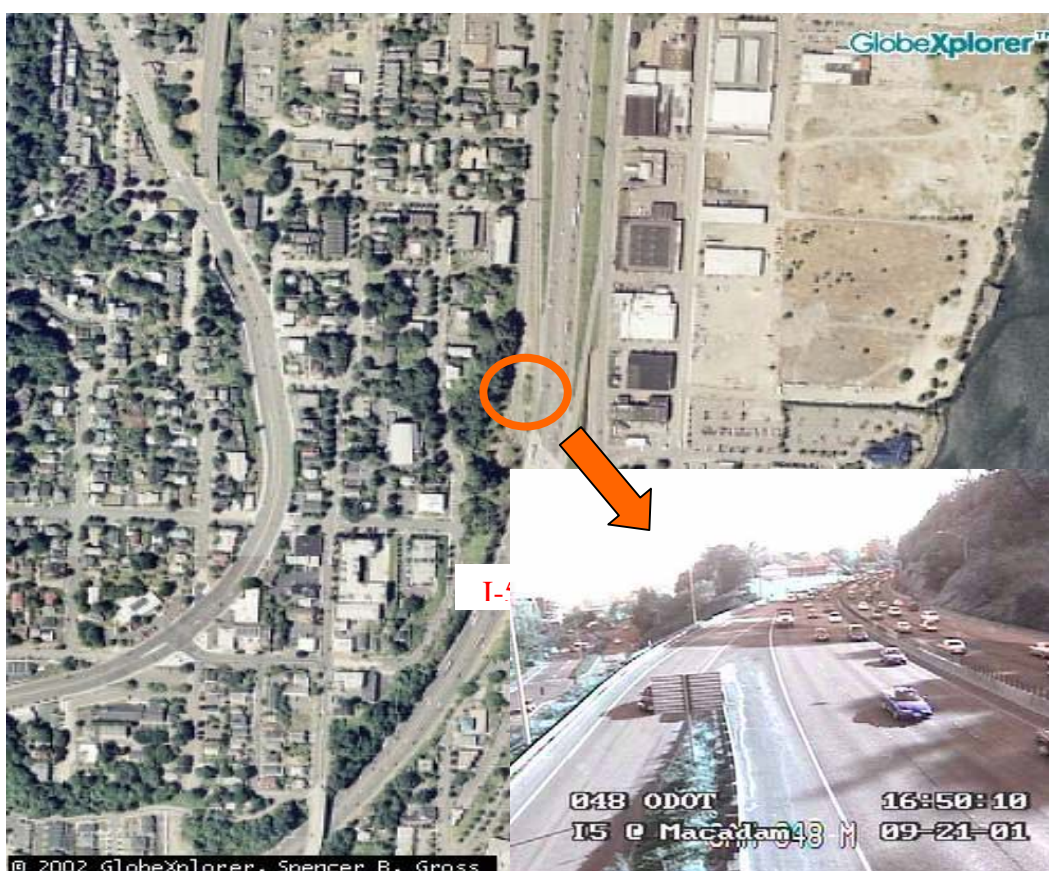
The aim of this analysis was to compare loop detector counts with “ground truth” counts obtained from video data in order to determine the level of loop accuracy. Video data from camera 48 on southbound I-5, MP 299.25, was recorded between 4:00 pm and 6:45 pm on Thursday, January 25, 2001. The loop detector data were requested from ODOT for the same location and the same period of time to be used in the validation process. Figure 22 shows the location and the view of the study segment.

- Camera # 48, Southbound I-5 MP 299.25.
Hood River Ave

FIGURE 22 View From Camera #48

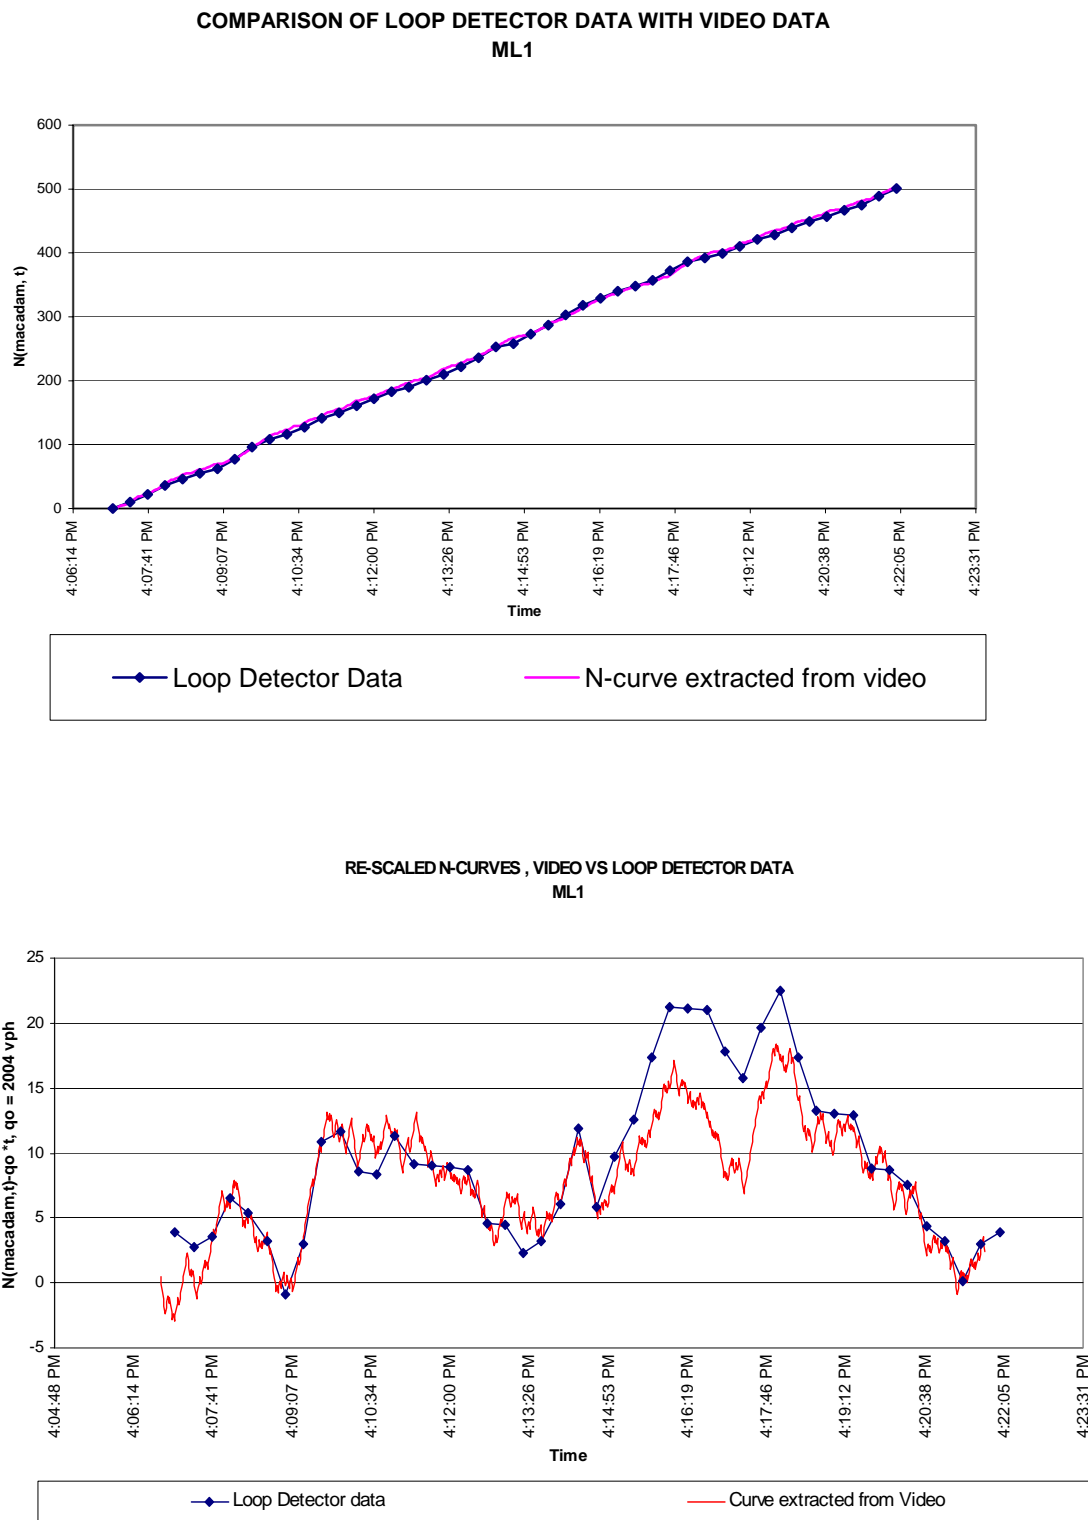
Figure 23 shows a comparison of loop detector and data with vehicle arrival times plotted cumulatively. As shown in the upper figure, the cumulative vehicle arrival curves are aligned almost perfectly. The lower curve uses a skewed axis to magnify the details of the vehicle arrival patterns. As shown, these patterns are also aligned remarkably well, though the individual vehicle level data extracted from the video archive reveals more about the fluctuations in the vehicle arrivals (and headways) than does the loop detector data. Figures 24, 25 and 26 show the comparisons for lanes 2, 3 and the ramp with similar results.

FIGURE 23 Lane 1 Comparison

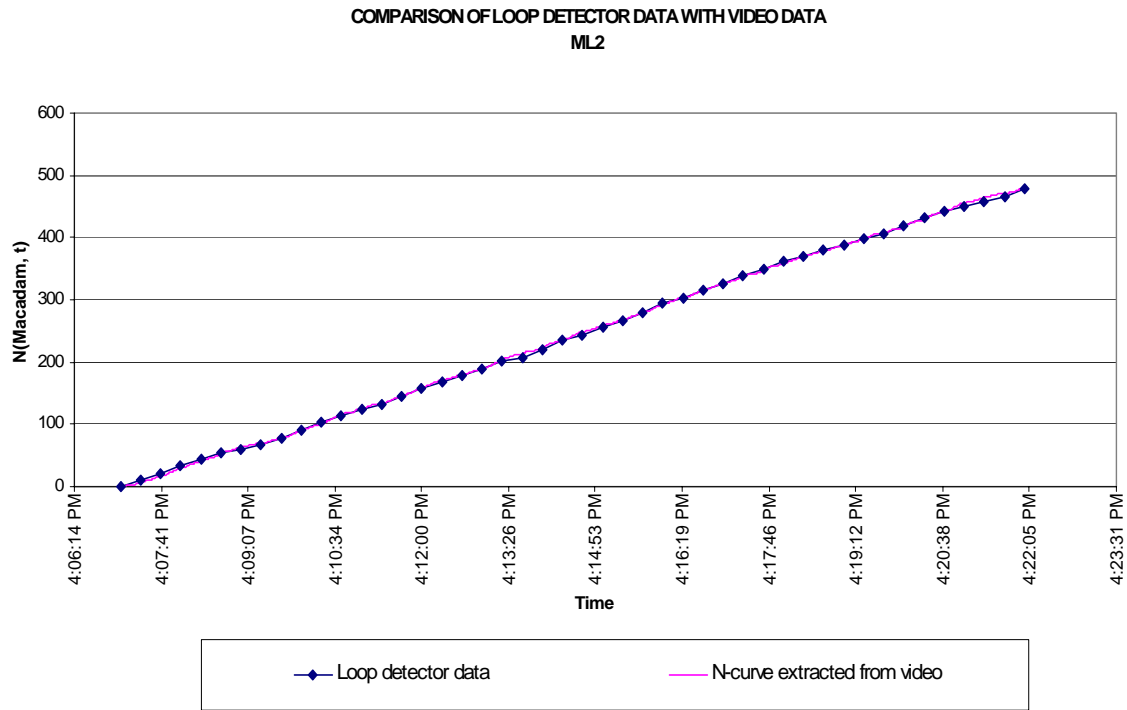
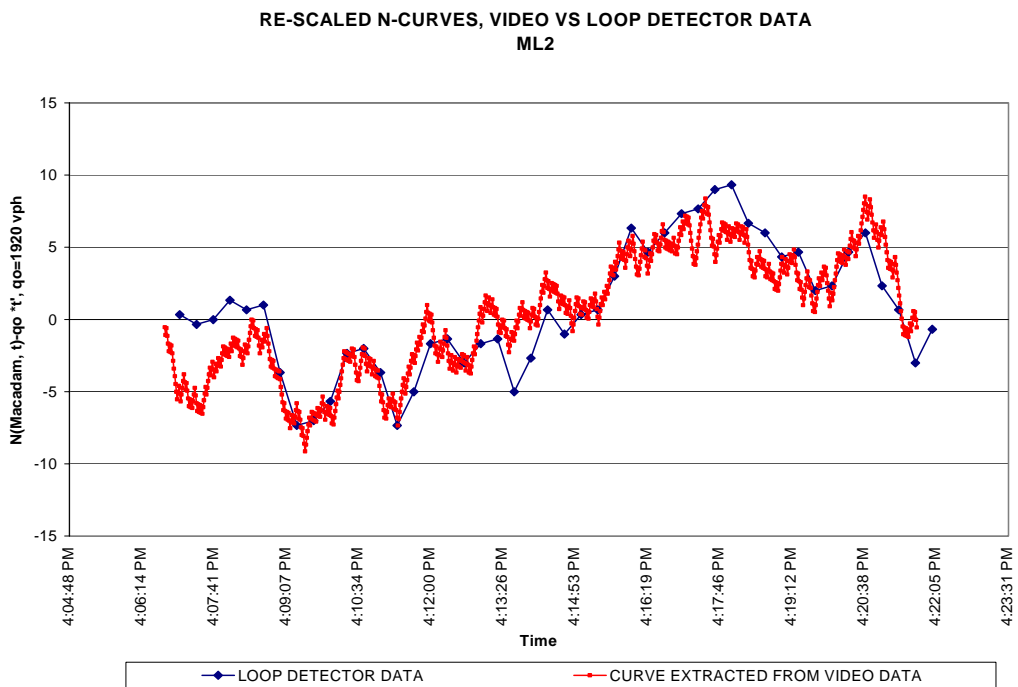
FIGURE 24 Lane 2 Comparison

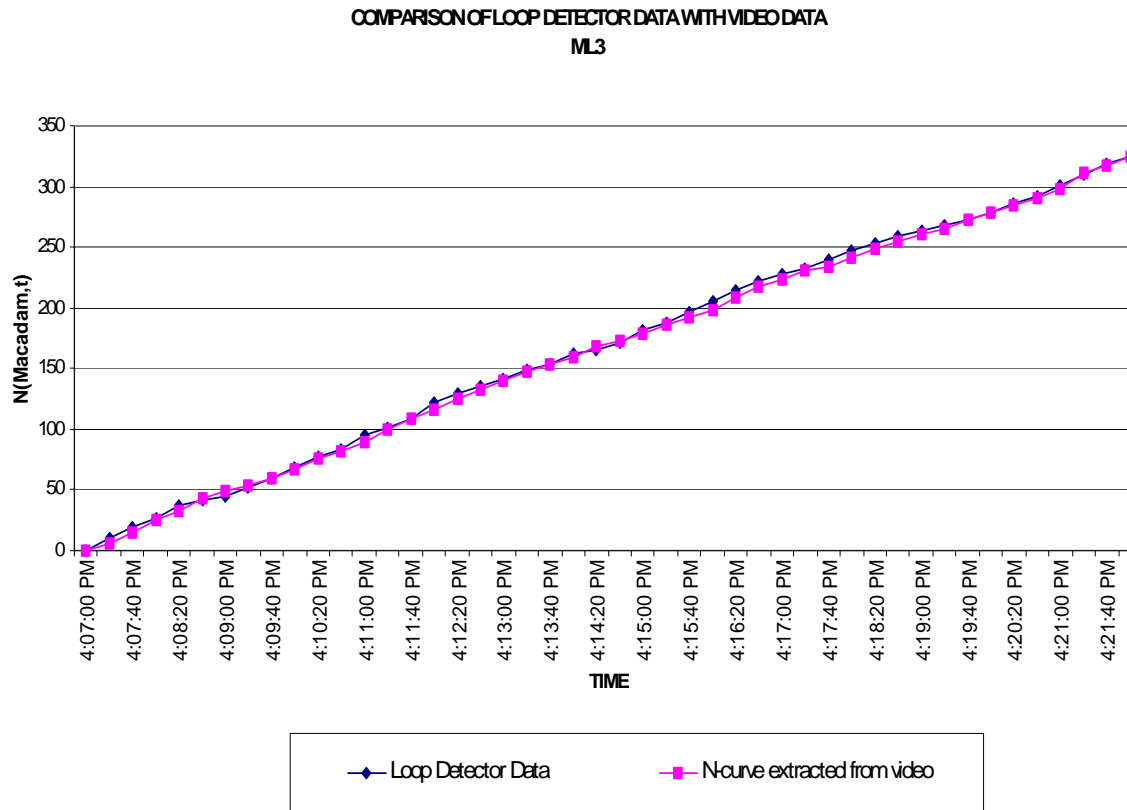
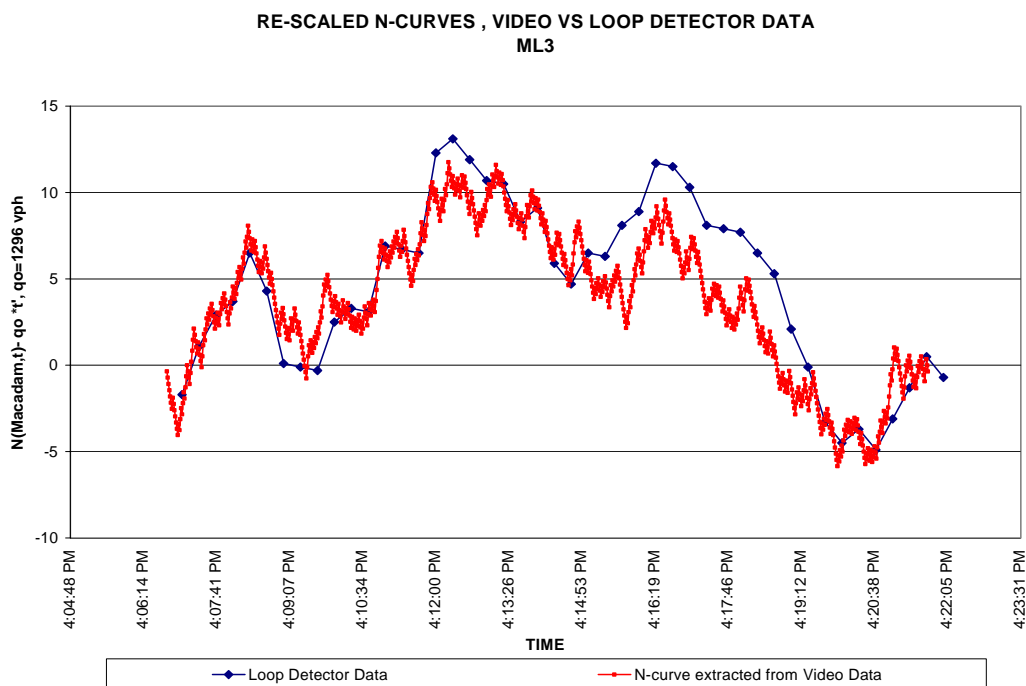
FIGURE 25 Lane 3 Comparison

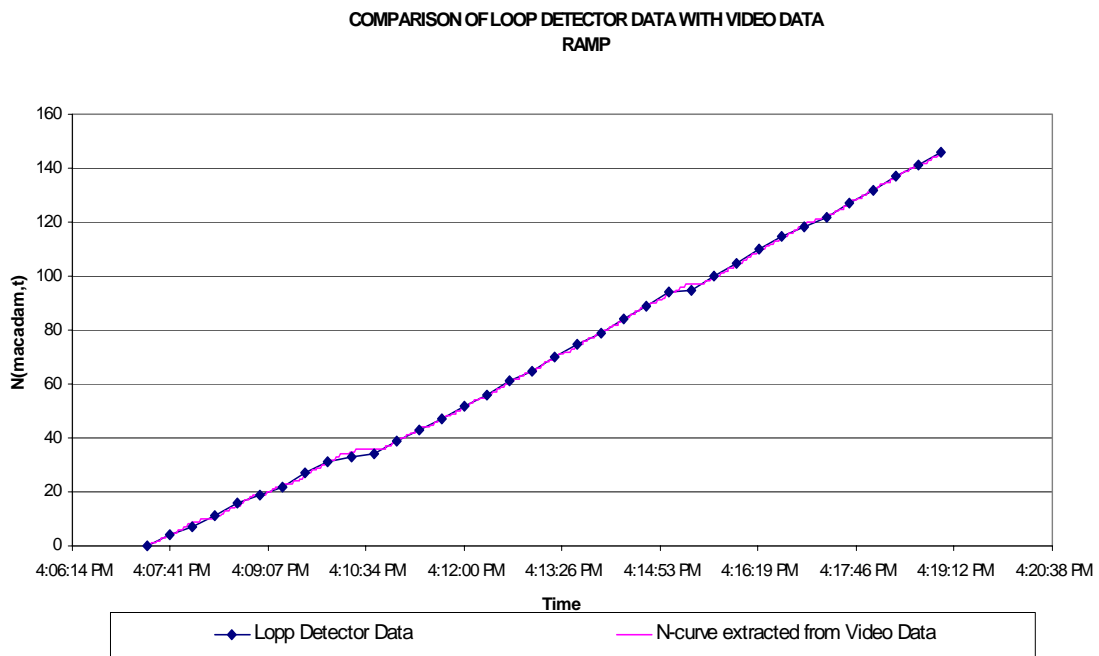
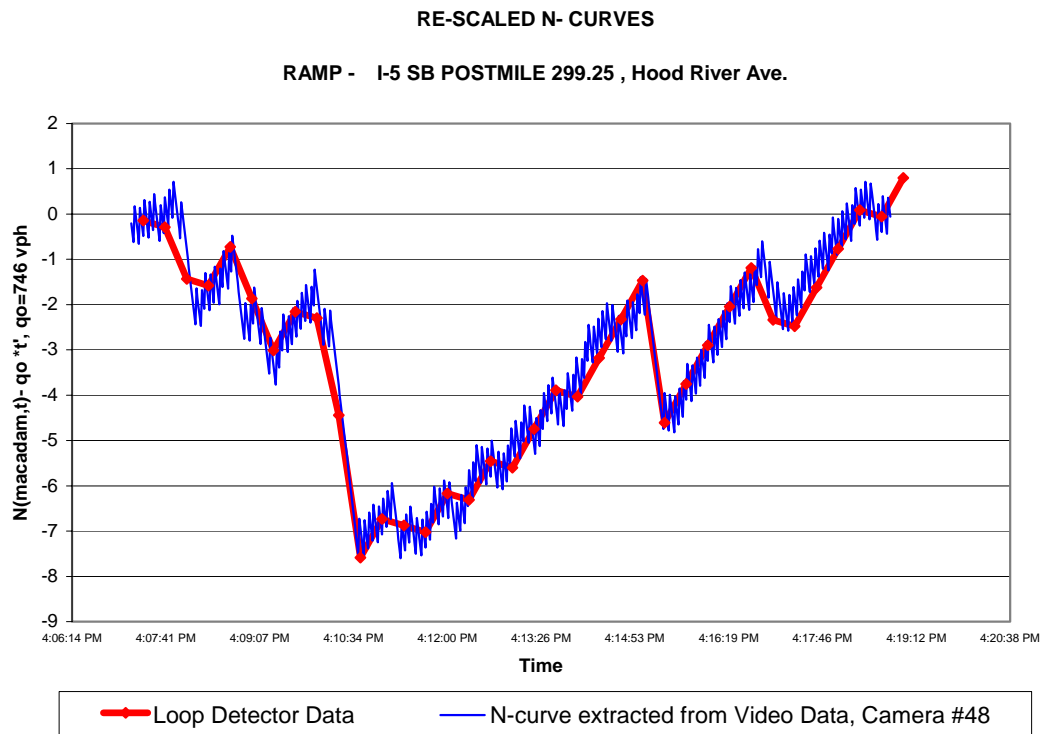
FIGURE 26 Ramp Comparison

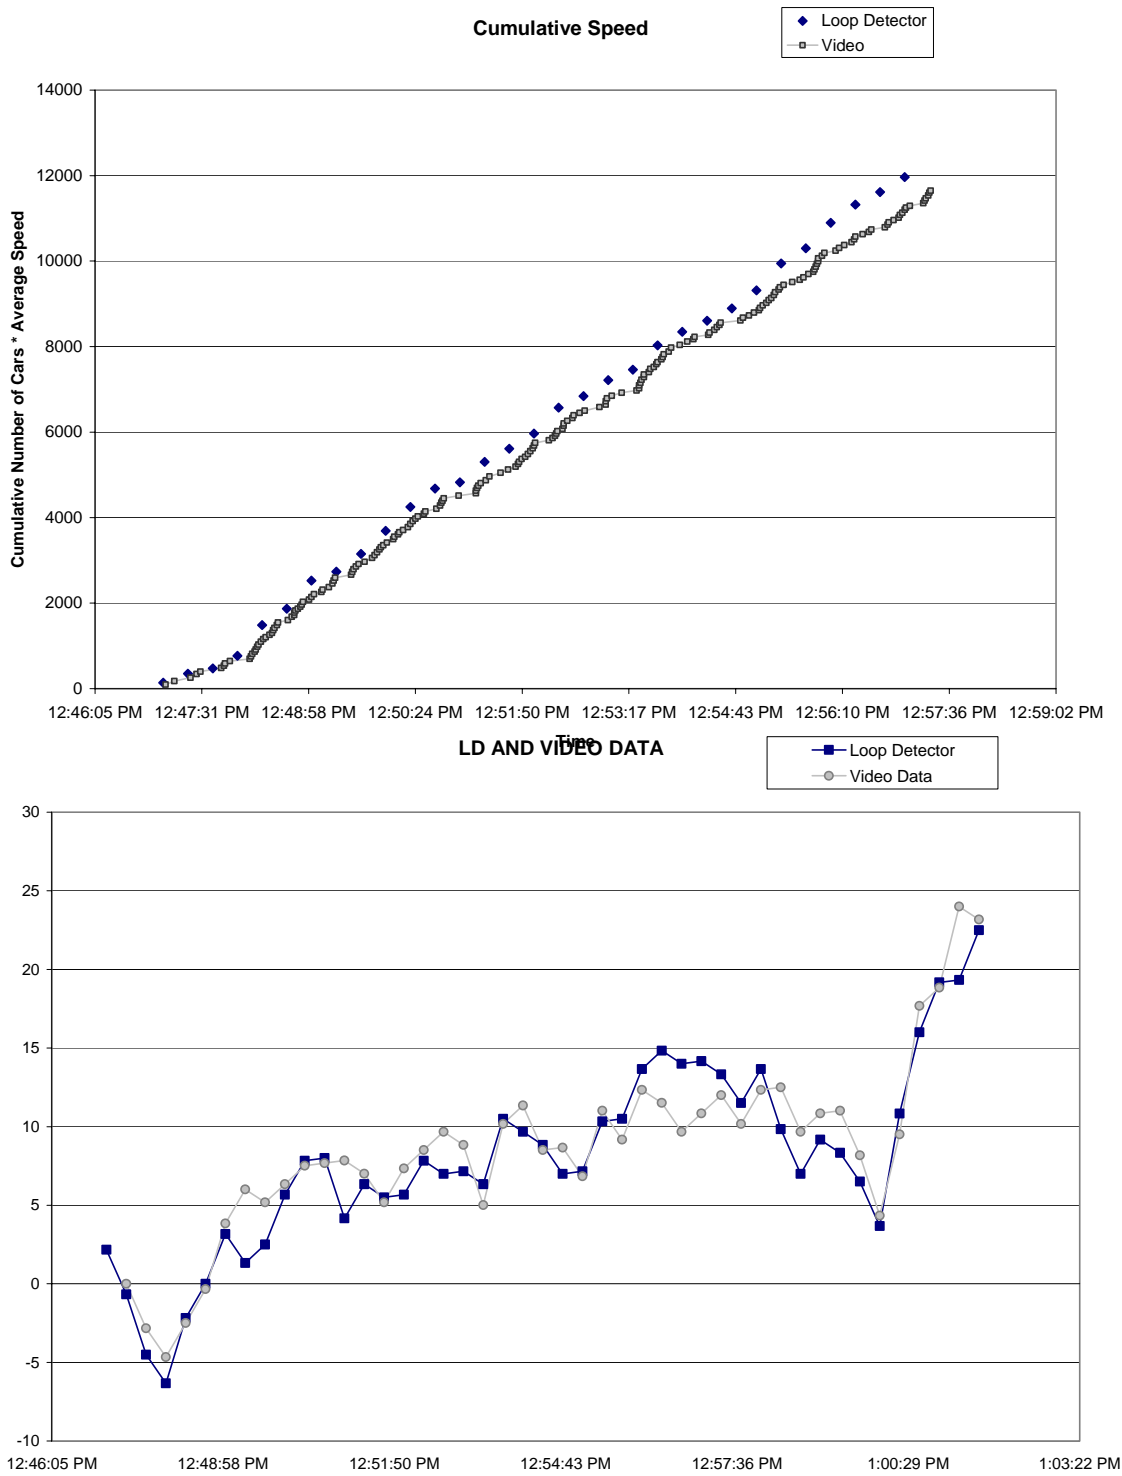
Some preliminary analysis of the speed data recorded by the loop detectors is shown in Figure 27. Speeds were recorded manually from video data (arrival and departure times of each vehicle were recorded over a fixed distance). As shown, the speeds were plotted cumulatively, with similar total values over a ten-minute period. The y-axis was then skewed (lower figure) to magnify the details of the fluctuations in speed, and as shown, the two curves are well-aligned. This indicates that the speed data reported by the detectors are valid.

FIGURE 27 Speed Validation
