Characterization of the Red Bluff Landslide,  
Greater Cascade Landslide Complex,  
Columbia River Gorge, Washington

Master of Science  
in  
Geology

Portland State University  
©2012

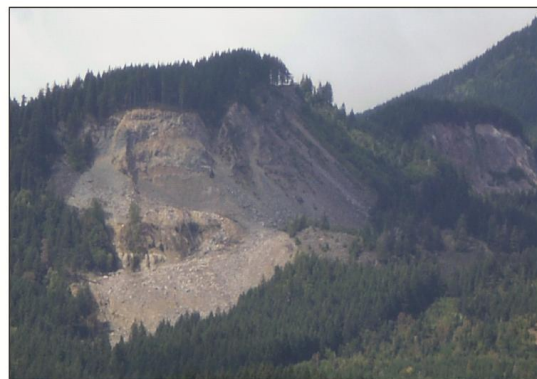
**Figure 5.** Greenleaf Basin Rock Avalanche. Photograph taken from Bonneville Dam.

In January of 2008, a moderately large rock avalanche landslide occurred on the southern portion of the Red Bluff scarp headwall (Greenleaf Basin Rock Avalanche) (Figure 5). The Greenleaf

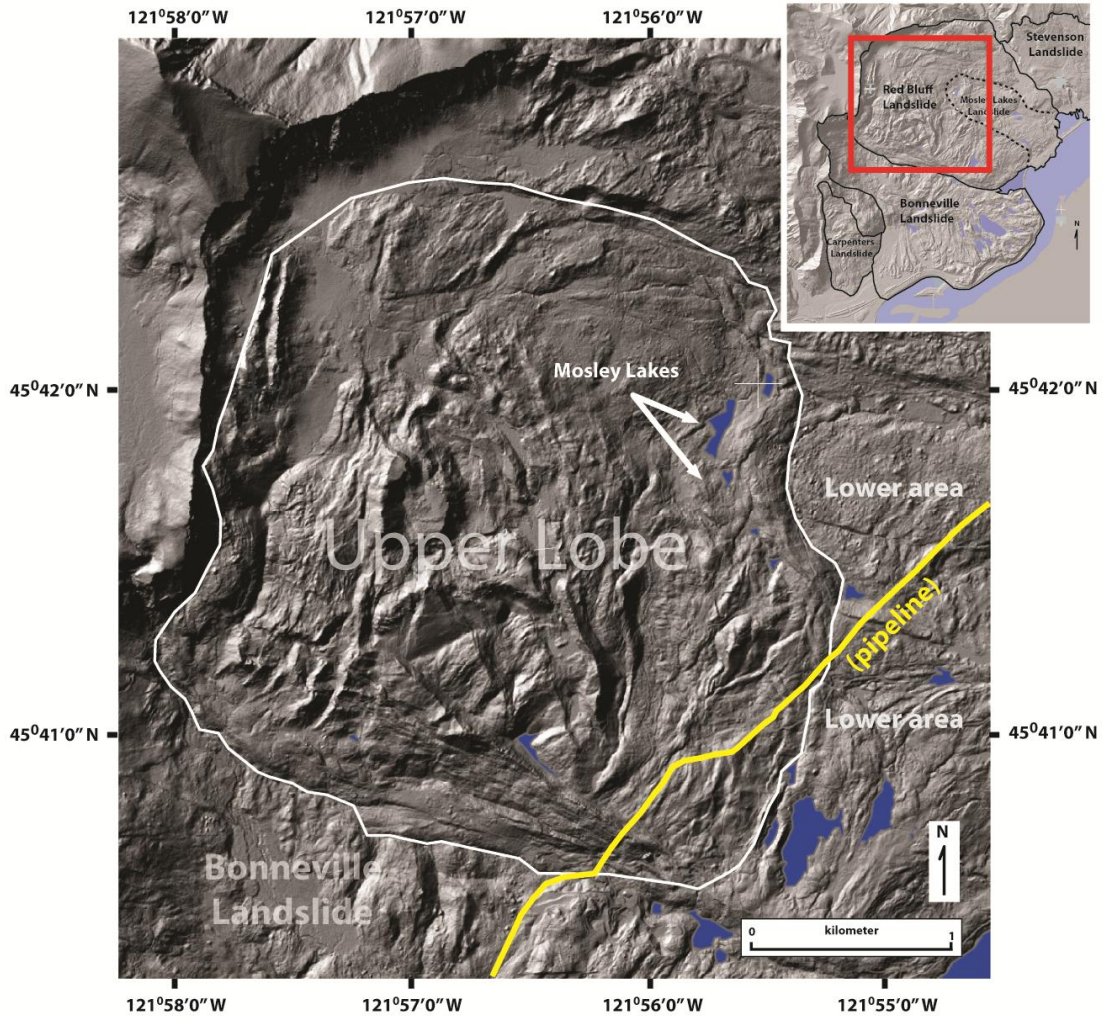
**Figure 6.** Upper lobe of the Red Bluff Landslide trending to the south overlapping the Bonneville Landslide and spreading laterally to the east over the lower in-place Ohanapecosh/Eagle Creek Formations. White line is boundary of upper lobe. Yellow line is transect of a gas pipeline (NWP) through the area. Inset shows location.

Until recently and presently, the Williams Northwest Pipeline (NWP) has been involved in the construction and maintenance of a natural gas pipeline through the Cascade Landslide Complex (Figure 6). Before 2007 they apparently became concerned about its movement and contracted Golder Associates Inc. (2009) to assess and evaluate the slide region. Golder Associates recommended a pipeline route north and around all landslides in the area. In the summer of 2010, after receipt of their study, a NWP maintenance crew was on site with heavy equipment inspecting and adding new laser monitoring equipment indicating a continued presence at the location. Movement data from Williams Northwest Pipeline (NWP) is not available to the public. Movement has been detected independently by **Interferometric Synthetic Aperture Radar (InSAR)** on 8.6 km<sup>2</sup> of the Red Bluff Landslide occurring during the winter of 2007-2008 and over

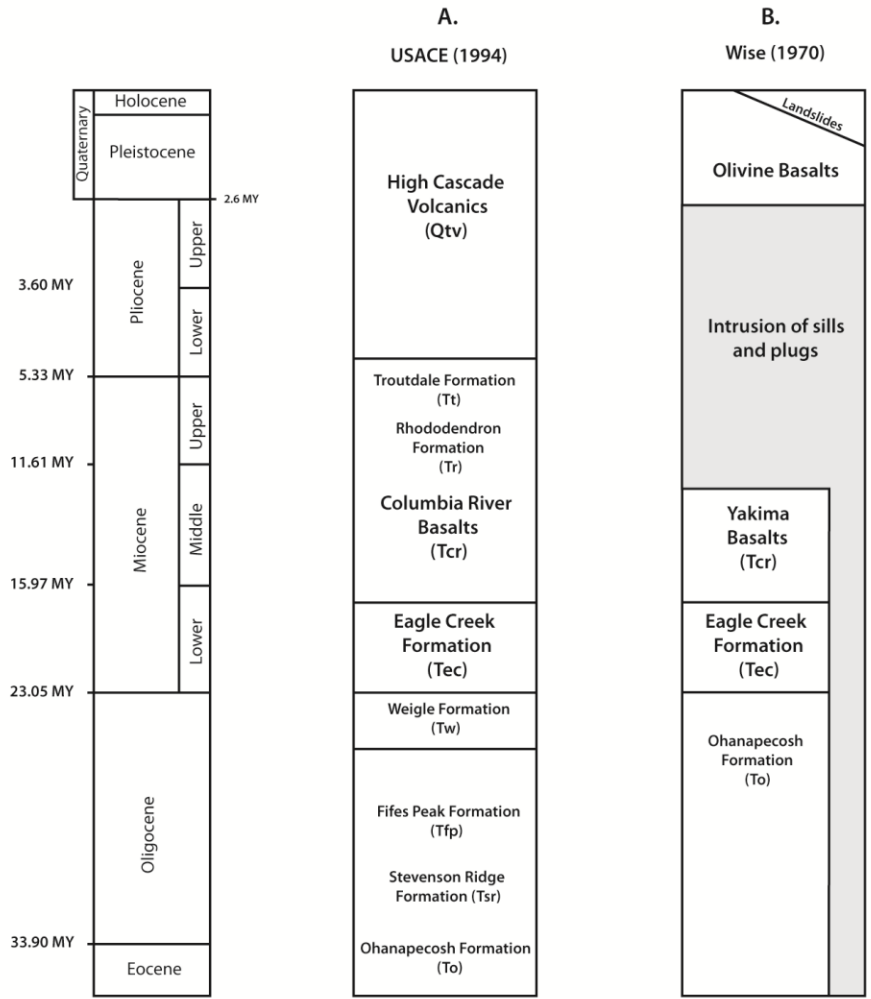
**Figure 7.** Stratigraphic section of Cascade Landslide Complex area. Shown are **a.** USACE (1994), **b.** Wise's Ohanapecosh (1970).

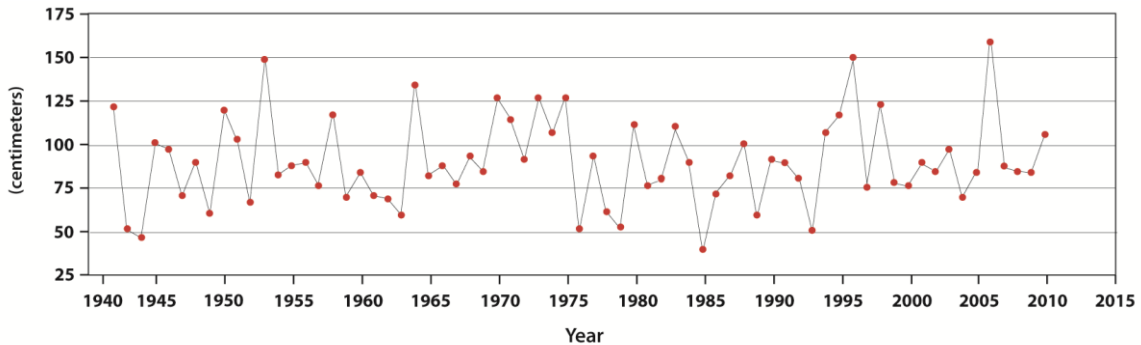
**Figure 11.** Precipitation from 1942 to 2011 for the months of November, December and January (WRCC, 2010)

(75.39 in.) (WRCC, 2010). Months with the heaviest precipitation are from the beginning of November through January (Figure 12). The maximum annual precipitation amount

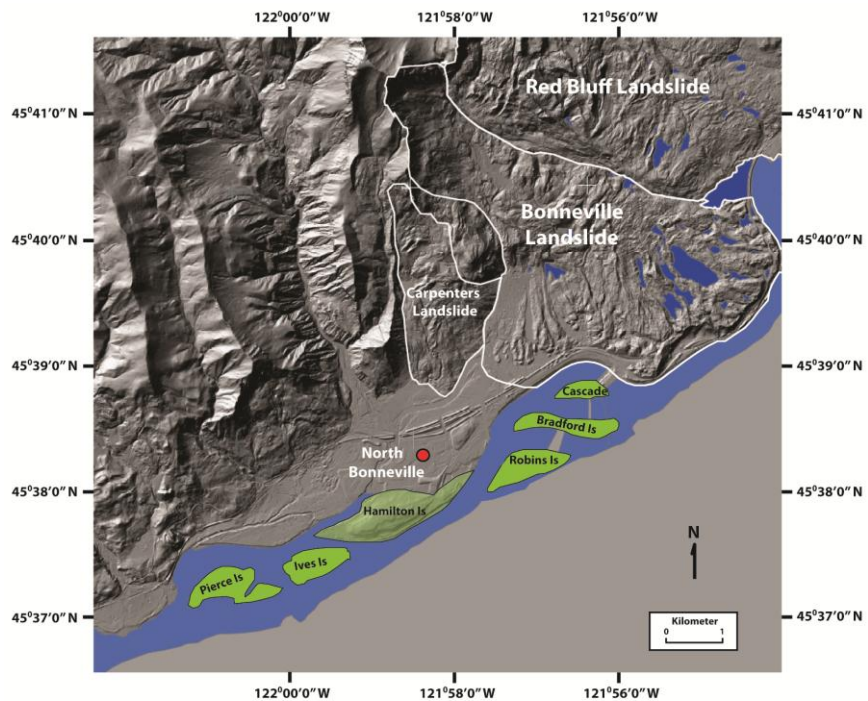
**Figure 14.** Breaching of the landslide induced dam resulted in the numerous outwash islands as shown in green.

The Bonneville Terrace, Robins, Bradford, Cascade, Hamilton and Ives Islands are all remnants of the former outwash delta (Allen et al., 2009) (Figure 14).

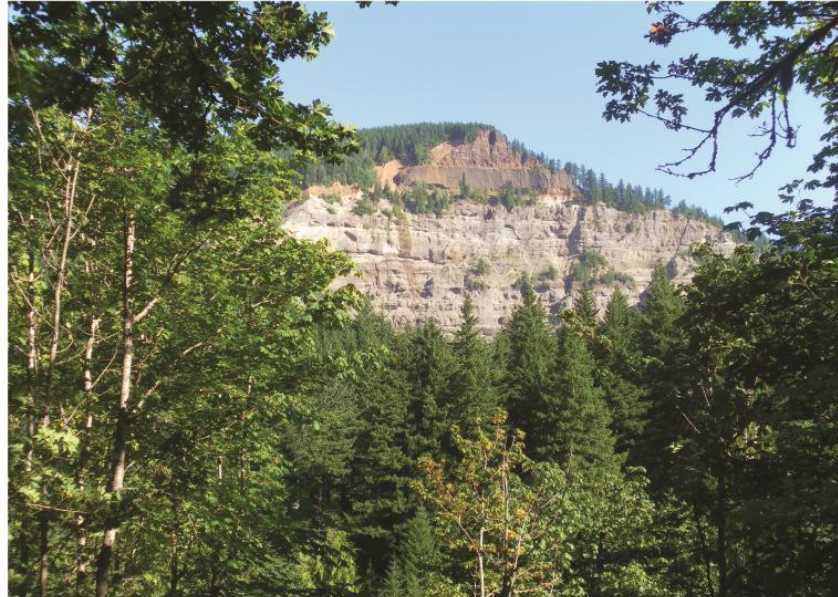
**Figure 16.** Photograph of the Red Bluffs from the Red Bluff Landslide.

striking feature is the scarp headwall, known as the Red Bluffs (Figure 16).

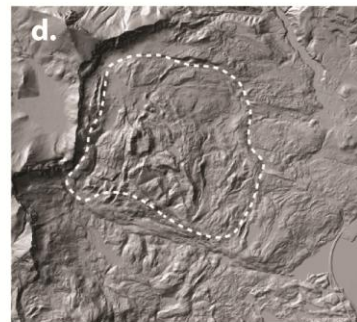
**Figure 18.** a. Pattern gives hint but no definite evidence of ground motion. Images not available for earlier in winter. b. Warm colors grading out to blue and green show location of reactivated part of landslide. c. Area of reactivation has grown slightly. d. Area of reactivation by the Cascade Volcano Observatory (Pierson and Lu, 2009). Note: Pixels in image represent 6 to 25 cm of movement. Greenish pixels indicate no movement while cayenne-colored and purplish blue represent the most and intermediate movements respectively.

the winter of 2008-2009 (Pierson and Lu, 2009) (Figure 18). The data showed 15-25 cm of slope-parallel motion from 06 November 2007 to 23 March 2008 and similar movement between 08 November and 08 February 2009 (Pierson and Lu, 2009). InSAR monitoring of the slide is ongoing.

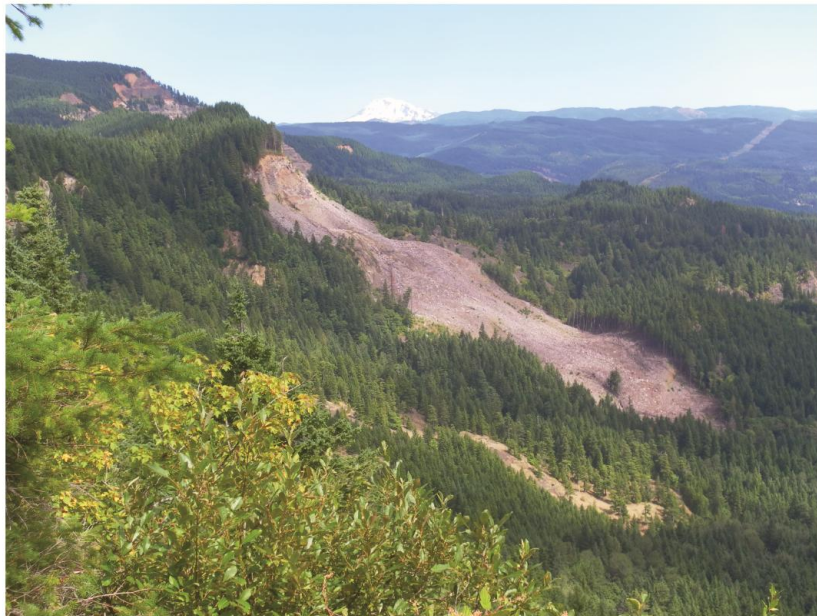
**Figure 19.** Photo of Greenleaf Basin Rock Avalanche from south flank of Table Mountain

On the southernmost section of the west headwall on the Red Bluff Landslide, the Greenleaf Basin Rock Avalanche occurred on January 3, 2008 (Russ Evarts, U.S.G.S., personal communication, 2008) (Figure 19), and it may have contributed to the recent reactivation of the Red Bluff Landslide (Scott Burns, P.S.U., personal communication, 2008). Evidence of potential failure was first observed on the headwall where tension cracks were observed in the summer of 2007 before the avalanche (Russ Evarts, U.S.G.S., personal communication, 2008).

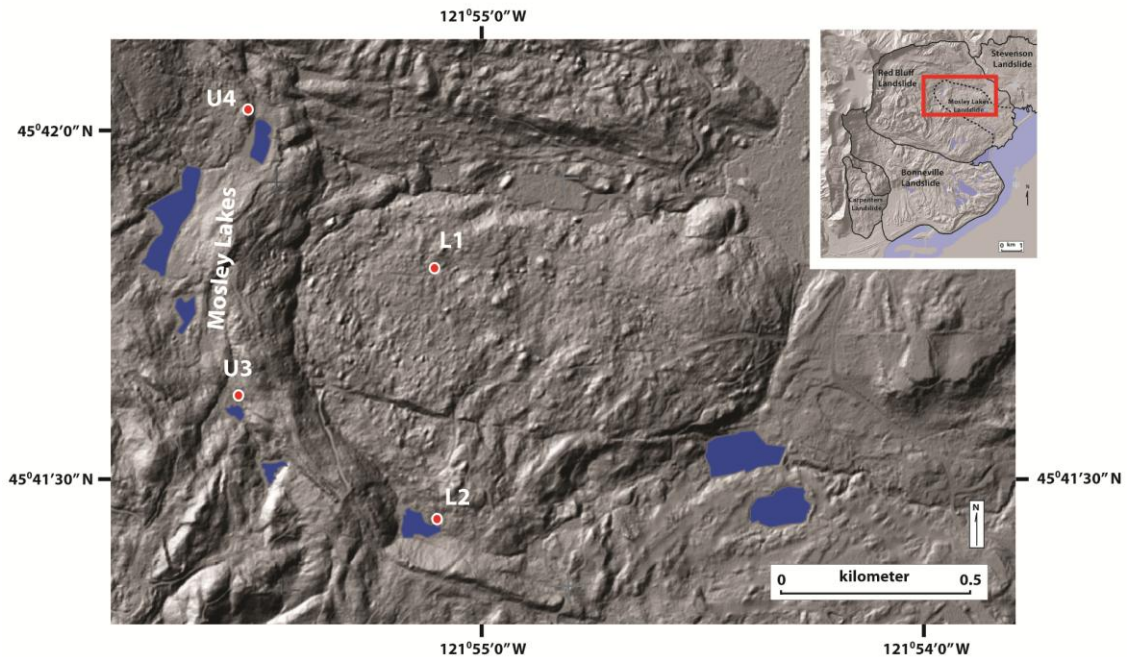
**Figure 20.** View of the eastern portion of the active upper lobe and the bottom area of the Red Bluff Landslide. Location of 4 soil pits. Soil pit U3 and U4 are on the upper lobe and L1 and L2 are on the lower portion of the slide. All four of these sites are on what was originally mapped as the Mosley Lakes Landslide.

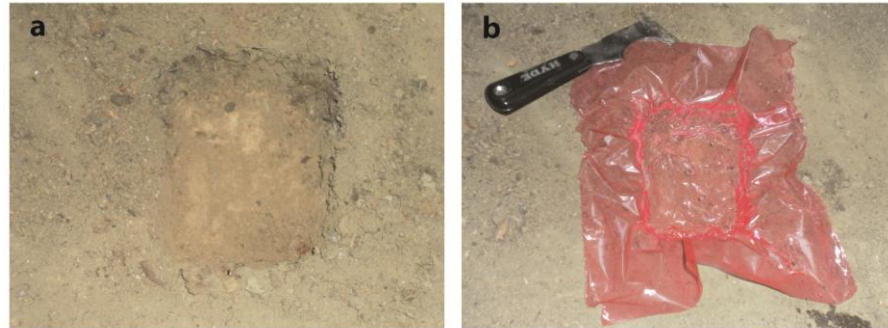
**Figure 21.** Method of getting densities: **a.** Small hole excavated to collect soil. **b.** Same hole is filled with water to get volume.

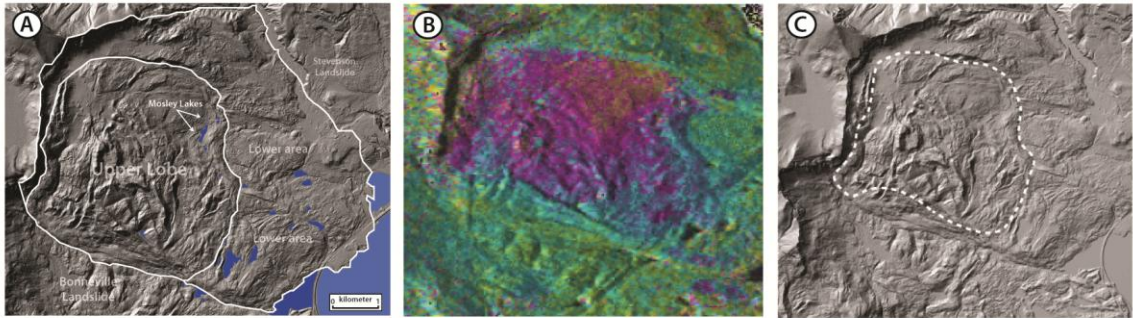
**Figure 23.** Figures showing the upper lobe and the re-activated area of the Red Bluff Landslide. **A.** Shows the upper lobe and the lower area of the Red Bluff Landslide. **B.** A clear indication of the re-activated area on an InSAR interferogram. **C.** The active area as indicated by the Cascade Volcano Observatory. Images **B** and **C** created by Pierson and Lu, (2009)

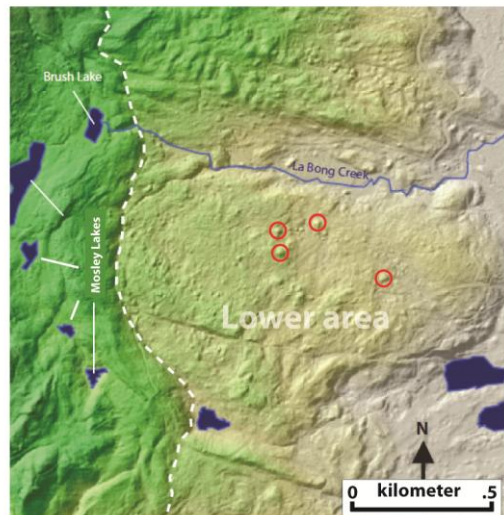
**Figure 24.** Displaced blocks of Eagle Creek Formation in lower portion of the slide (red circles). White dashed line is border between the upper active area and the lower area.

investigated and were found to be large boulders and/or blocks of Eagle Creek Formation (Figure 24). Russ Evarts (personal communication, 2011) and I confirmed one hummock to be Eagle Creek. The conglomeratic boulders were difficult to break, were well cemented, but broke apart around its matrix. There are no visible signs of alteration. Grain size is larger relative to

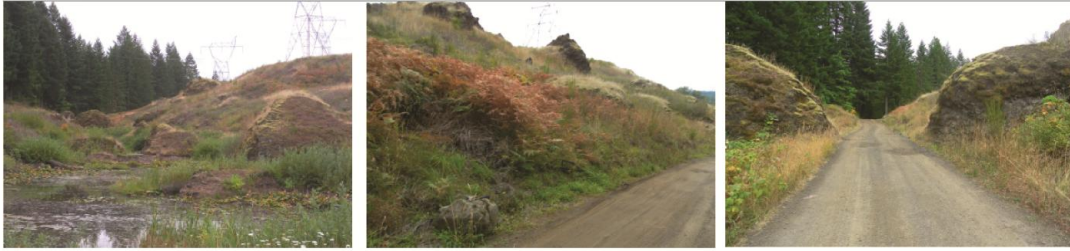
**Figure 25.** Eagle Creek Formation blocks/boulders litter the lower portion of the slide.

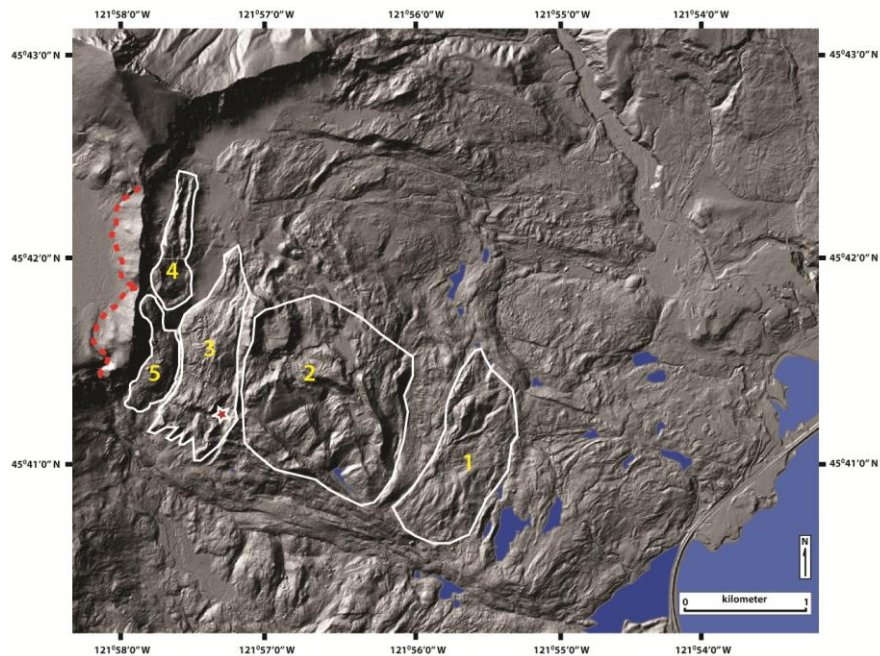
**Figure 28.** Conceptualized sequence of events of the break-up of the Red Bluff Volcanoes. The first event is the collapse of the eastern flank(s) of the volcano. Event two is different than the rest of the units because it's lineation is to the NW where the others are to the NE. It is probably the biggest event in recent times. Events three, four, and five are the western flank(s). Red star is the location of the neck of the Red Bluff Volcano. Event number five is apparently the last major event that transpired and is the unit upon which the Greenleaf Basin Rock Avalanche flowed over. Red dashed lines are what is remaining of the volcanoes.

Events three, four, and five are preliminarily identified as post Missoula Flood events. Event number one is suspected to be pre-Missoula Flood based on its separation from the other events and its smoother appearance. Event two may be a pre-Missoula Flood feature and its orientation may have been influenced by Missoula Flood waters. Another possibility for its lineation may have come from the failure of the Bonneville Landslide.

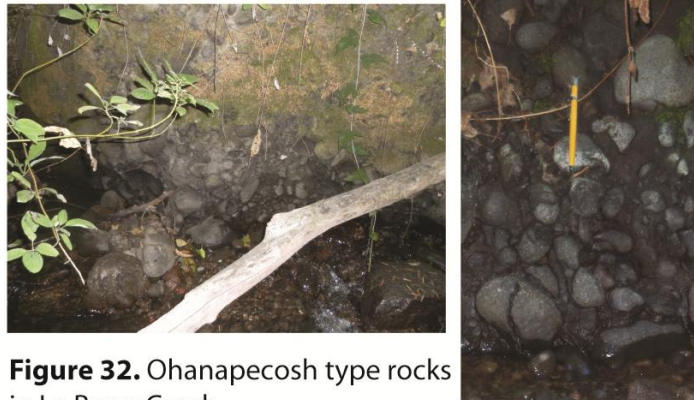
**Figure 32.** Ohanapecosh type rocks in La Bong Creek.

There appears to be Ohanapecosh type rocks in the La Bong Creek area (Figure 32), an area typified by a thin layer of landslide debris. About a third of the way down from Brush Lake along La Bong Creek's north bank, an apparent Ohanapecosh type outcropping, or a block of it was observed. The rocks were conglomeratic, very dark in color, extremely inundated, and the grain size of the matrix is finer than that of the

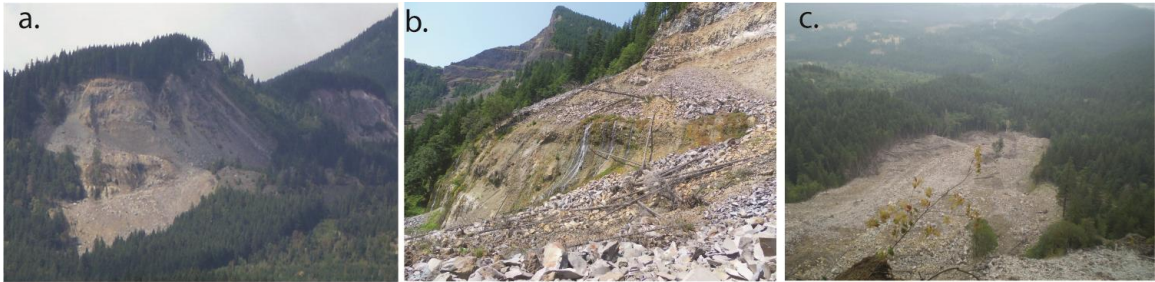
**Figure 34.** Photographs of the Greenleaf Basin Rock Avalanche. **a.** Photo looking north from Bonneville Dam. Note the easterly direction the rock avalanche took at its inception. **b.** Looking west at the failure surface near the scarp base. Note the water exiting from the apparent failure plane. **c.** Photo taken from the top of the the headscarp.

communication). A tension crack observed in the summer of 2007 by Russ Evarts (2008, personal communication) was the first evidence of potential failure. It separated off the main scarp headwall and collapsed, breaking apart as it hit the base. It flowed easterly

(Figure 34a) until deflected by a west dipping slope re-directing its flow southward, where the failure plane intersects the slope (Figure 34b). Figure 34c shows a view from

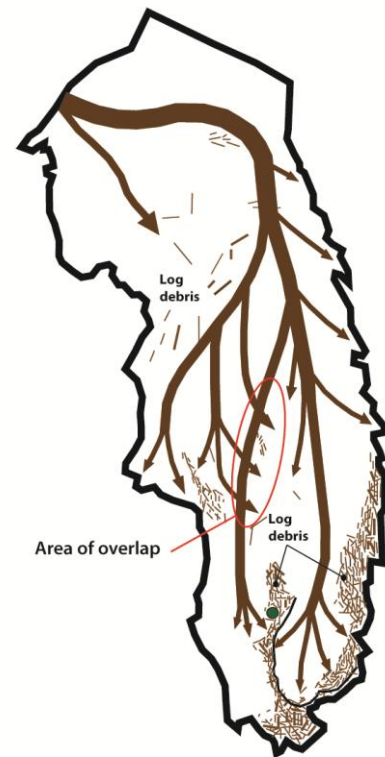
**Figure 35.** Flow lines for the Greenleaf Basin Rock Avalanche. Green dot represents single surviving tree.

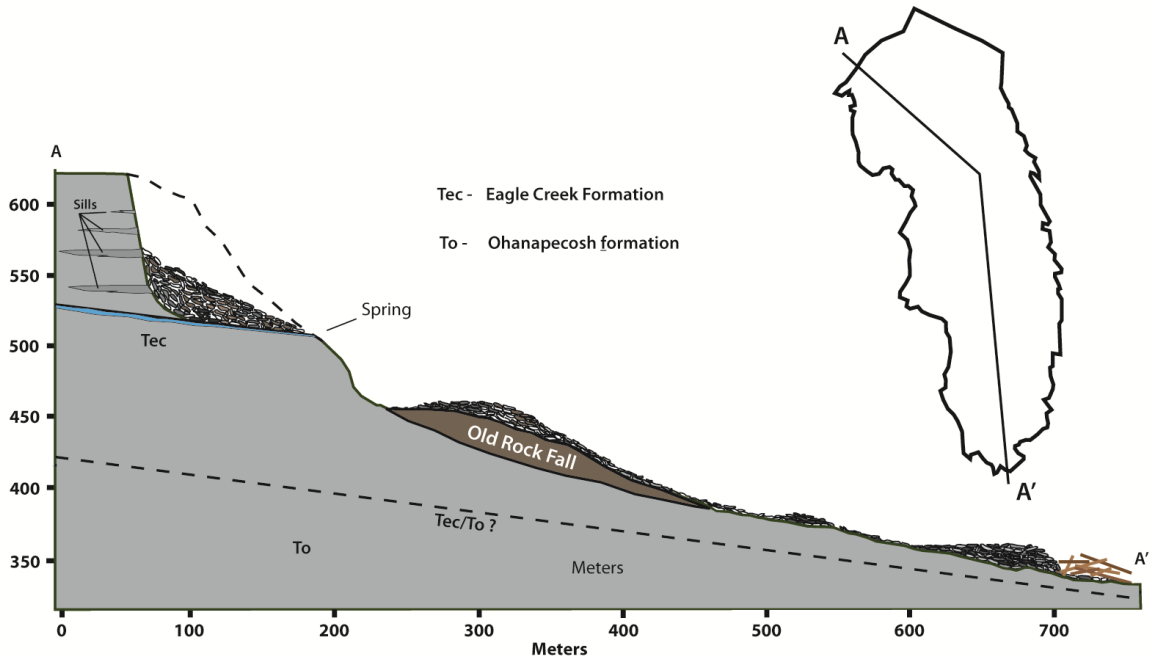
**Figure 36.** Profile of the Greenleaf Basin Rock Avalanche.

depth was estimated based on a rendition of the profile before its failure (Figure 36). Its area is about 161,250 m<sup>2</sup> and its volume is estimated at approximately 1.9 million m<sup>3</sup> based on an estimated depth of 12 m. The Old Greenleaf Basin Rock Slide is at least 78 years old based on a 1934 Aerial Photo (Figure 38) and estimated to have an age 100 to 150 years based on the vegetation cover in 1934.

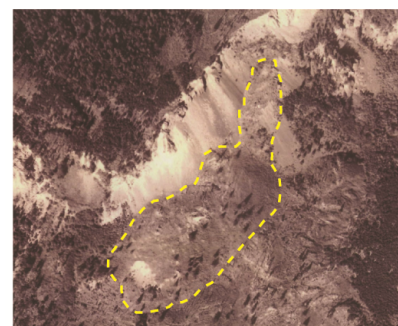
**Figure 38.** Aerial Photograph taken in 1934 of the Old Greenleaf Rockfall (Yellow dashed line). Aerial Photograph courtesy of the United States Corps of Engineers (USCE)

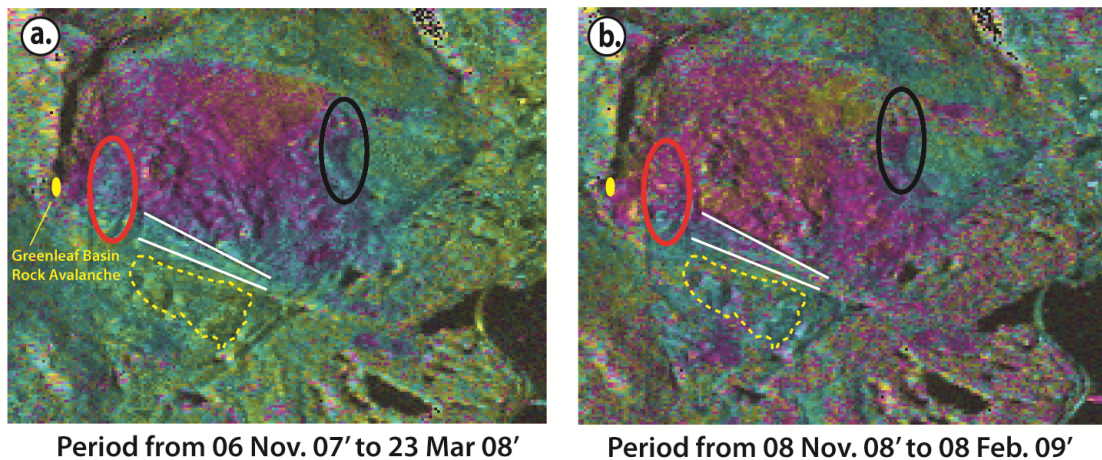
**Figure 39.** InSAR interferograms for **a.** winter of 07'/08' and **b.** winter of 08'/09'. Yellow dot is Greenleaf Basin Rock Avalanche. Compare the ellipses from one image to the other. One image shows areas of movement while the other shows less movement. White lines outline a compression wedge which is apparently an area of resistance. Yellow dashed line is mapped as basalt by Wise (1961). Images from (Pierson and Lu, 2009).

While the Greenleaf Basin Rock Avalanche has contributed to the load on the Red Bluff Landslide, it was not the cause of the winter 07/08 movement of the upper lobe. The driver and the principal cause of movement is most likely pore water pressure due to seasonal precipitation (Burns, 2010 personal communication) (Table2). Referring

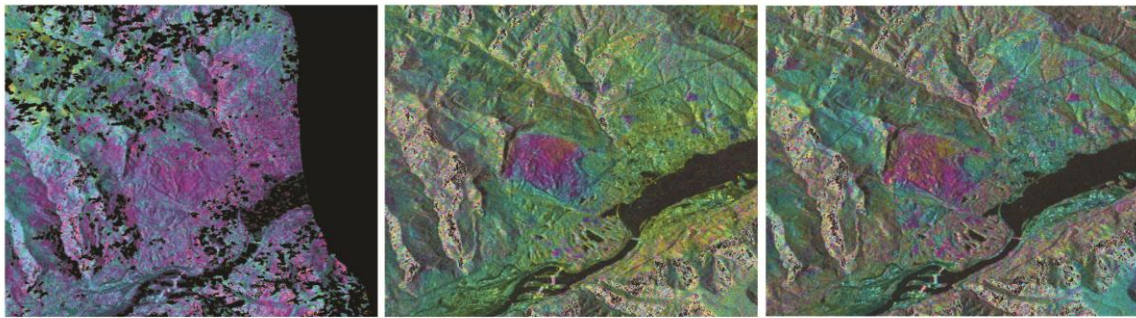
**a.** InSAR Interferogram for period from 5 Jan 2007 to 23 May 2007. Oblique view from southwest.

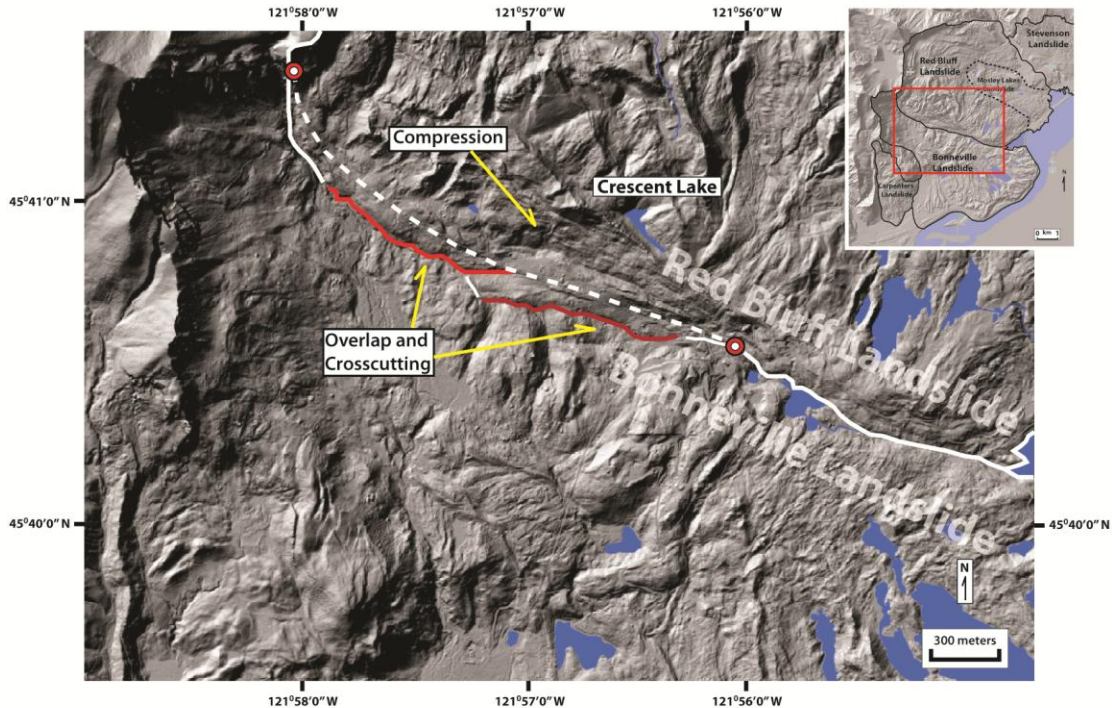
**Figure 41.** Hillshade relief shows overlap the Red Bluff Landslide has on the Bonneville Landslide. White dashed line is an estimation of where the eastern margin of the Bonneville Landslide was originally after time of failure. Red lines are the maximum extent of the overlap from the Red Bluff Landslide. Compressional, overlap, and crosscutting features indicated. Rate of movement estimated between the red dots.

Based on morphological features on the southern portion of the active upper lobe, the upper lobe is moving over the Bonneville Landslide. Figure 41 indicates a region of compressional ridges probably caused by an area of resistance mapped by Wise (1961) as a massive block of basalt (Figures 3, 29,39). The overlap and cross cutting features onto the Bonneville Landslide appear to be an extensional features. Jim O'Connor (written communication, 2012) believes the southwest margin of the topographically higher Red Bluff Landslide is 'relaxing' (extending) south into the space resulting from the Bonneville Landslide". One would think that the Bonneville Slide would show cross cutting features over an older part of the Cascade Landslide Complex.

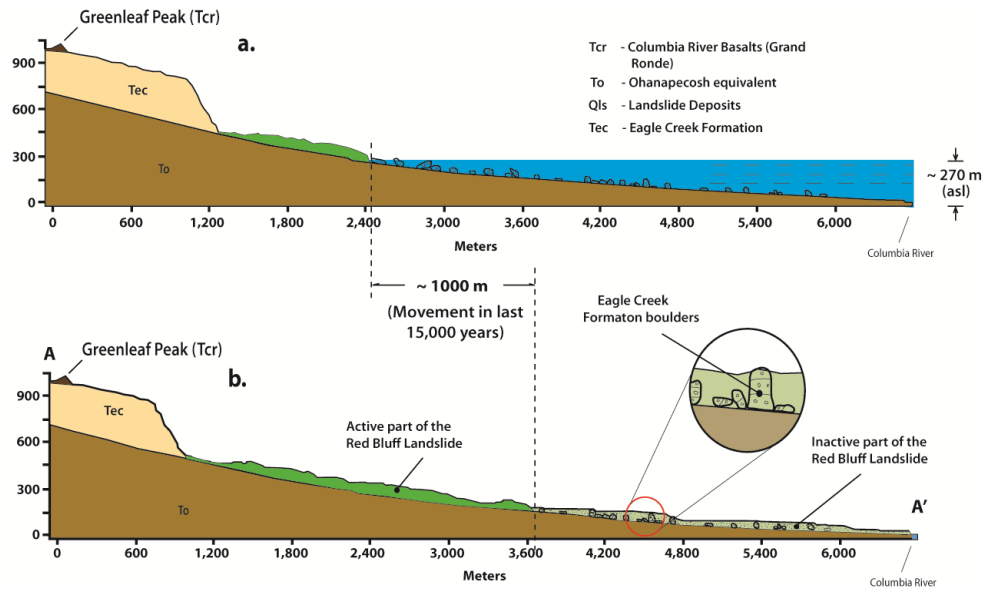
**Figure 42.** Conceptualized graphic on the evolution of the Red Bluff Landslide. (a.) During Highest Missoula Floods. (b.) Today (reference Figure 29 for section A - A')

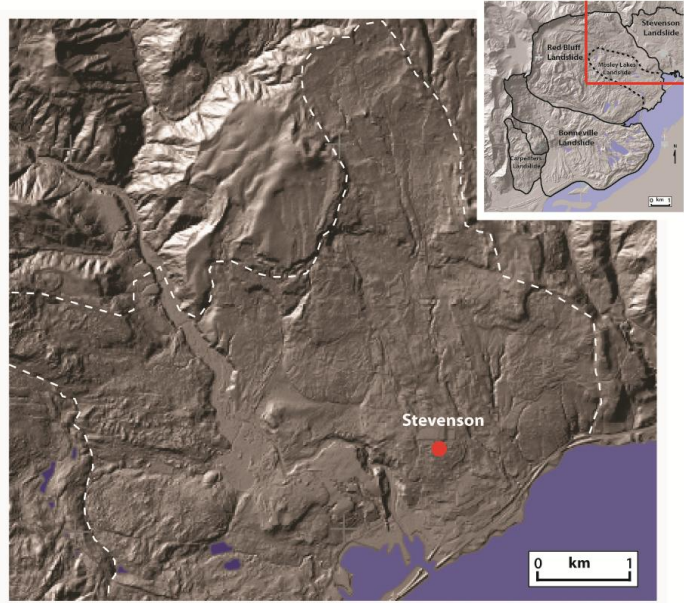
**Figure 43.** Dip slope outlined by white dashed line

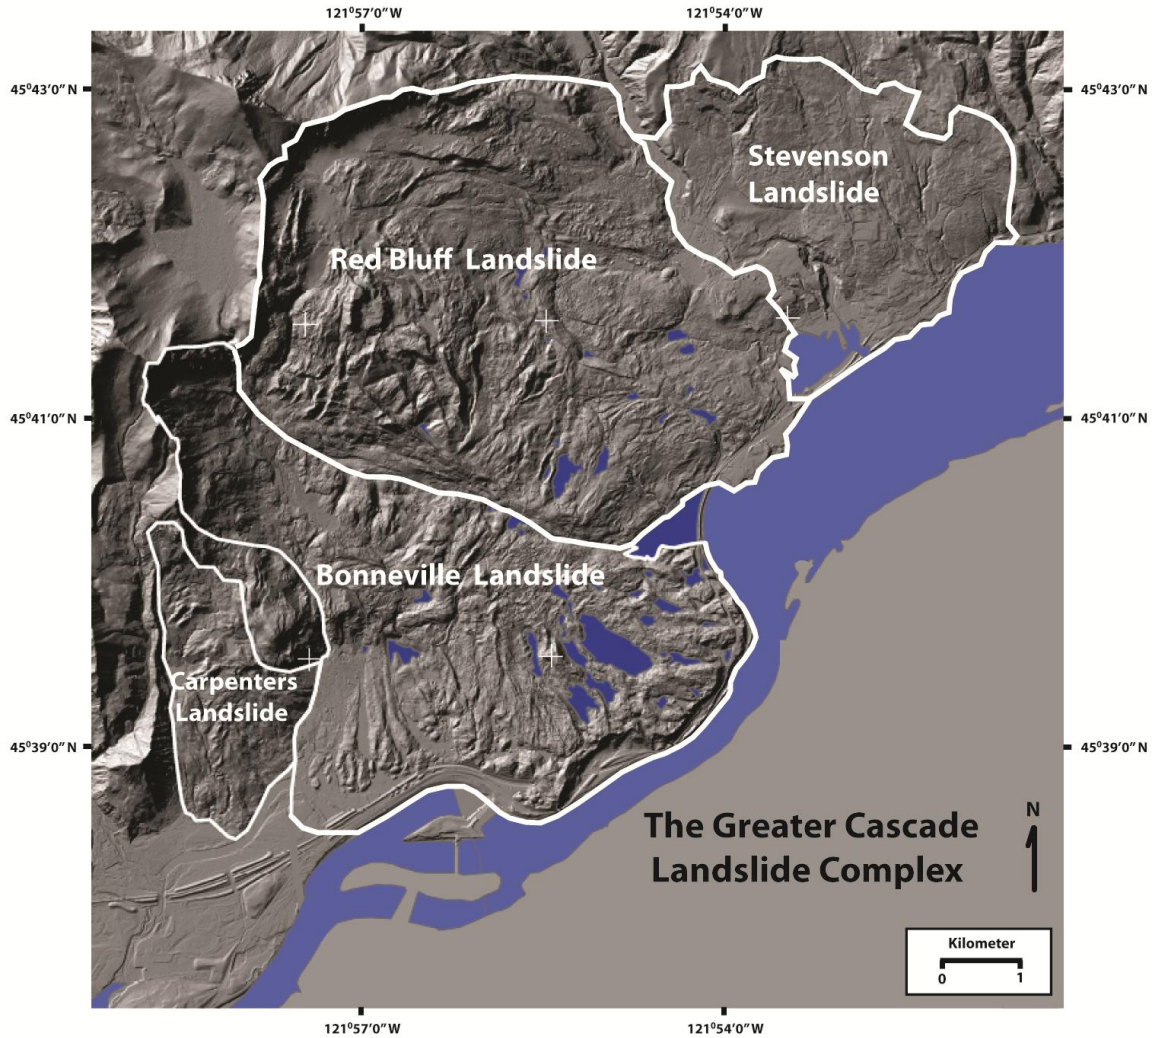
**Figure 46.** The Greater Cascade Landslide Complex (43.0 km<sup>2</sup>) and members: The Carpenters Landslide, Bonneville Landslide, Red Bluff Landslide and the Stevenson Landslide.

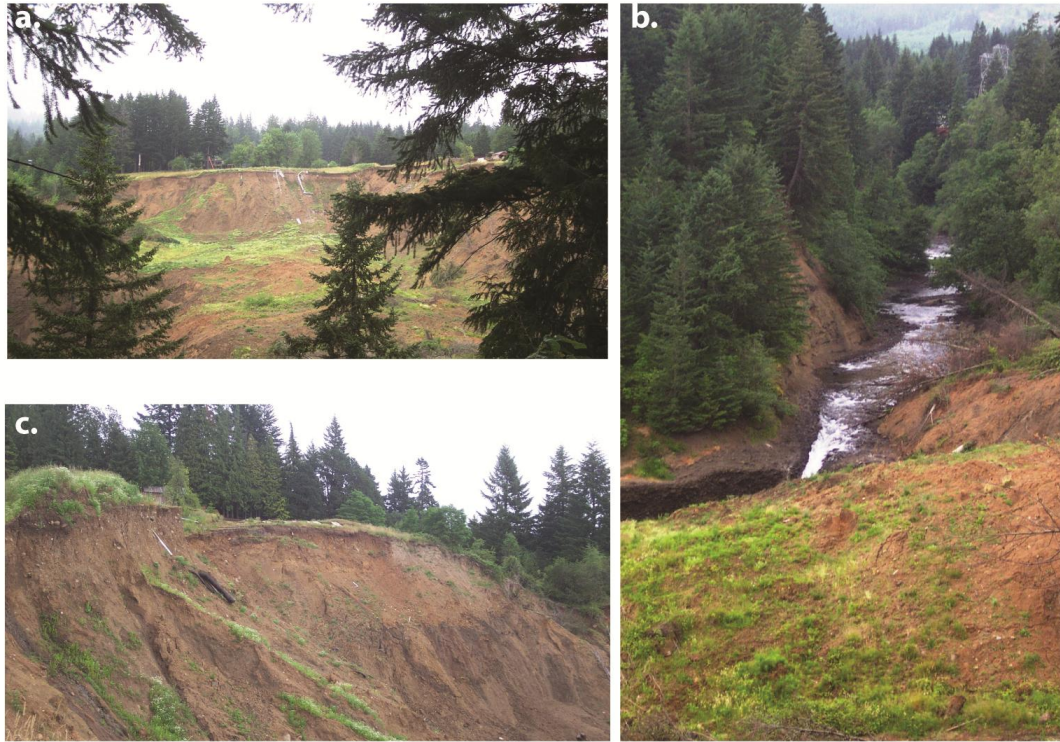
**Figure 47.** Lower Rock Creek area on the Stevenson Slide. **a.** Looking at an active scarp on the north side of Rock Creek. **b.** Photo of Rock Creek looking in a southerly direction at steep embankments. **c.** Closer look at the north side of Rock Creek.

The Stevenson Landslide is not without risk as it is being undermined with landslide activity at Rock Creek (Figures 47 and 48), on the lower portion of the Stevenson Landslide (Figure 45). The Rock Creek Slide has been characterized as sediment failing over an Ohanapecosh surface into Rock Creek presenting a problem for the town of

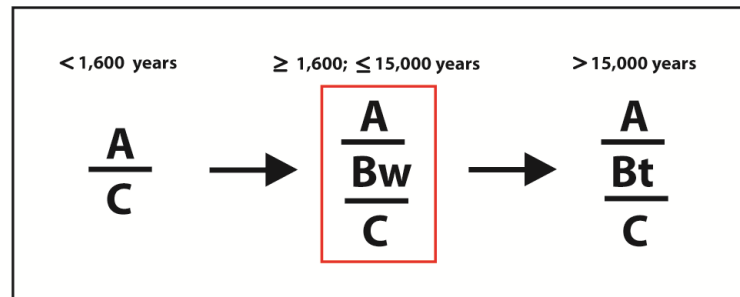
**Figure 49.** Soil chronosequence based on study of soils on Red Bluff Landslide (Based on Burns et al., 2008)

years old (Figure 49) (Burns et al., 2008), and support the idea that the upper lobe is less than or close to 15,000 years old and the same for the sediments below the lobe. The

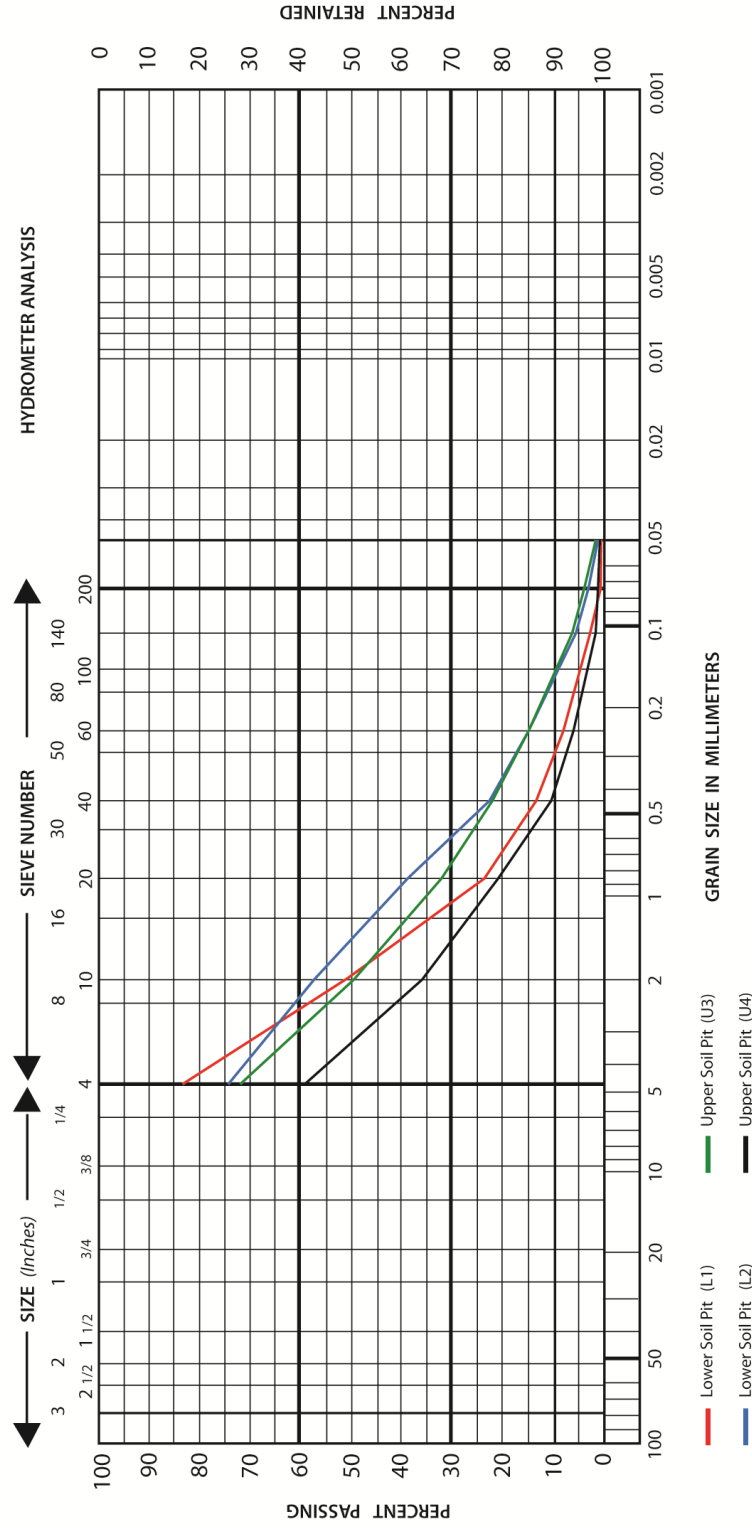
**Figure 52.** Sieve analysis on the two lower and two upper soil pits of the Red Bluff Landslide.

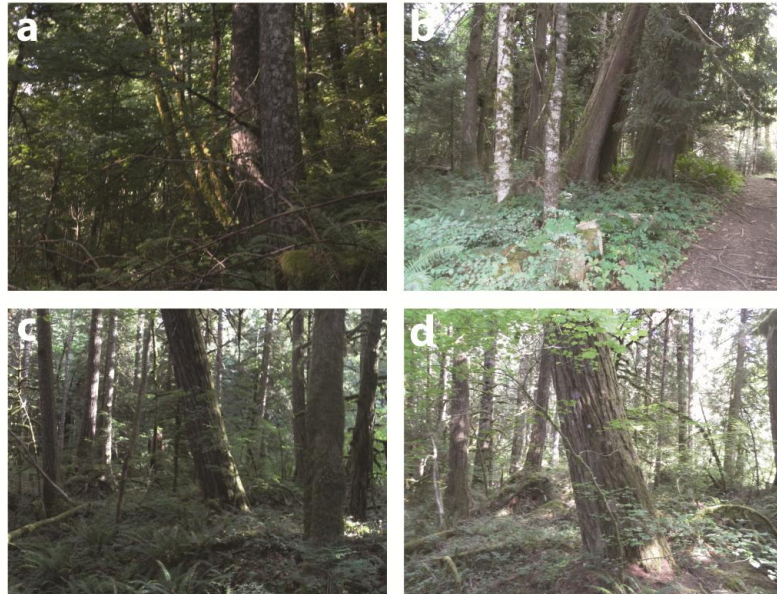
**Figure 53.** **a.** leaning trees on the southern flank of the scoria block seen in Figure 26 between events 2 and 3. **b.** clump of trees leaning to the NE close to headwall and where tension cracks are located. **c** and **d.** trees leaning in different directions by Brush Lake

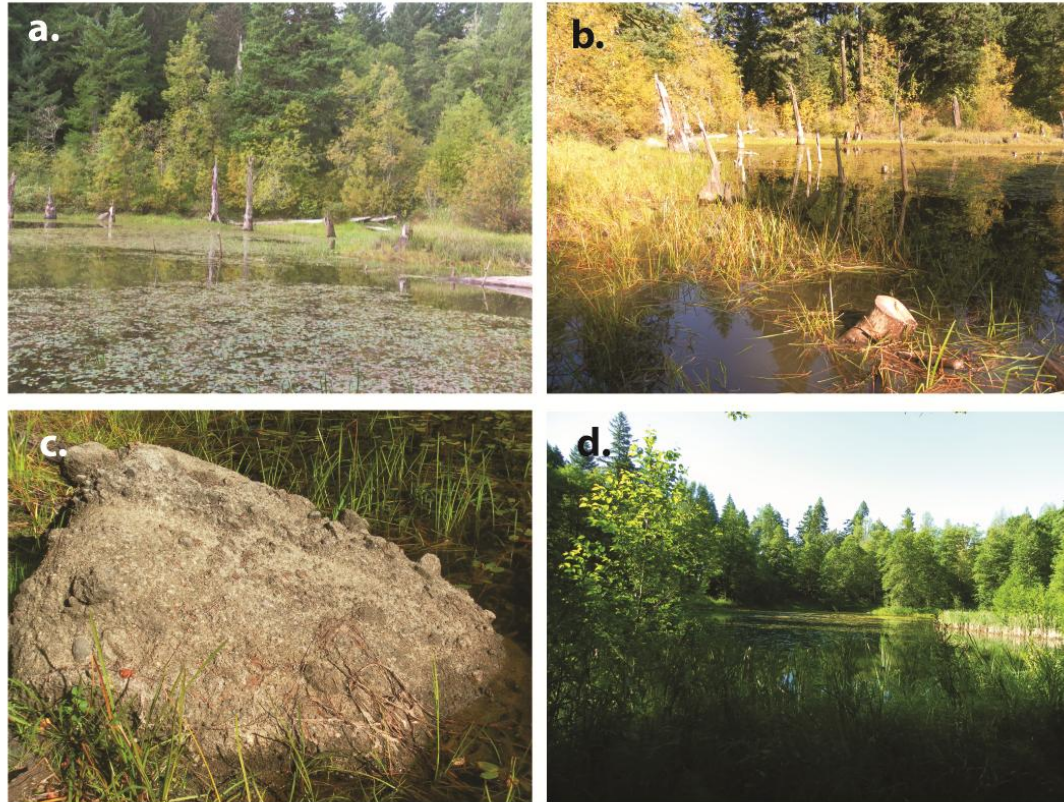
**Figure 54.** Some of the sag ponds on the Red Bluff Landslide. **a.** and **b.** a couple of the smaller Mosley Lakes. **c.** An Eagle Creek boulder on one of the Mosley Lakes. **d.** Photo of Brush Lake
