# **Pedestrian/Bicycle Overcrossings: Lessons Learned**

Prepared by: Rory Renfro  
Portland State University Masters of Urban and Regional Planning  
Field Area Paper  
June 2007

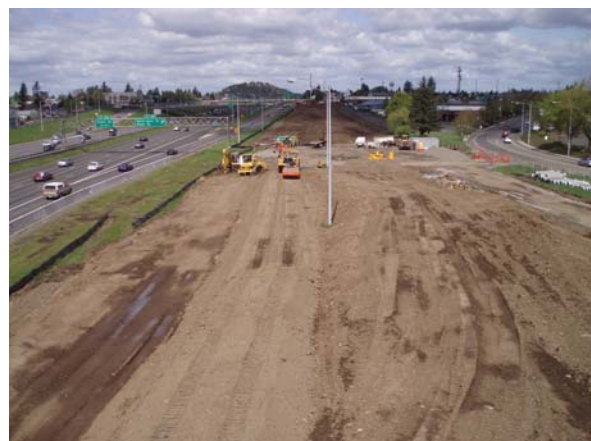
Figure 2 – Light rail station under construction near the I-205 at SE Main St. Bridge

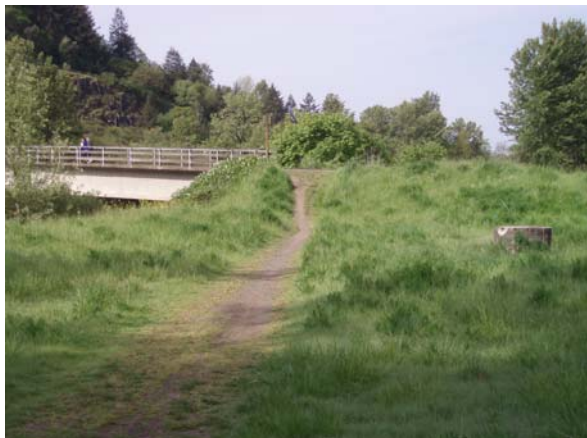
Figure 5 – Informal path leading to the Knickerbocker Bridge

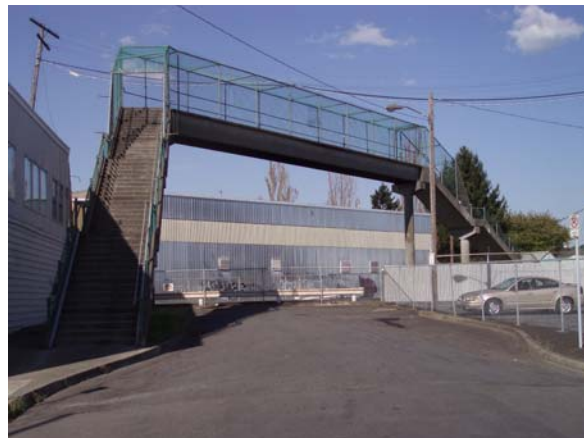
Figure 6 – Stairways are the only access provision at the SE Brooklyn St. at Union Pacific Railroad Bridge

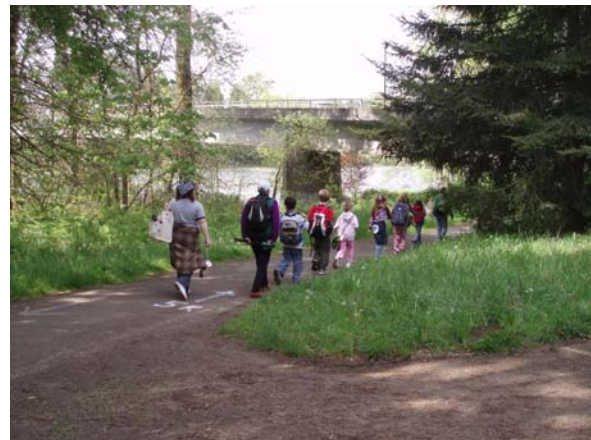
Figure 7 – Shared use path near the Autzen Bridge

Depicted in Figure 7, shared use paths lie within close proximity and directly connect with many overcrossings surveyed for this report. While most pedestrian/bicycle facilities serve utilitarian purposes, shared use paths potentially yield the greatest potential to attract a greater mix of utilitarian and recreational users. In many cases, the bridge itself functions as part of a surrounding shared use path system, providing a key system link over a major barrier. This can translate into greater utilitarian and recreational use of overcrossings.

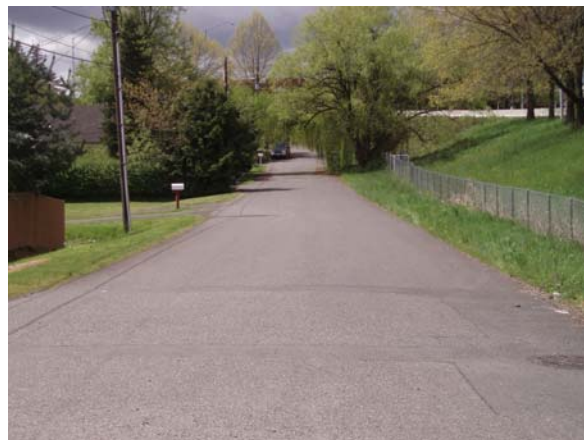
Sidewalks, with varying levels of “completeness” and condition, provide access to most of the bridges surveyed for this study. Where sidewalks do not exist, pedestrians accessing a bridge area must either walk on roadway shoulders (if they exist) or share the street with motor vehicles. Figure 8 depicts an example of a local street lacking sidewalks.

Figure 8 – Many streets near the I-5 at Barbur Transit Center Bridge lack sidewalks

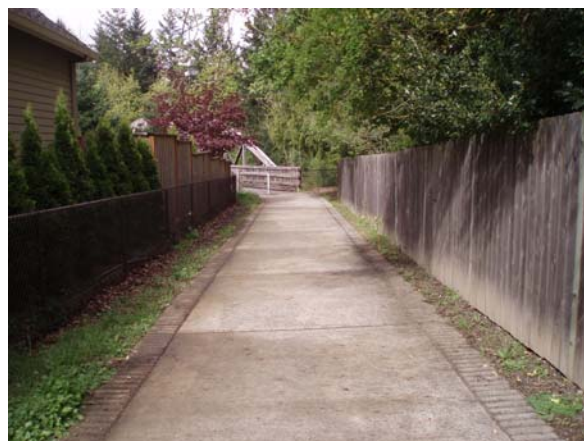
Figure 9 – Neighborhood accessway near the NW Cedar Hills Blvd. at George Foege Park Bridge

Cedar Hills Boulevard at George Foege Park Bridge with an adjacent residential subdivision (see Figure 9). An accessway has also been built to better connect the Springwater Trail at SE McLoughlin Boulevard Bridge with Portland's Sellwood neighborhood.

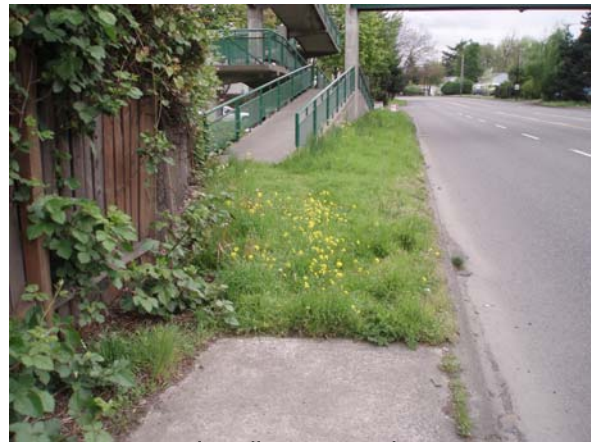
Sidewalks represent the most common facility linking bridges with the surrounding street system. Relatively-complete sidewalk networks exist near most bridges surveyed for this report, however bridge users encounter fragmented sidewalks in some areas. Missing or fragmented sidewalks complicate bridge access for mobility-impaired users, especially wheelchairs. For instance, the N Columbia Boulevard at Midway Avenue Bridge provides ADA-compliant access ramps, but sidewalk gaps create difficult transitions to the surrounding street system (as shown in Figure 10).

Figure 10 – Sidewalk gap complicates access to the N Columbia Blvd. at Midway Ave. Bridge

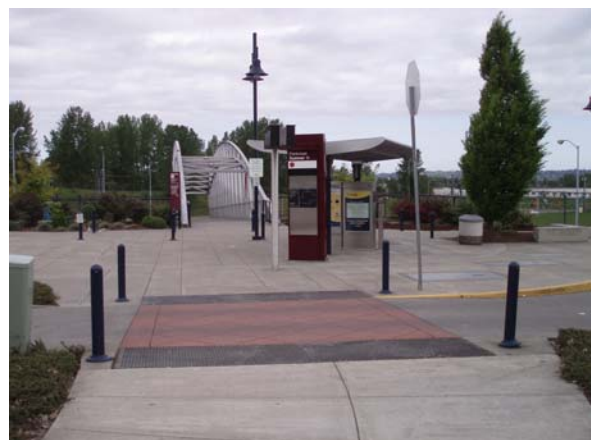
Figure 11 – Raised crosswalk near the I-205 at Parkrose Transit Center Bridge

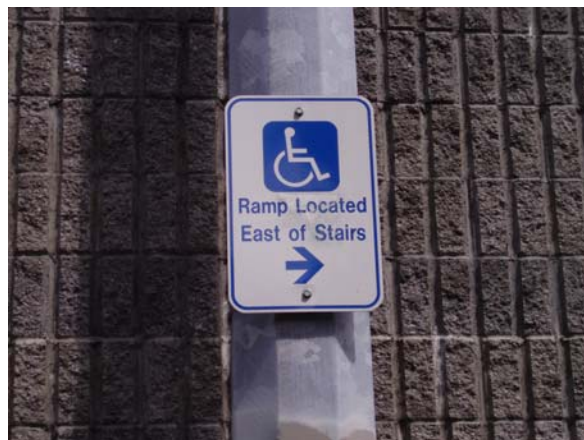
Figure 12 – Signage identifying ADA-accessible route to the I-84 at Hollywood Transit Center Bridge

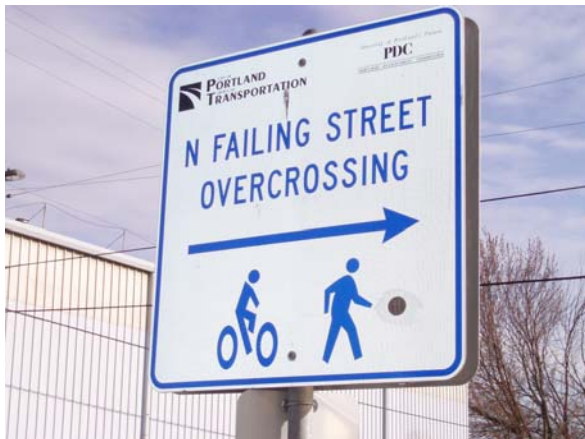
Figure 13 – Signage orienting pedestrians and bicyclists to the I-5 at N Failing St. Bridge

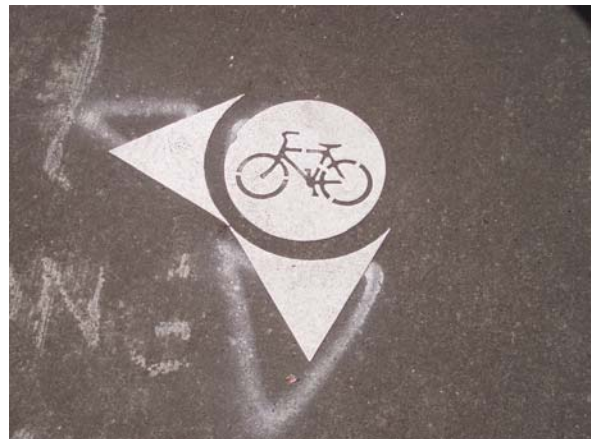
Figure 14 – “Bicycle boulevard” pavement markings on the I-84 at Hollywood Transit Center Bridge

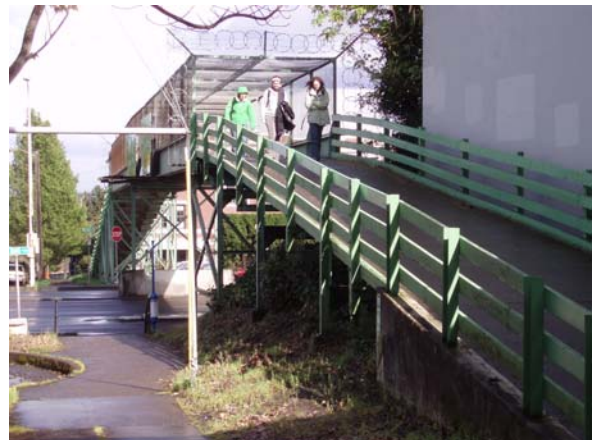
Figure 16 – Linear access ramps at the SW Hooker Street at Naito Pkwy. Bridge, and bus stop directly below the structure

In areas with minimal physical constraints, linear paths and ramps can provide easy transitions to and from the overcrossing for all users, and facilitate continuous movement for “wheel” users (e.g., bicyclists and wheelchairs). Linear paths can also minimize real or perceived out-of-direction travel by eliminating the need for circuitous ramps or switchbacks. Although linear ramps and paths facilitate easy transitions between overcrossings and the surrounding transportation system, the length necessary to provide reasonable grades could result in these facilities meeting the street system at lengthy distances from the bridge structure. This could create a perception of out-of-direction travel for users wishing to reach destinations immediately adjacent to the overcrossing. For instance, the linear access ramps on the SW Hooker Street at Naito Parkway Bridge require users to double-back to reach transit stops directly below the overcrossing (shown in Figure 16).

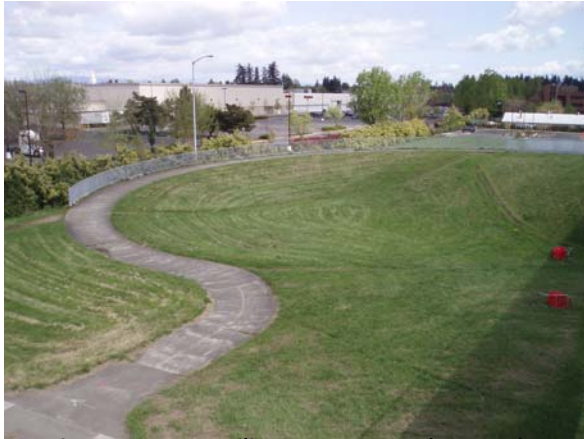
Figure 17 – Curvilinear access path near the I-205 at SE Main St. Bridge

Depicted in Figure 17, curvilinear paths and access ramps integrate broad turns to overcome vertical elevation gains in areas somewhat constrained by topography and other physical elements. Curvilinear paths do not include tight turns common on switchback ramps, but they could create the perception of longer travel distances to reach a bridge. At several overcrossings surveyed for this report, bridge users have responded by creating informal paths serving as short-cuts. In extreme cases, bridge users have cut holes in fences to create shorter routes, as shown in Figure 18.

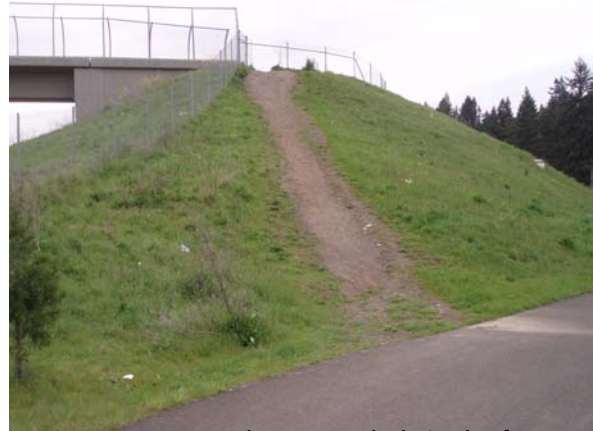
Figure 18 – Users have cut a hole in the fence to create a shorter access route to the I-5 at Main St. Bridge

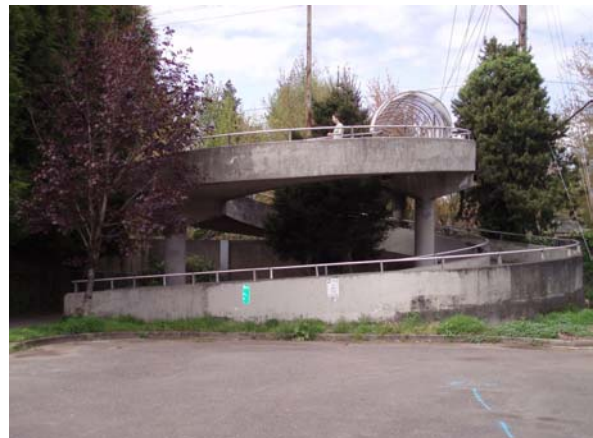
Figure 19 – Spiral ramp on the N Going St. at Concord Ave. Bridge

Spiral ramps can effectively serve bridge users in physically-constrained areas. These facilities transition users to and from the overcrossing via a continuous “loop” (see Figure 19). Depending on the tightness of curve, spiral ramps facilitate slow but continuous movement for “wheel” users, thereby potentially minimizing perceived out-of-direction travel. Caution should be used in spiral ramp design to ensure sufficient sight distances and adequate widths to accommodate bi-directional traffic. Consideration should also be given to perceived out-of-direction travel for pedestrians, especially if spiral ramps are the only access provision.

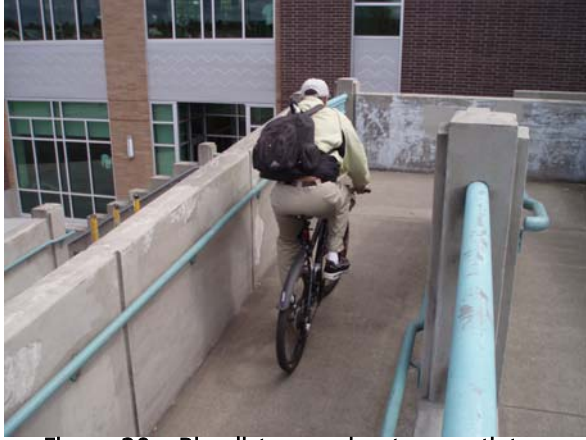
**Figure 20 – Bicyclist preparing to negotiate a narrow switchback turn approaching the I-84 at Hollywood Transit Center Bridge**

avoid them for several reasons. First, numerous switchbacks create the perception of circuitous travel and long travel times to overcome relatively short distances. For instance, the north ramp at the I-84 at Hollywood Transit Center Bridge includes seven switchbacks, while the north ramp at the Padden Parkway at NE 142nd Avenue Bridge includes nine switchbacks. Second, narrow switchback ramps can be difficult to maneuver on a bicycle or in a wheelchair, especially when users must negotiate 180-degree turns in relatively tight spaces (see Figure 20). Switchback ramps can better accommodate multiple users through wider widths and a minimal number of turns, as in the case of the Eastbank Esplanade-Rose Quarter Connector (see Figure 21). It should be noted however that despite the presence of wide switchback ramps, some bicyclists were observed carrying their bikes on adjacent stairways, suggesting that some users may always equate switchback ramps with out-of-direction travel regardless of their quality. Furthermore, some users might avoid bridges altogether if switchback ramps provide the only access option.

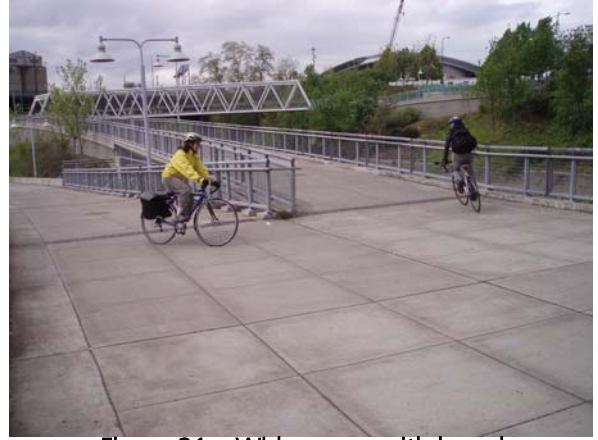
**Figure 21 – Wide ramps with broad switchbacks on the Eastbank Esplanade-Rose Quarter Connector**

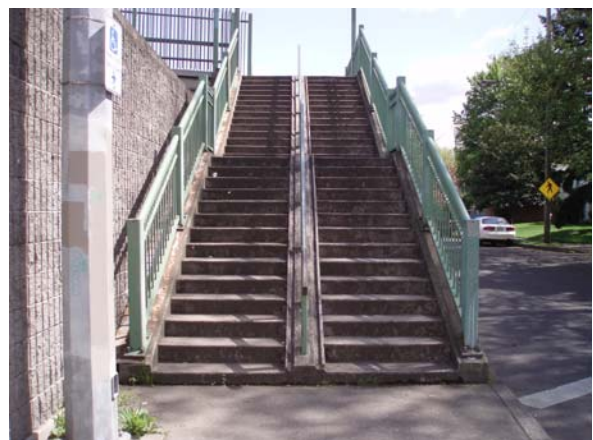
**Figure 22 – Stairways near the I-84 at Hollywood Transit Center Bridge include “bike gutters”**

Stairways provide the most direct bridge access for able-bodied pedestrians, and can be built in space-constrained areas. Stairways provide access to numerous bridges surveyed for this report, and stairways compliment adjacent curvilinear or switchback ramps. In addition to providing bridge access options for able-bodied pedestrians, stairways can be built with “bike gutters” to serve bicyclists wishing to avoid lengthy ramps. Depicted in Figure 22, a bike gutter is a small grooved concrete trough located between the stairway and adjacent

railing, providing a smooth surface to push a bicycle while walking up or down stairs.<sup>14</sup>

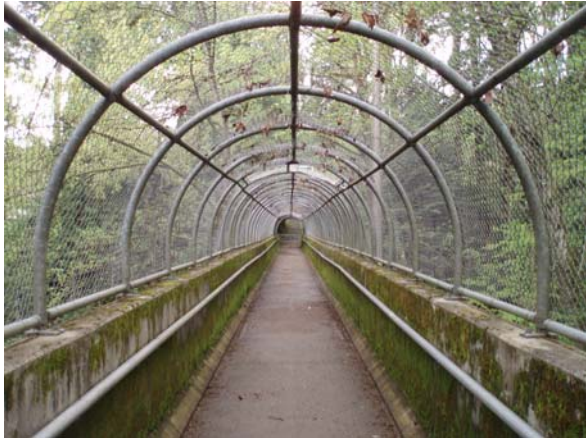
Figure 24 – A relatively low vertical clearance creates the perception of isolation on the Trillium Cr. Bridge

Nearly half of the overcrossings surveyed for this report lack overhead elements, while fences, structures and vegetation lie immediately above the remaining bridges. The range of vertical clearances varies from less than 8 feet on the Searle Street Bridge, to over 10 feet on the Eastbank Esplanade-Rose Quarter Connector. Some bridges with relatively narrow widths and low vertical clearances evoke a sense of isolation from the surrounding area, which can create safety and security concerns for some users (see Figure 24).

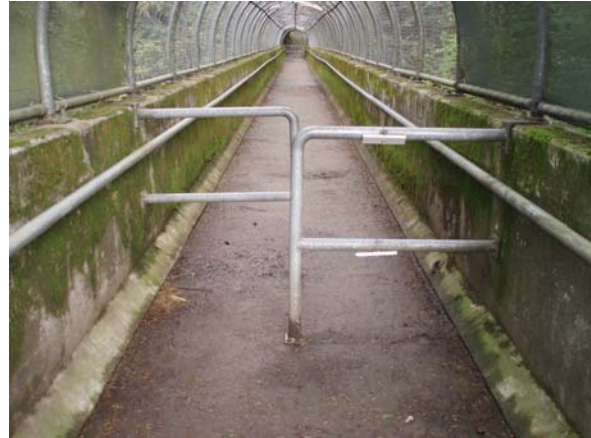
Figure 25 – Horizontal railings create a tight “pinch point” at both ends of the Trillium Cr. Bridge

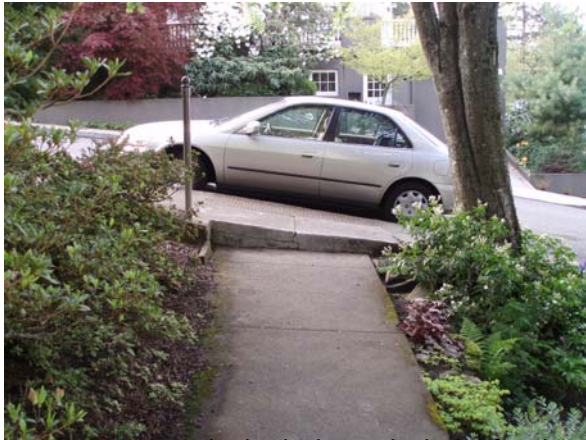
Figure 26 – Parked vehicles and a lack of curb ramps complicates access to and from the SW Spring St. Bridge

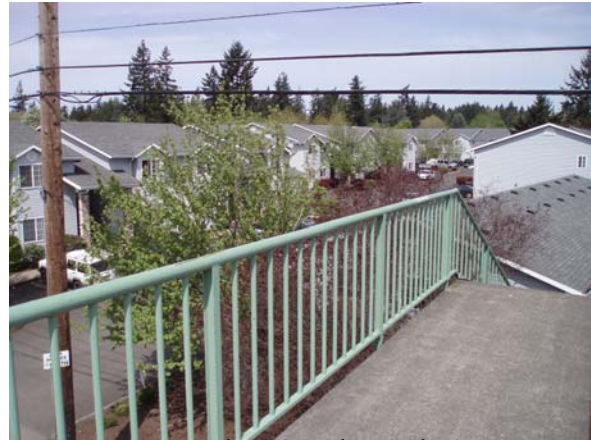
Figure 27 – Low-hanging electrical wires create safety issues at the SE Division St. at 136th Ave. Bridge

Design-related obstructions refer to permanent physical objects that may or may not have been integrated with an overcrossing’s original design. Regardless, these elements create or have the potential to create issues for bridge users. For instance, in an apparent effort to prevent bicycling on the bridge structure, the Trillium Creek Bridge includes two sets of railings in the travelway at each end, providing only 34 inches of horizontal clearance (as shown in Figure 25 above). Although this treatment succeeds in blocking bicycle traffic, this measure also prevents wheelchairs and other mobility devices from using the bridge. “Wheel” users might also experience difficulty using the SW Spring Street Bridge. Depicted in Figure 26, the bridge’s west access ramp leads directly to a raised sidewalk with no ramp (the presence of parked cars immediately adjacent to the sidewalk also complicates bicycle access). Finally, the overcrossings at NE 122nd Avenue at Sacramento Street, and at SE Division Street at 136th Avenue present safety issues where less than 7 feet of vertical clearance separates the uncovered bridge decks with low-hanging electrical wires above (see Figure 27).

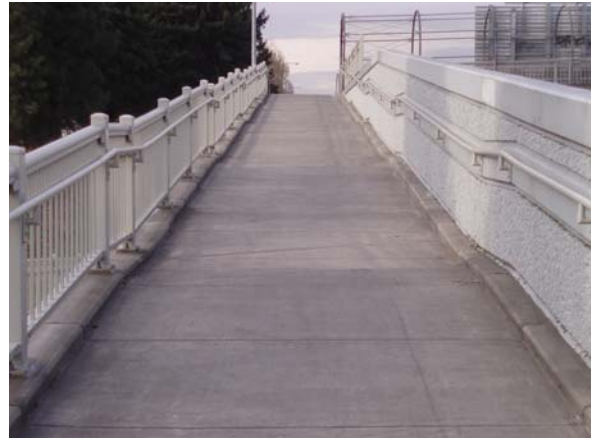
Figure 28 – Access ramp with level landings on the I-5 at N Failing St. Bridge

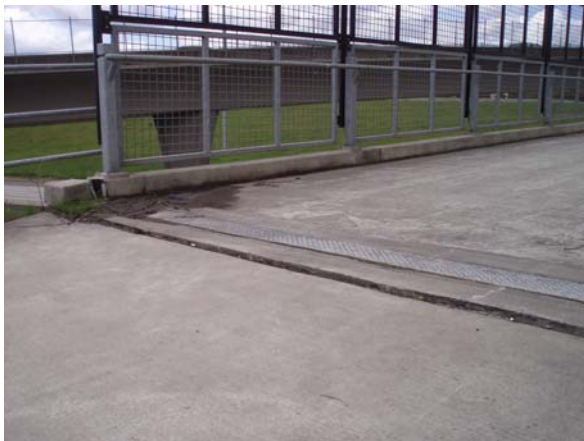
Figure 29 – Pavement “lip” at the I-5/Oregon 217 Interchange Bridge

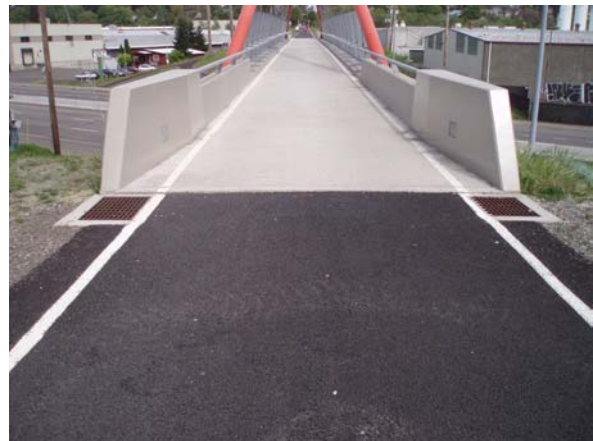
Figure 30 – Drainage grates placed outside the pedestrian/ bicycle travelway near the Springwater Trail at SE McLoughlin Blvd. Bridge

Drainage grates and manhole covers could also impact surface conditions on bridges and access ramps. Most pedestrian/bicycle design guidance documents recommend placing drainage grates and manhole covers off paths or as far away from the bicycle/pedestrian travelway as possible (see Figure 30 on Page 25). If located on the bridge or path, drainage grates should include openings narrow and short enough to prevent bicycle tires from dropping into the grates. Where drainage grates and manhole covers must be located within the pedestrian/bicycle travelway, they should be constructed flush with the surrounding pavement.

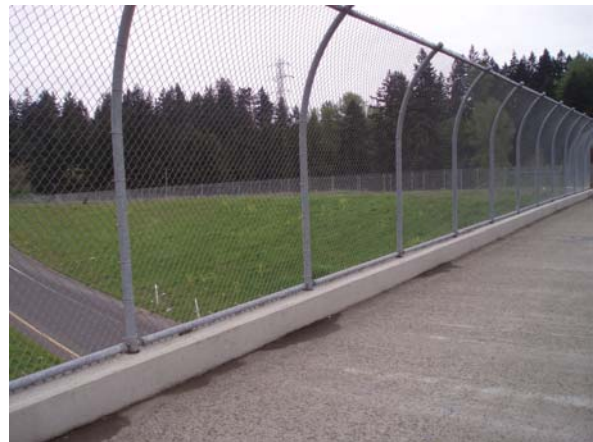
Among the bridges surveyed for this study, most fence heights far exceed the recommended height guidelines, as shown in Figure 31. Heights range from approximately 6 feet, 7 inches to about 10 feet, 6 inches. Some bridges include railings on one side only or lack railings altogether. Railings exist on both sides of most other bridges with heights ranging from about 32 inches to about 55 inches.

Figure 31 – Fencing on the I-5 near Main St. Bridge is about 10' 5" tall

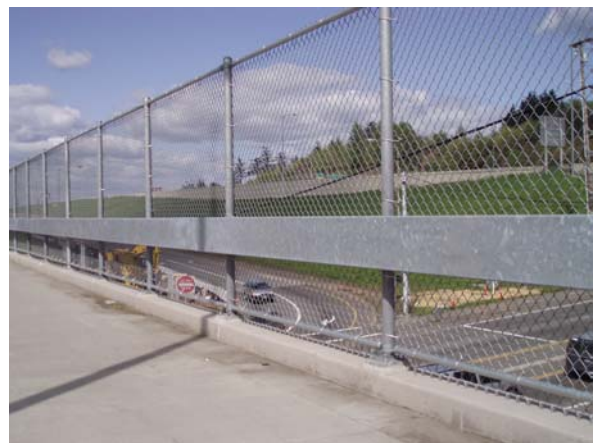
Figure 32 – Bicycle "rub rail" on the SE Powell Blvd. at I-205 Bridge

between openings in the railing.<sup>28</sup> With the exception of some overcrossings, most bridges surveyed for this report include railing openings 6 inches wide or smaller. This is especially true for bridges with cyclone fencing or mesh siding. It should be noted that railings on the relatively-new SE Powell Boulevard at I-205 Bridge include a smooth, wide “rub rail” to prevent bicycle handlebars from catching the vertical bars should a bicyclist come into contact with the railing (see Figure 32 on Page 26).

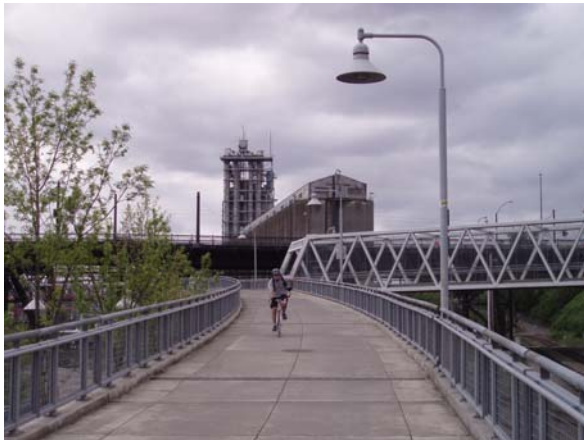
Figure 33 – Pedestrian-scale lighting on the Eastbank Esplanade-Rose Quarter Connector

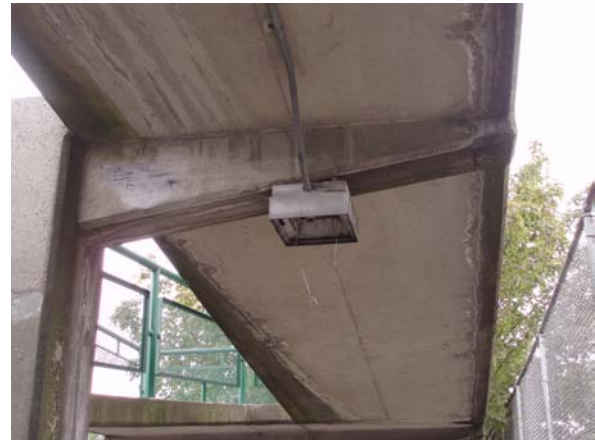
Figure 34 – Missing light at the N Columbia Blvd. at Midway Ave. Bridge

Overcrossings require on-going maintenance. Agencies should perform routine bridge inspection and maintenance to address surface conditions (e.g. pavement cracking), remove obstructions (e.g., glass and debris), replace lighting, and address any other relevant issues as needed.

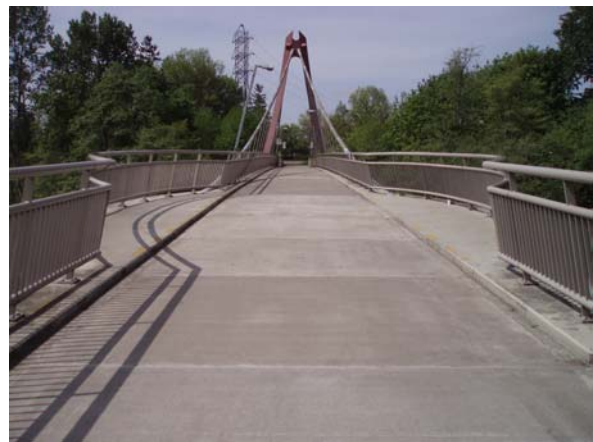
Figure 36 – Viewpoints on the DeFazio Bridge

Several bridges surveyed for this study include elements that add aesthetic value. Architectural details have created aesthetically pleasing overcrossings, including Padden Parkway at NE 142nd Avenue, NW Cedar Hills Boulevard at George Foege Park, Springwater Trail at SE McLoughlin Boulevard, and the DeFazio Bridge. Designers have taken additional steps by creating viewpoints and congregating areas on bridges and approach ramps, as exhibited at the Eastbank Esplanade-Rose Quarter Connector, and at the Autzen, DeFazio, and Knickerbocker Bridges (see Figure 36).

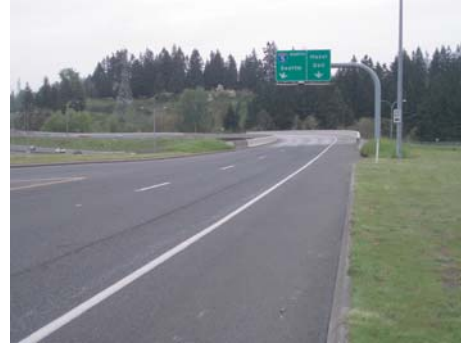
The nearest alternative crossing (I-5 at Main St.) lacks sidewalks

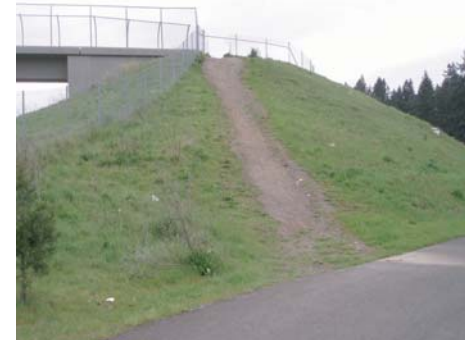
Informal path created by bridge users to reduce out-of-direction travel

- Vertical rise between bridge and base of access ramps: Data unavailable
- Bicycle: Circuitous path on east end creates a perceived sense of out-of-direction travel, especially for users travel to/from the south
- Pedestrian: Stairways not provided on east end to address perceived out-of-direction travel; users have created informal paths to reduce travel distances

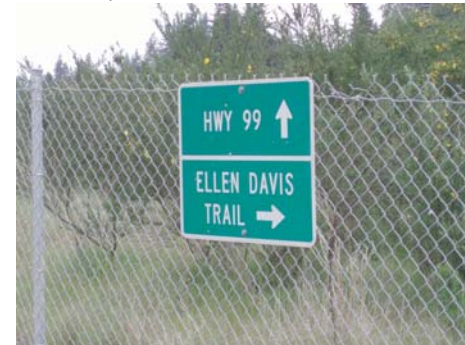
Wayfinding signage directing bridge users to nearby trails and streets

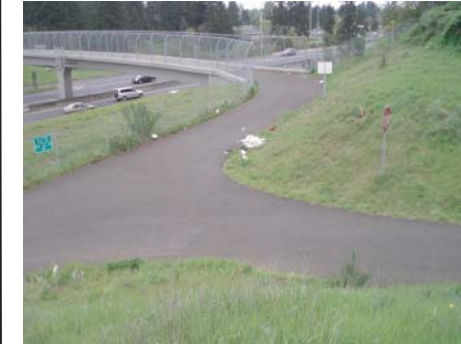
Surrounding shared use paths provide direct access to the bridge

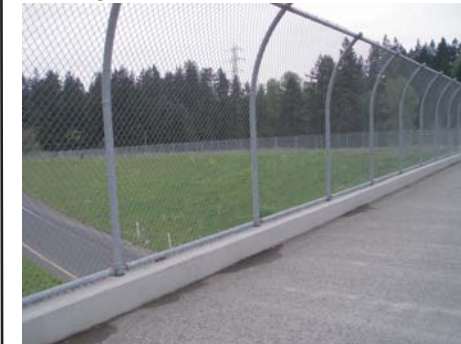
Railings not present on bridge structure

- Shared use paths: No immediate fences, walls or railings
- Bridge: ~10' 5" fence, no walls or railings

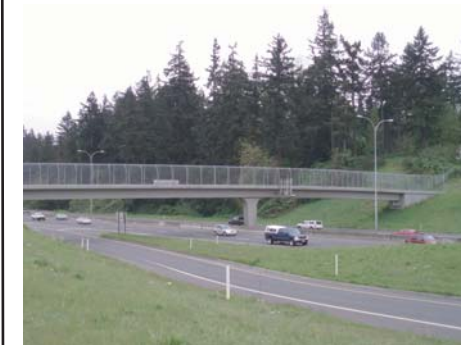
The only source of lighting is provided by surrounding light poles on I-5

Lighting: Ambient freeway lighting only

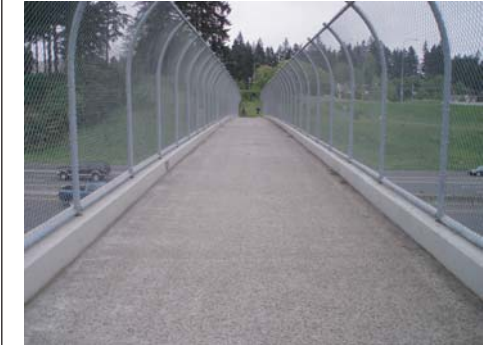
12' curb-to-curb width on bridge structure

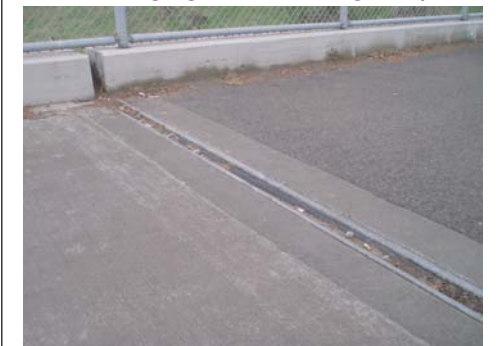
- Bridge: Pavement in good condition; large expansion joint gaps at bridge ends (creates issues for "wheel" users)
- Shared use paths: Pavement in good condition
- No drainage grates on bridge or paths

Expansion joint gap at west end of bridge structure

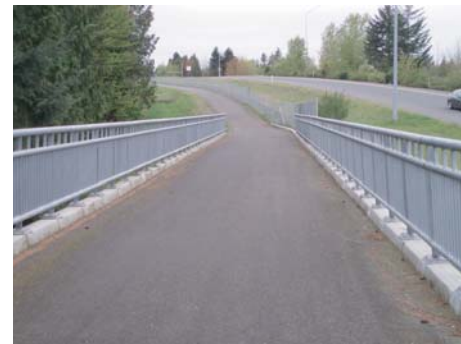
The bridge is part of the Padden Parkway shared use path

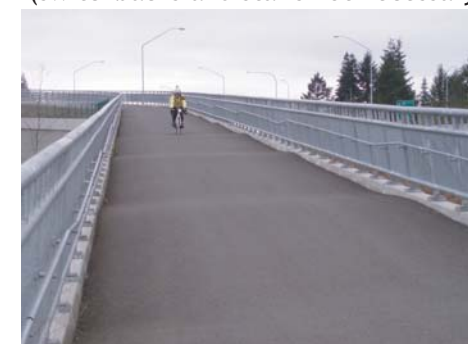
- Vertical rise between bridge and base of shared use path approaches: Data unavailable
- Bicycle: Linear approach ramps eliminate out-of-direction travel and facilitate continuous bicycle travel
- Pedestrian: Linear approach ramps eliminate out-of-direction travel (switchbacks and stairs not necessary)

Linear access ramps facilitate continuous bicycle travel

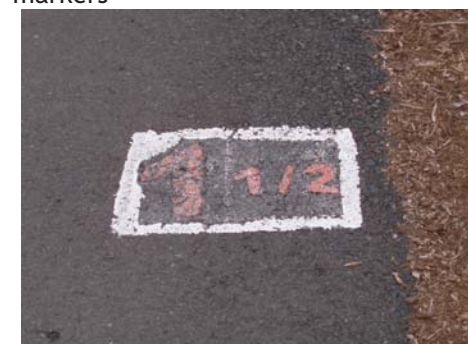
Wayfinding or other signage/pavement markings: Pavement markings on shared use path serving as mileage markers

Mileage markers on Padden Pkwy. shared use path

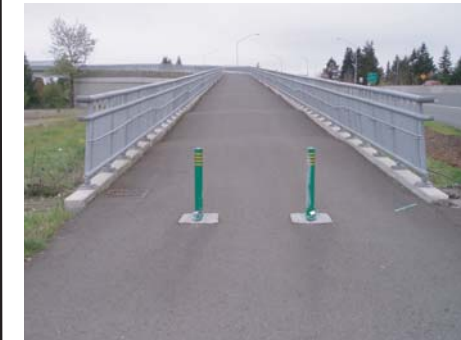
- Access ramp length/width:
- No specific lengths (bridge is part of a continuous shared use path)
  - Shared use path width: ~14'
  - Twin bollards near east end of bridge (4' 7" horiz. clearance on outer ends; 3' 9" horiz. clearance between bollards); minimal reflectivity and height could create vision difficulties for nighttime path users

Twin bollards near east end of bridge

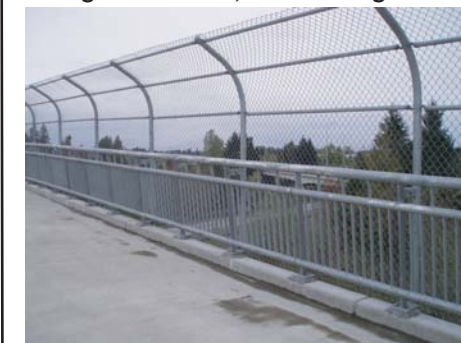
- Shared use path approach ramps:
  - West ramp: ~54" railings
  - East ramp: ~31" lower railings, ~54" upper railings
- Bridge: ~9' fence, ~54" railings

Railing and fence on bridge structure

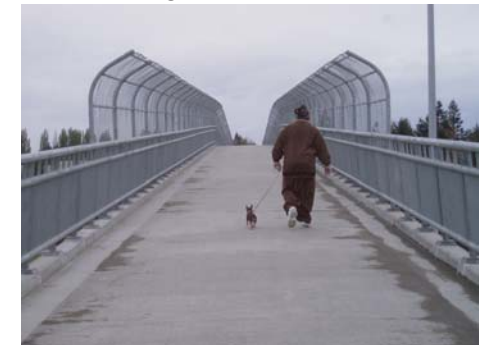
Minimum bridge structure width: ~14'

Bridge cross-section includes a 14' width (curbs and railings are flush with one another)

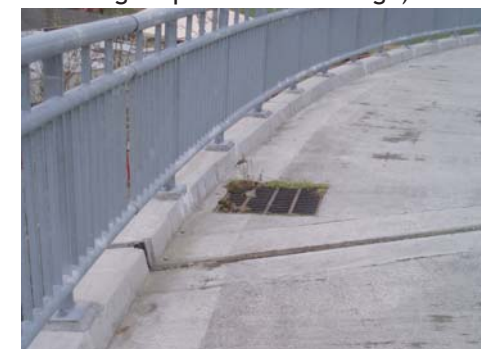
- Bridge: Pavement in good condition; large expansion joint gaps at bridge ends (creates issues for "wheel" users); drainage grates on far edges of pavement
- Shared use paths: Pavement in generally good condition (some cracking on path east of bridge)

Drainage grate and expansion joint on bridge structure

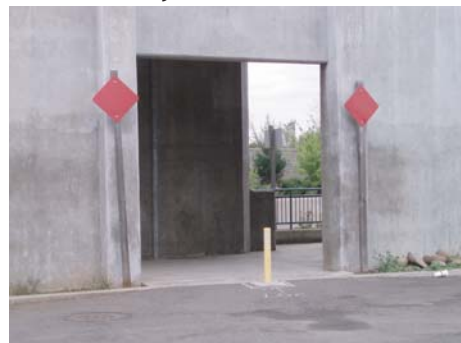
- Curb ramps provided where access ramps meet the street system
- Fragmented sidewalks on NE 142nd Av.
- Shared use path on south side of Padden Pkwy.

A smooth transition is provided at the base of the bridge's south access ramp with NE 142nd Ave.

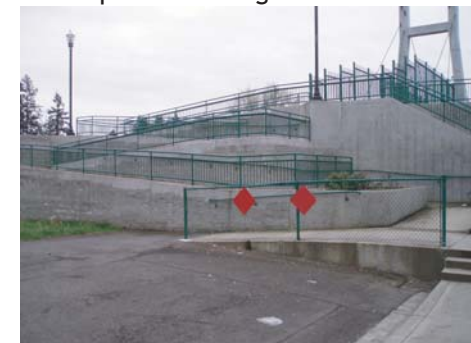
- Vertical rise between bridge and base of access ramps: Data not available
- Bicycle:
  - North end: Excessive out-of-direction travel on north access ramp (9 switchbacks); "bike gutter" not provided on adjacent stairways to provide alternative routing
  - South end: Depends on direction of travel (switchback ramp creates some out-of-direction travel for bicyclists traveling to/from the north, south, and west); "bike gutter" not provided on adjacent stairway to provide alternative routing
- Pedestrian:
  - North end: Depends on user (stairways provided as an alternative to switchback ramp; switchback ramp creates long travel distances for wheelchair users)
  - South end: Depends on user (stairways provided as an alternative to switchback ramp; switchback ramp creates long travel distances)

Narrow access ramp with multiple switchbacks complicates bicycle access on the bridge's north end

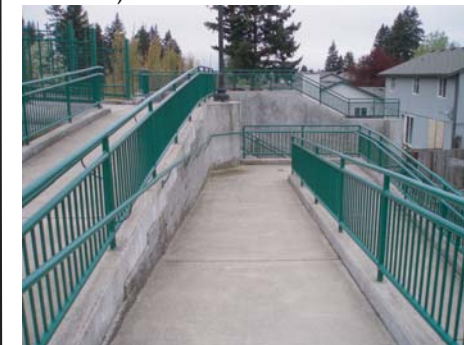
- Switchback ramp with level landings on north end (9 switchbacks)
- Stairways with landings on north end
- Linear ramp with landing on south end (# of switchbacks depends on direction of travel)
- Stairway with landings on south end
- "Bike gutter" not provided on stairways
- Center bollard present where south access ramp meets NE 142nd Ave. (6' 2" horiz. clearance on each side of bollard)

North access ramp

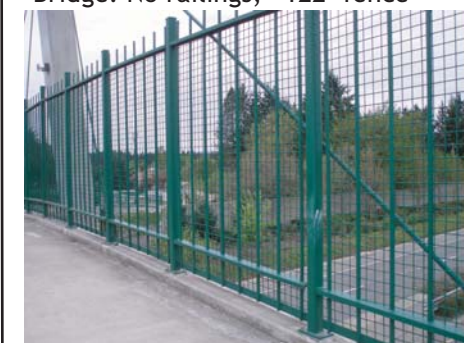
- Ramps/stairways: ~35" lower railings, ~42" upper railings
- Bridge: No railings, ~122" fence

Railings not provided on bridge structure

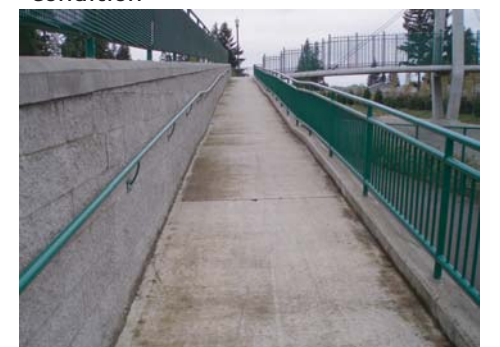
- Bridge: Pavement in good condition
- Access ramps: Pavement in good condition

The bridge and access ramps benefit from relatively good pavement conditions

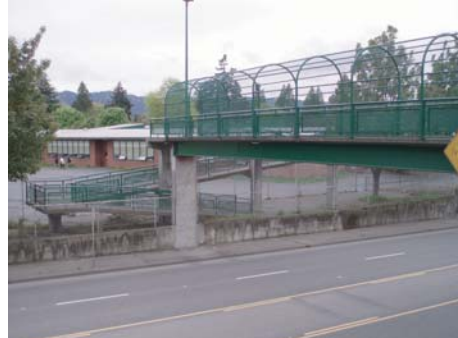
Elements precluding/discouraging at-grade crossings in bridge area:  
Fencing on south side of Columbia Blvd.

Fencing on south side of Columbia Blvd. discourages at-grade crossings near George Middle School, and encourages students to use the bridge

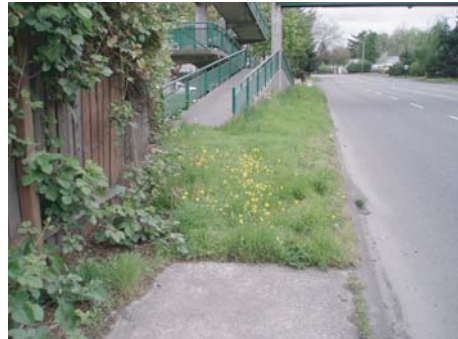
Bike/ped accommodations immediately adjacent to bridge:  
- Fragmented sidewalks where bridge access ramps meet the street system  
- Curb ramps lacking at adjacent intersections

Gap between bridge access ramp and sidewalk on N. Columbia Blvd.

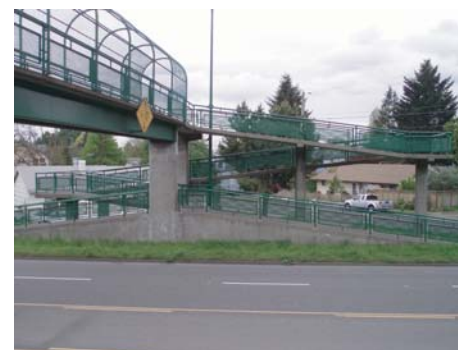
Degree of out-of-direction travel to overcome any vertical rise to reach the bridge:  
- Vertical rise between bridge and base of access ramps: ~16'  
- Bicycle: Numerous switchbacks on access ramps discourage bicycle use  
- Pedestrian: Numerous switchbacks on access ramps increase travel distances; pedestrians may opt to use nearby at-grade crossings

Bridge users must negotiate through several switchbacks on both ends of the structure

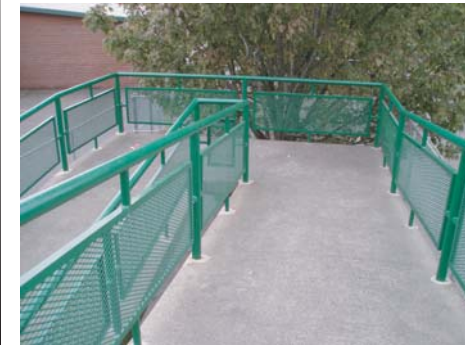
Bridge access provisions:  
- Switchback ramps with level landings  
- 2 switchbacks on south access ramp  
- 2-3 switchbacks on north access ramp (depending on direction of travel)

Access ramp with level landings

Access ramp length/width:  
- South ramp: ~145'/~6'  
- North ramp: ~175'/~6'

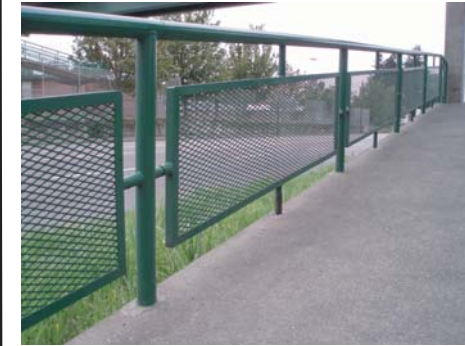
Fence/wall/railing heights:  
- Access ramps: ~42" railings  
- Bridge: ~42" railings

Railing style on access ramps and bridge

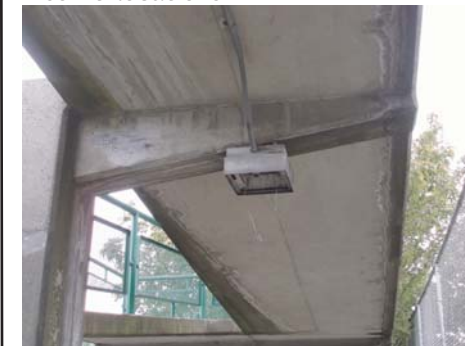
Lighting: Provided on north and south ends of bridge; lights missing or broken in some locations

Missing light on south side of bridge

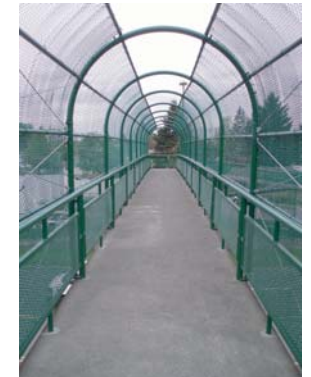
Minimum bridge structure width: ~6'

Bridge cross-section includes a 6' rail-to-rail width

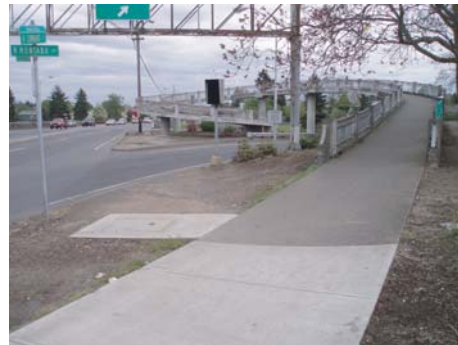
Elements precluding/discouraging at-grade crossings in bridge area: None

No physical or other elements exist to discourage at-grade crossings of the I-5 entrance ramp

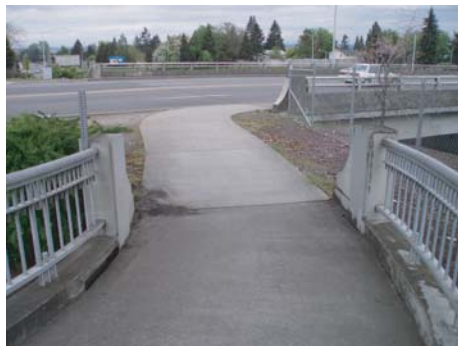
- Sidewalk on N. Lombard St.
- No curb ramp between N. Lombard St. and bridge (bicyclists must ride on sidewalk to access bridge)

Transition between sidewalk and bridge access ramp

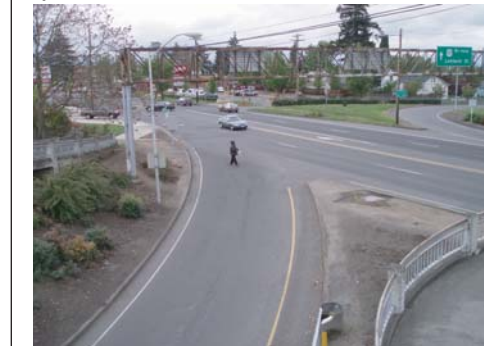
Observed at-grade crossing behaviors indicate that some pedestrians view the bridge as requiring excessive out-of-direction travel

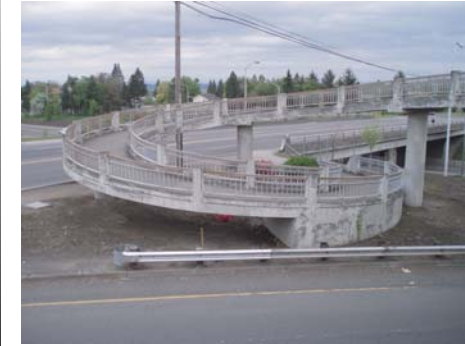
- Linear and "spiral" ramps
- No level landings

East access ramp

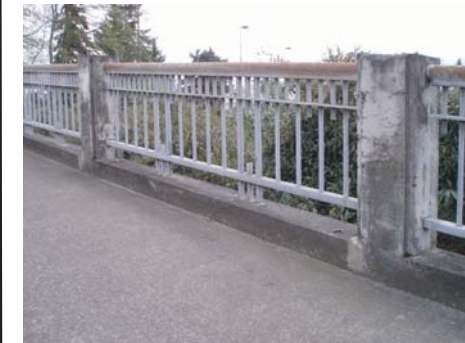
- Access ramps: ~40" railings
- Bridge: ~40" railings

Railing style on access ramps and bridge

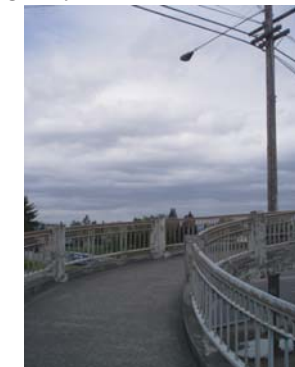
Lighting: Ambient street and freeway lighting only

Light poles on N. Lombard St. are the bridge's primary illumination source

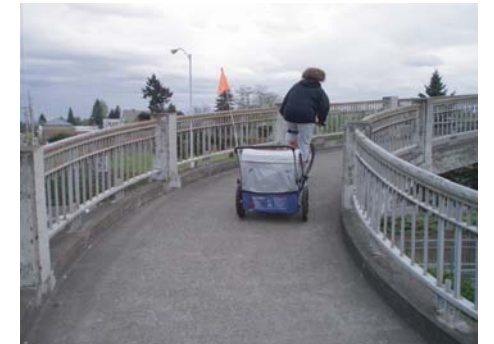
Minimum bridge structure width: ~8'

Bridge cross-section includes an 8' curb-to-curb width

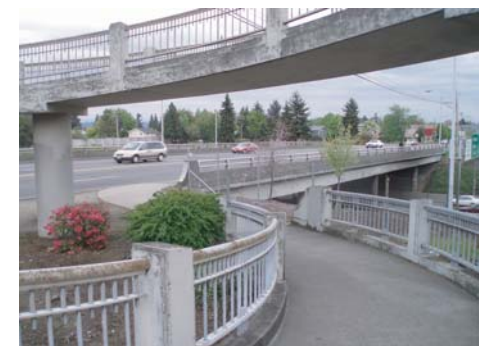
~11' 7" vertical clearance between bridge and access ramp below

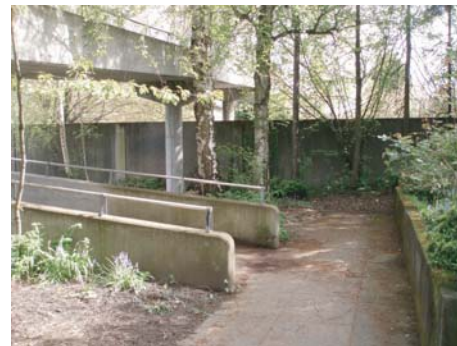
Elements precluding/discouraging at-grade crossings in bridge area:  
Sound walls on north and south sides of Going St.

Sound wall discourages at-grade crossings and encourages use of the bridge

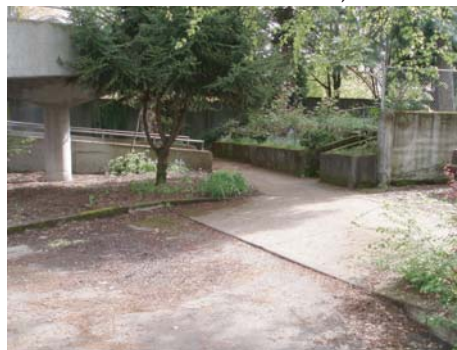
- Curb ramps provided at adjacent intersections
- Large "lip" on driveway apron providing access to bridge's north entrance (could complicate travel for wheelchair users)

"Lip" on driveway apron at bridge's north access point

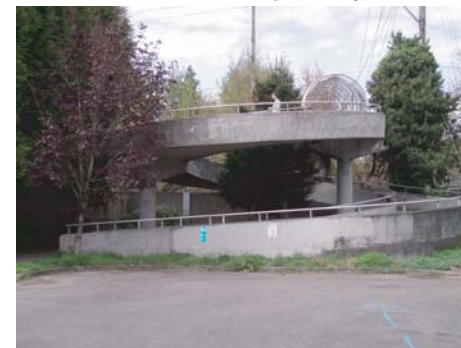
- Vertical rise between bridge and base of access ramps: ~18'
- Bicycle: "Spiral" ramps minimize travel distance to overcome vertical rise, and permit slow but continuous bicycle movement
- Pedestrian: "Spiral" ramps minimize travel distance to overcome vertical rise; stairways not provided

"Spiral" access ramp on bridge's south side

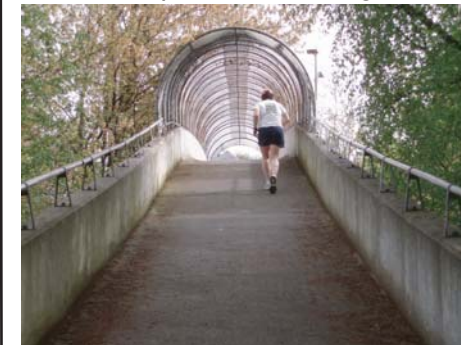
- "Spiral" ramps
- No level landings
- No bollards where access ramps meet streets
- Ramp slope becomes especially steep where ramps meet the bridge

Access ramp slope is relatively steep immediately near the bridge structure

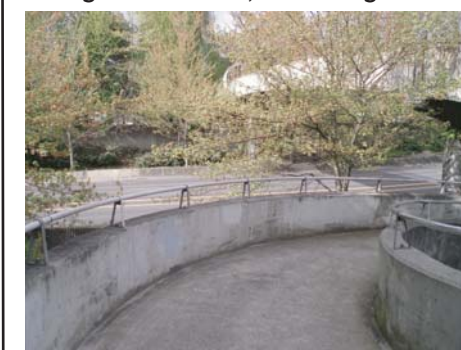
- Access ramps: ~30" walls, ~42" railings
- Bridge: ~30" walls, no railings

South access ramp

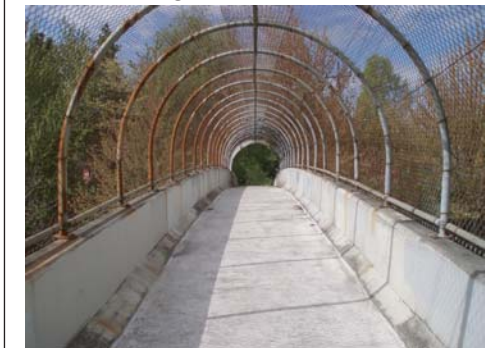
Extruded curbs reduce the bridge's usable width

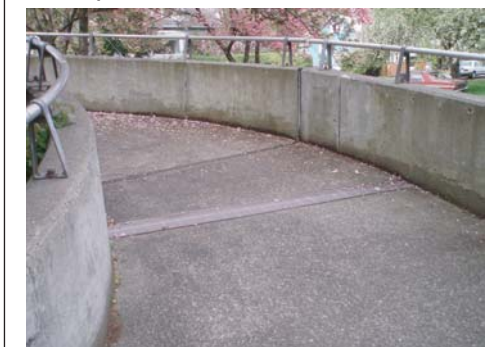
Drainage grates are flush with the pavement, thereby easing travel for "wheel" users

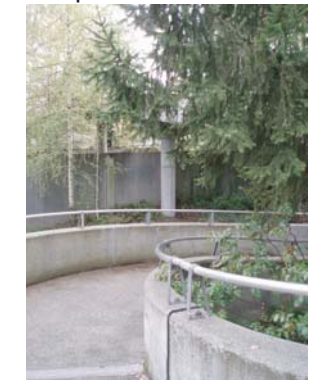
- Encroaching vegetation on both access ramps

Encroaching vegetation on north access ramp

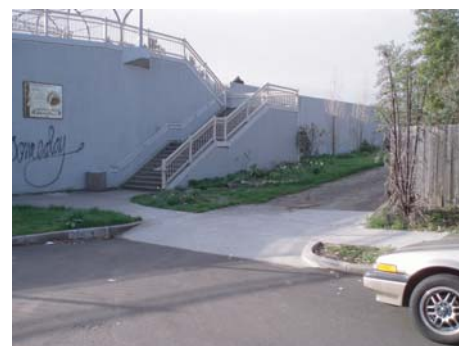
Driveway apron on the bridge's east end facilitates easy bicycle transitions to/from the street

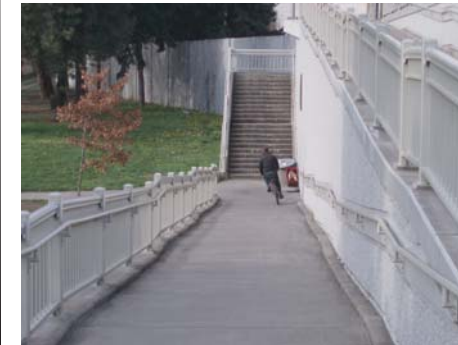
Bridge access provisions:  
- Switchback ramps with level landings  
- 1 switchback on east and west access ramps  
- Stairways with level landings

Level landings provided on stairways and access ramps

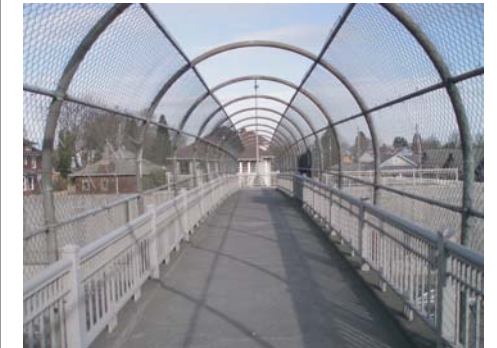
Minimum bridge structure width: ~8'

Bridge cross-section includes an 8' curb-to-curb width

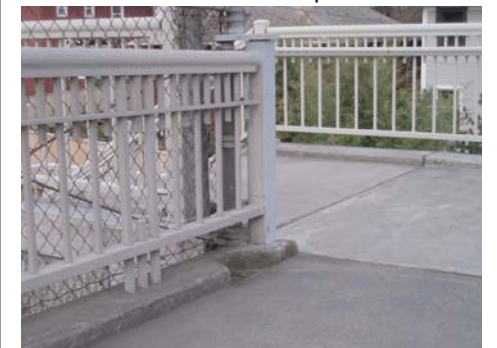
- Bridge: Pavement in good condition; drainage grates placed outside the bridge's curb-to-curb width
- Access ramps: Pavement in good condition; minor water ponding at base of east access ramp

Drainage inlets placed out of the bicycle/pedestrian travelway

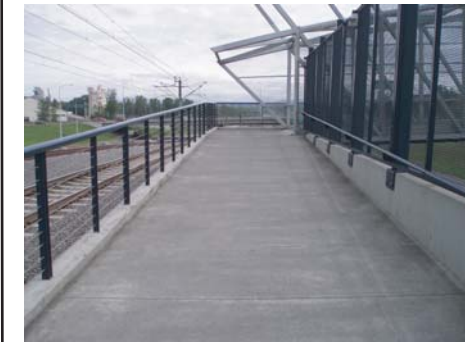
- Access ramp on west side
- Access ramp not necessary on east side (bridge and transit center are at the same elevation)

West access ramp

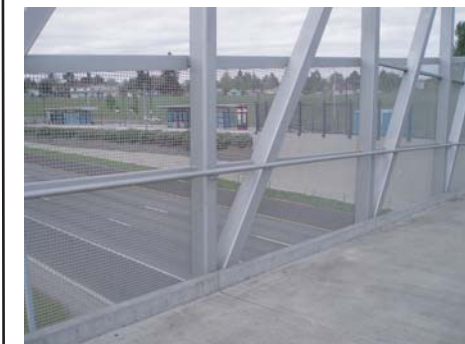
- West access ramp: ~32" railings, 42" barrier (west side)
- Bridge: ~42" railings

The bridge structure includes 42" high railings on both sides

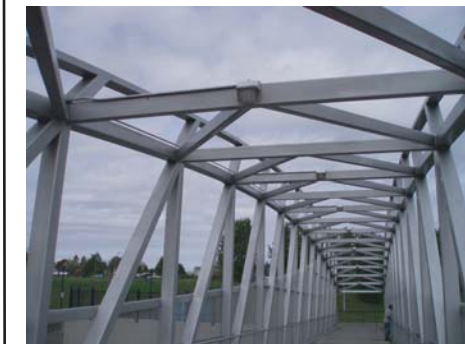
Overhead lighting on bridge

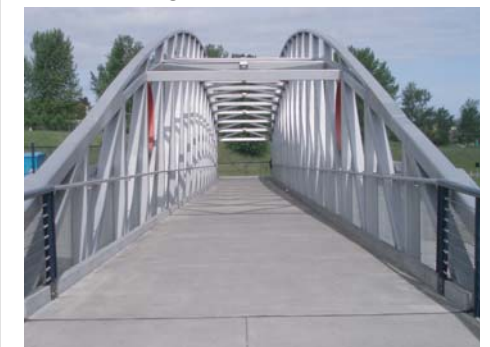
Minimum bridge structure width: ~12'

Bridge cross-section includes a 12' rail-to-rail width

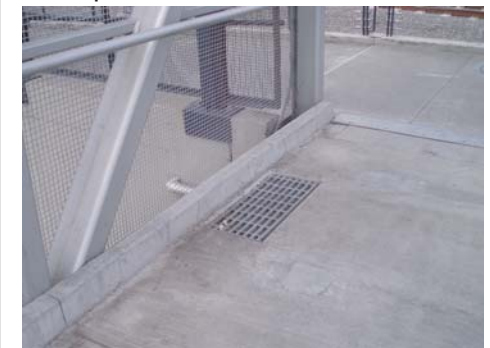
- Bridge: Pavement in good condition; small drainage grates at west end; minor expansion joint "lip" at west end
- Access ramps: Pavement in good condition; drainage grates are flush with pavement

Drainage grate at bridge's west end

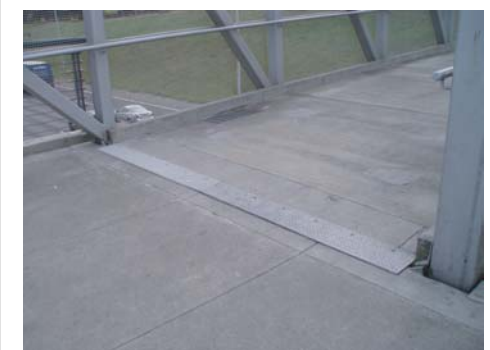
Expansion joint "lip" at bridge's west end
