# **Pedestrian/Bicycle Overcrossings: Lessons Learned**

Prepared by: Rory Renfro  
Portland State University Masters of Urban and Regional Planning  
Field Area Paper  
June 2007

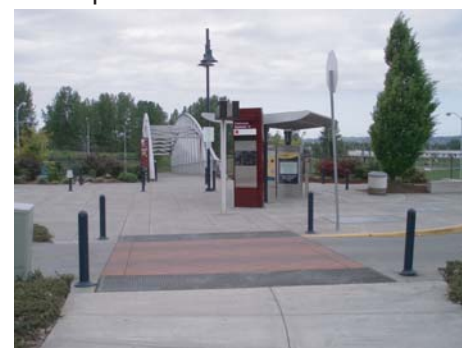
Raised crosswalk at bridge's east end

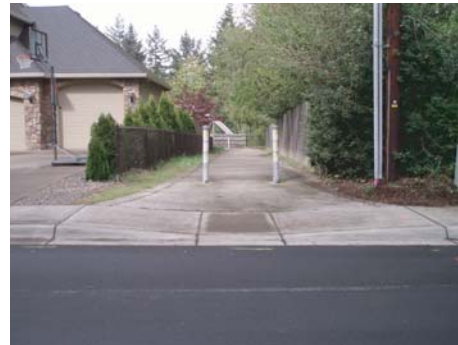
Accessway connecting the bridge with NW 112th Ave. provides curb ramps for easy bicyclist transitions to/from the street

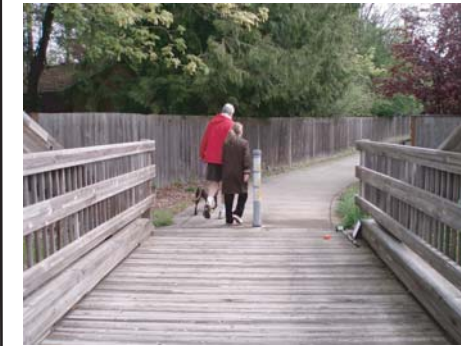
- Bridge access provisions:
- Shared use path on west side
  - Neighborhood accessway on east side
  - Bollards provided at bridge ends and on neighborhood accessway at NW 112th Ave.
  - Center bollard at bridge ends (5' horizontal clearance on each side of bollards)
  - Twin bollards on accessway (2' 10" horiz. clearance on outer ends, 4' 6" horiz. clearance between bollards)

Bollards placed at the bridge's center provide sufficient clearance for passing bicyclists, wheelchairs and other users

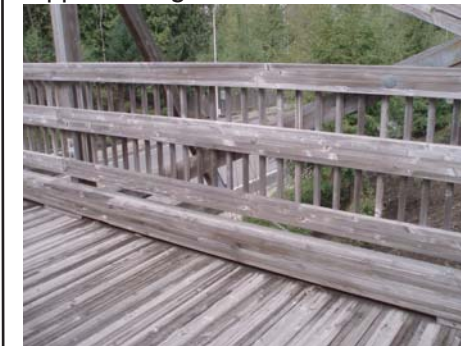
- Fence/wall/railing heights:
- Shared use path/accessway: No immediate fences, walls or railings
  - Bridge: 38.5" middle railing, 54" upper railing

Railings on bridge structure

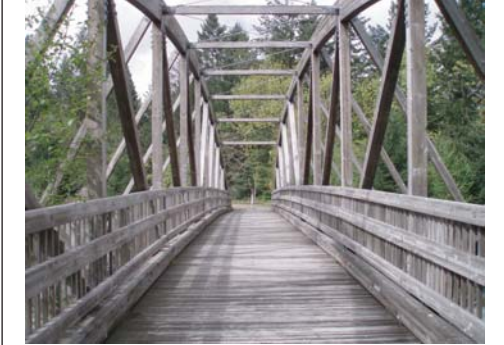
- Bridge structure length (excluding access ramps): ~148'
- Bridge structure vertical clearance: varies
- Minimum bridge structure width: ~10'

Bridge cross-section includes a 10' curb-to-curb width, plus 3.5" of "shy distance" on each side

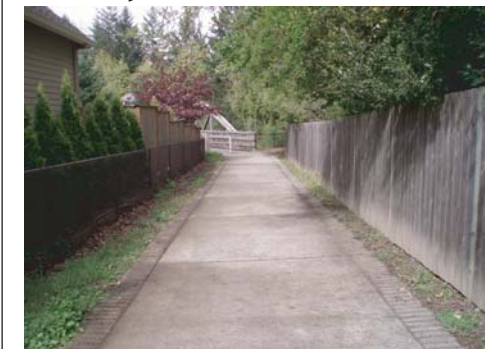
- Horizontal/vertical obstructions: Low-hanging vegetation on east accessway

Minor vegetation encroachment on east accessway

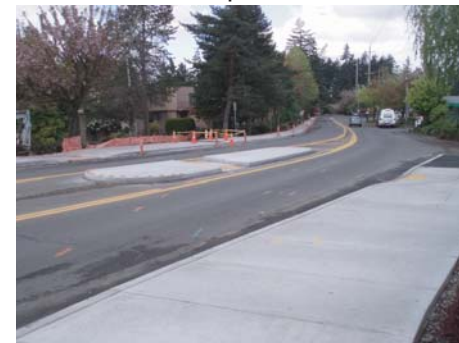
- Sidewalk gaps being filled on SW Butner Rd. near south access ramp
- Mid-block pedestrian crossing being installed on SW Butner Road near south access ramp

Mid-block pedestrian crossing under construction on SW Butner Road adjacent to bridge's south access ramp

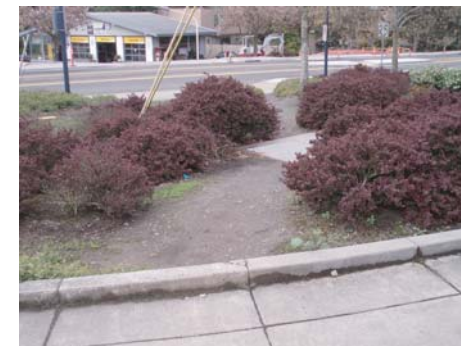
- Bicycle: Minimal out-of-direction travel (bridge lies on a relatively direct route between the transit center and areas to the south); short informal path connecting south access ramp with SW Butner Rd. may indicate some perceived out-of-direction travel
- Pedestrian: Minimal out-of-direction travel (bridge lies on a relatively direct route between the transit center and areas to the south); short informal path connecting south access ramp with SW Butner Rd. may indicate some perceived out-of-direction travel

Informal path connecting south access ramp with SW Butner Rd.

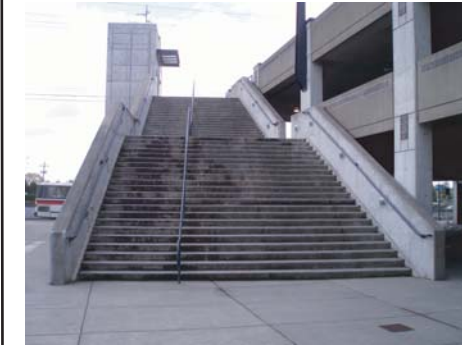
- Linear access ramp on south side; stairways provided for alternative routing
- Stairway with landings and "bike gutters" on north side
- Elevator on north side

Stairway at bridge's north end

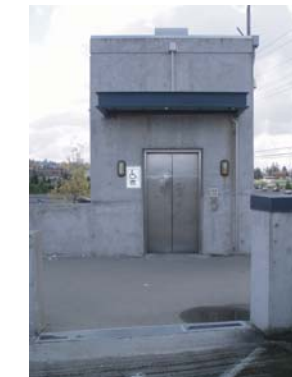
Elevator connecting the bridge with Sunset Transit Center below

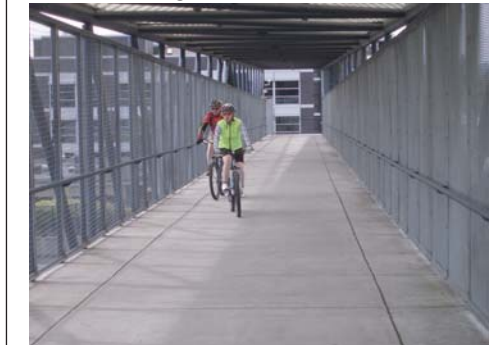
Minimum bridge structure width: ~11' 1"

Bridge cross-section includes an 11' 1" rail-to-rail width

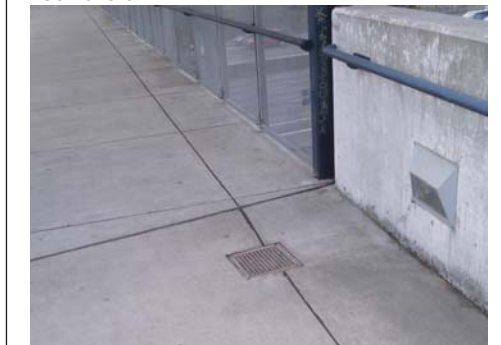
- Bridge: Pavement in good condition; small drainage grates at north end
- Access ramps: Pavement in good condition

Drainage grate at bridge's north end

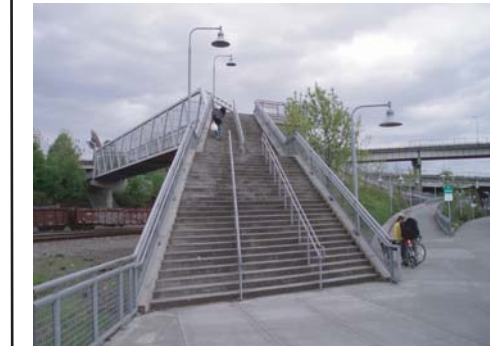
- Switchback ramp with level landings on west end (number of switchbacks depends on direction of travel)
- Multiple stairways with landings on west end
- Circular access ramp on east end
- Stairway on east end

Stairway with landing on bridge's west end

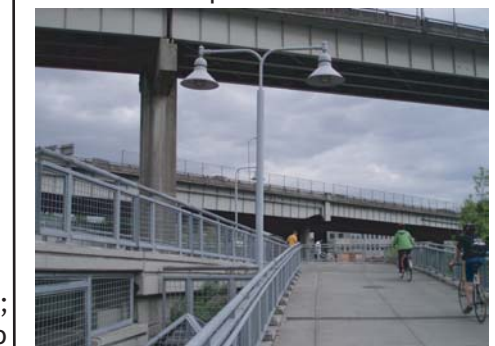
Lighting: Provided on bridge structure and access ramps

Lighting on west access ramp

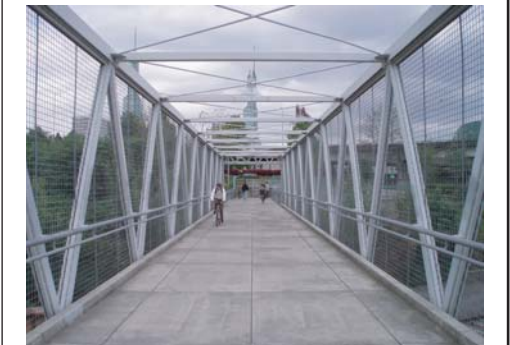
Minimum bridge structure width: ~14'

Bridge cross-section includes a 14' width (curbs and railings are flush with one another)

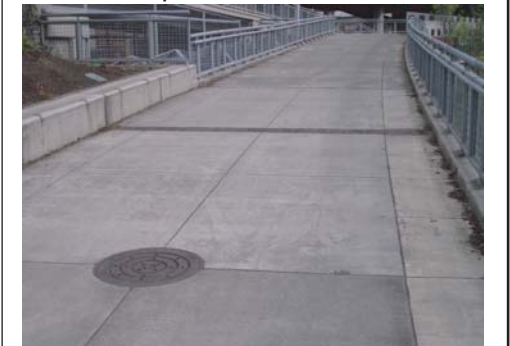
- Bridge: Pavement in good condition
- Access ramps: Pavement in good condition; drainage grates and manhole covers on west ramp are flush with pavement

Drainage grates and manhole covers are flush with the pavement

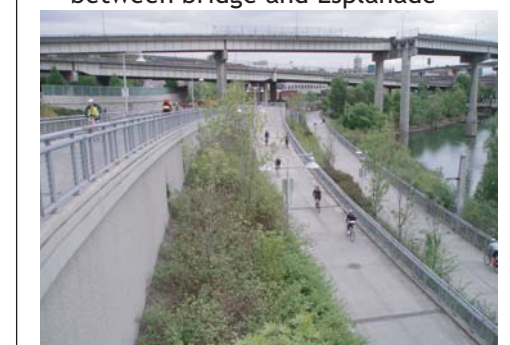
- Vertical rise between bridge and base of access ramps: ~25'
- Bicycle:
  - East end: Minimal out-of-direction travel (bridge is at roughly the same elevation as nearby street, therefore requiring no circuitous access ramps)
  - West end: Some out-of-direction travel created by switchback ramp (some bicyclists were observed using adjacent stairways; "bike gutter" not provided on stairways to provide alternative routing); however, wide ramps allow faster travel speeds

Wide access ramps enabling faster bicycle travel off-set their circuitous layout

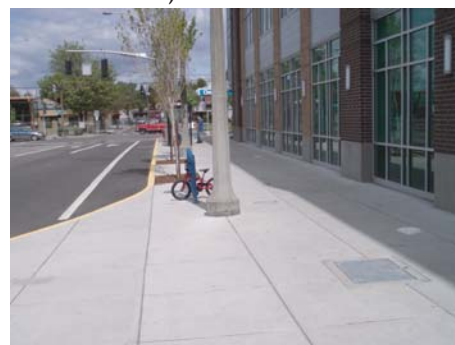
- Bike/ped accommodations immediately adjacent to bridge:
- Curb ramps lacking at some nearby intersections
  - Audible pedestrian signal on NE 42nd Ave. at Halsey St.
  - Difficult bicycle movements at NE 42nd/Halsey intersection (conflicts with buses leaving transit center)
  - No transition ramp to bicycle lane immediately north of bridge
  - "Cycletrack" north of bridge (bikes use sidewalk)

Bicycle lane without transition ramp from sidewalk/cycletrack (north side of bridge)

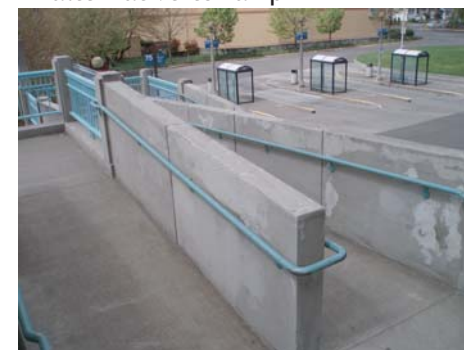
- Degree of out-of-direction travel to overcome any vertical rise to reach the bridge:
- Vertical rise between bridge and base of access ramps: Data not available
  - Bicycle:
    - North end: Excessive out-of-direction travel on north access ramp (7 switchbacks); "bike gutter" provided on adjacent stairways to provide alternative routing
    - South end: Depends on direction of travel (out-of-direction travel required for bicyclists continuing on 40s bikeway); "bike gutter" provided on adjacent stairway to provide alternative routing
  - Pedestrian:
    - North end: Stairways provided as an alternative to switchback ramps
    - South end: Stairways provided as an alternative to ramp

Narrow access ramp with multiple switchbacks complicates bicycle access on the bridge's north end

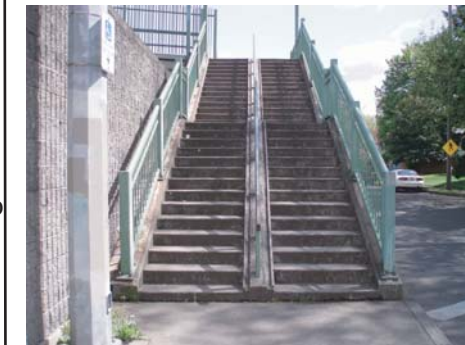
- Bridge access provisions:
- Switchback ramp with level landings on north end (7 switchbacks)
  - Stairways with landings and "bike gutter" on north end
  - Stairway with landings to MAX station
  - Elevator to MAX station
  - Linear ramp with landings on south end
  - Stairway with landings and "bike gutter" on south end

Stairway with "bike gutter" on bridge's south end

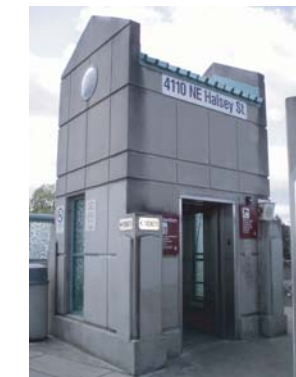
Elevator providing access between bridge and MAX station below

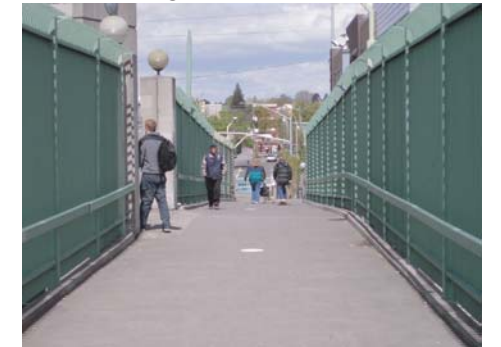
Minimum bridge structure width: ~11' 6"

Bridge cross-section includes an 11' 6" width (curbs and railings are flush with one another)

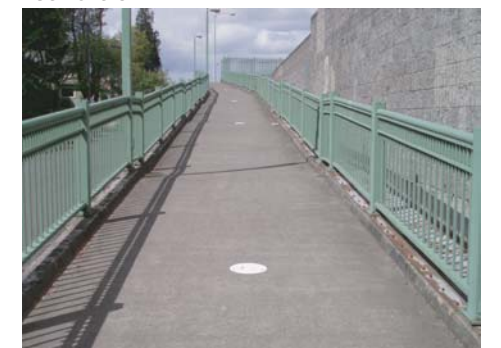
- Surface conditions:
- Bridge: Pavement in good condition
  - Access ramps: Pavement in good condition

The bridge and access ramps benefit from relatively good pavement conditions

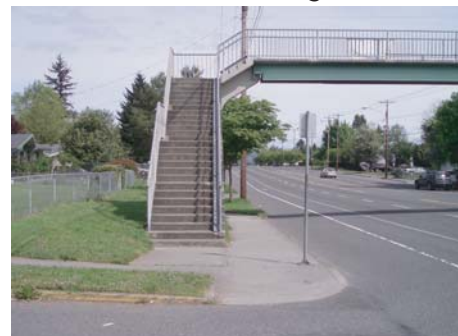
- Curb ramps provided at adjacent intersections
- Sidewalks on surrounding streets

Curb ramps are present at adjacent intersections

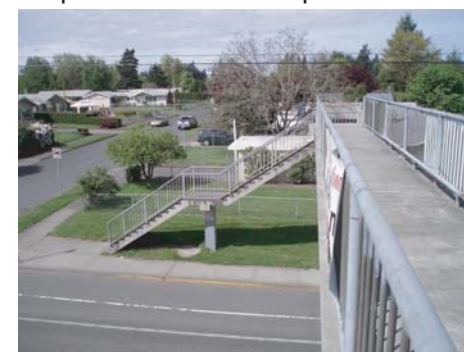
- Vertical rise between bridge and base of access ramps: ~18'
- Bicycle: Out-of-direction travel required for bicyclists traveling on NE 122nd Ave. (stairs are oriented in opposite direction of adjacent bicycle lanes), however less out-of-direction travel required for east-west bicyclists; "bike gutters" provided on stairways
- Pedestrian: Stairway orientation creates out-of-direction travel for southbound pedestrians on west side of NE 122nd Ave., and for northbound pedestrians on east side of NE 122nd Ave.; less out-of-direction travel required for east-west pedestrians

At each bridge end, stairways are oriented in one direction of travel only, which may not be useful to pedestrians wishing to travel in the opposite direction

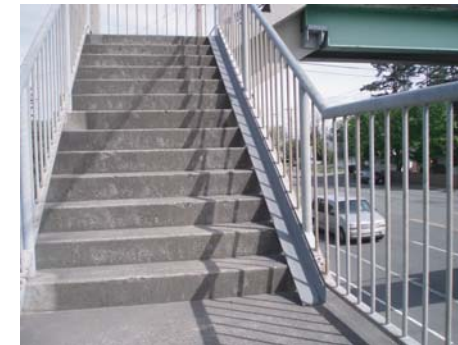
- Stairways with level landings and "bike gutters"
- No access ramps for bicyclists or mobility-impaired users

Stairway with landings and "bike gutter"

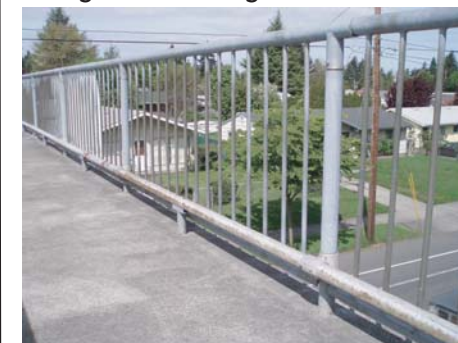
- Stairways: ~42" railings
- Bridge: ~42" railings

Railing style on stairways and bridge

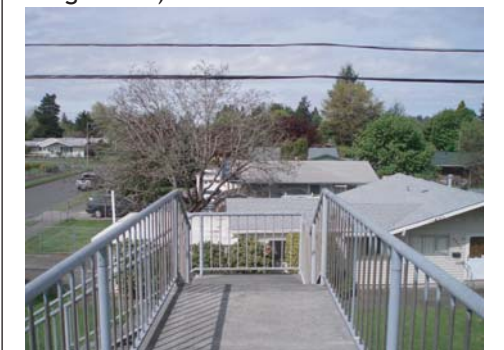
Horizontal/vertical obstructions: Low hanging electrical wires over east and west bridge ends (~6' 8" above bridge deck)

Low-hanging electrical wires above bridge

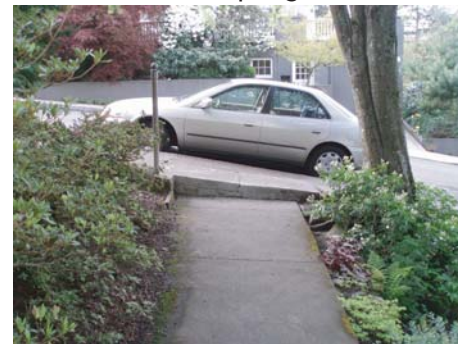
Bike/ped accommodations immediately adjacent to bridge:  
- Presence of parked vehicles and lack of curb ramps complicate travel at bridge's west end for all users  
- Sidewalks on SW Spring St.

Difficult transition between bridge's west end and surrounding sidewalk and street system

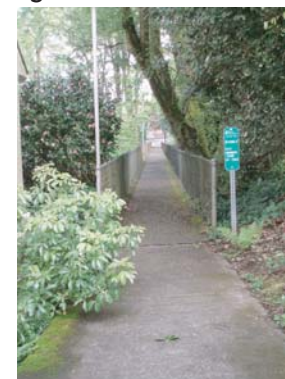
Bridge and surrounding streets are at roughly the same elevation, therefore requiring no stairways or circuitous access ramps

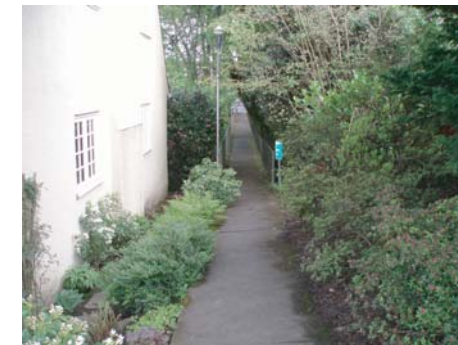
West access ramp

Access ramp length/width:  
- West ramp: ~36' / ~4' 4"  
- No east ramp

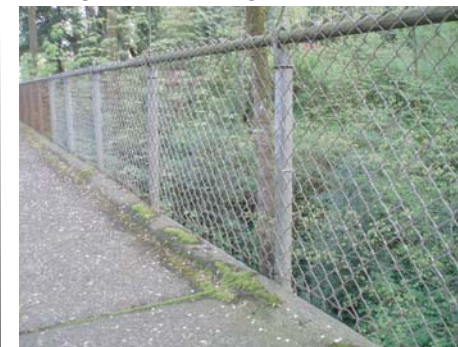
Fence/wall/railing heights:  
- Access ramp: No fences, walls, railings  
- Bridge: ~36" railings

Railing style on bridge

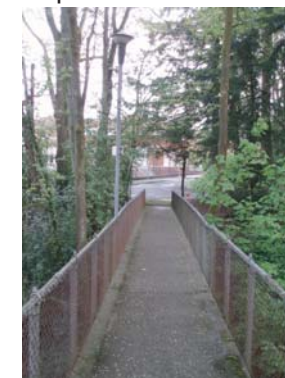
Light pole on bridge structure

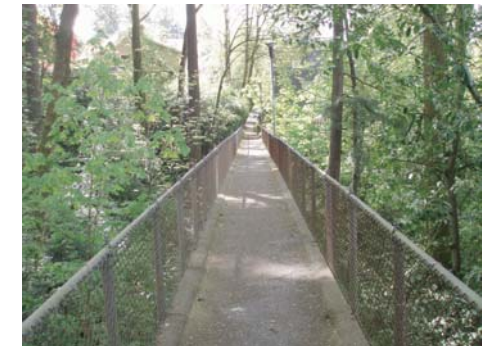
Extruded curbs reduce the bridge's usable width

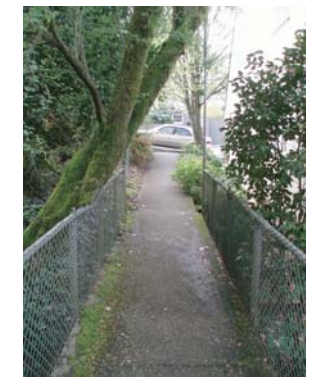
Horizontal/vertical obstructions:  
Encroaching tree branches at bridge's west end

Encroaching vegetation on sidewalk near bridge's west end

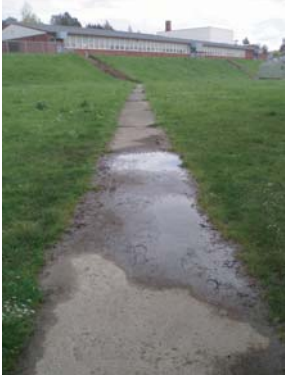
Pedestrian path connecting the bridge with Hillsdale Park and Robert Gray Middle School

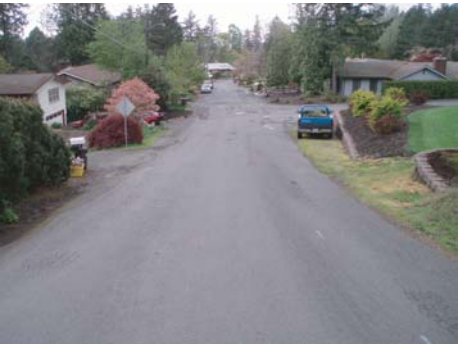
Sidewalks lacking on SW Boundary St. north of the bridge

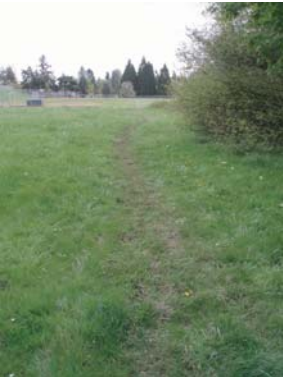
Informal walking path between the bridge and Hillsdale Park

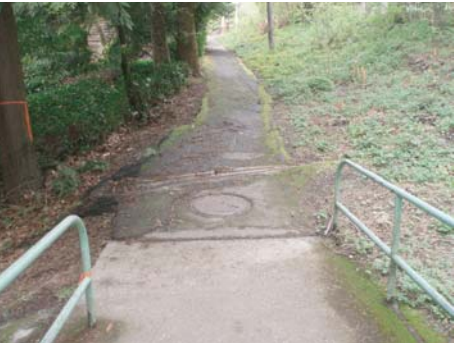
Pedestrian path on the bridge's north end

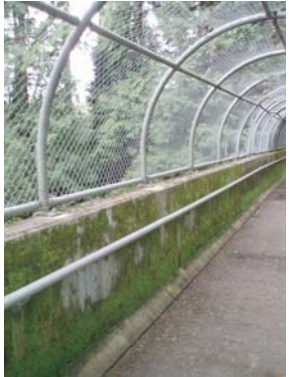
Fence/wall/railing heights:  
- Paths: No fences, walls, railings  
- Bridge: ~33" railings

Railing style on bridge

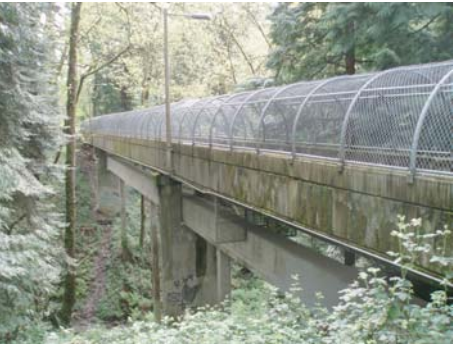
Lighting on bridge structure

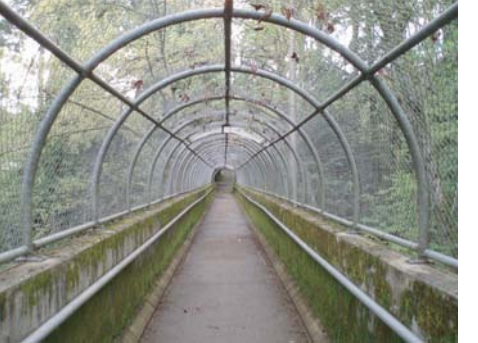
The bridge includes a relatively narrow height and width

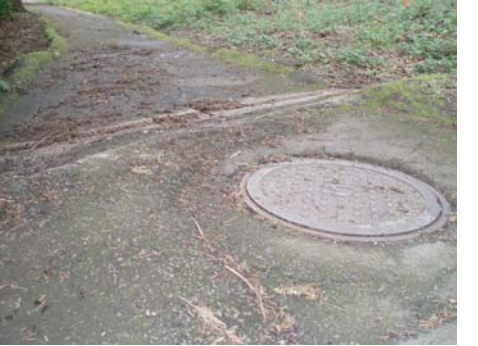
Surface conditions:  
- Bridge: Water ponding on bridge deck  
- Access ramps: Pavement in poor condition (cracking, heaving, weeds growing between pavement cracks, manhole covers and drainage grates not flush with pavement)

Poor pavement conditions on north path

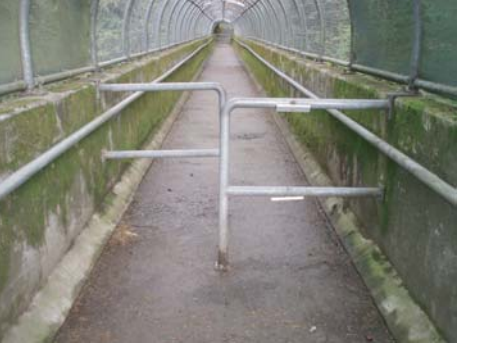
Horizontal/vertical obstructions:  
Railings at bridge ends (designed to discourage bicycling on the bridge) create major "pinch points" for all users

Railings obstructing travel on the bridge

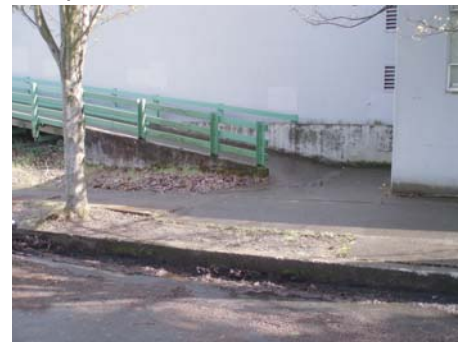
The absence of a curb ramp creates difficult transitions between SW Hooker St. and the bridge's west access ramp

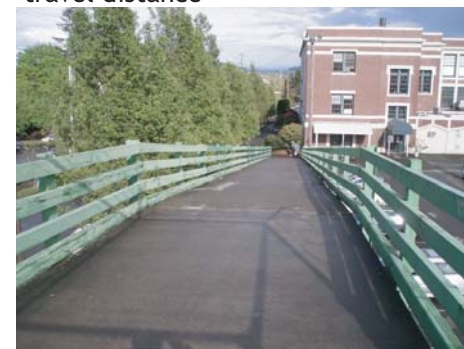
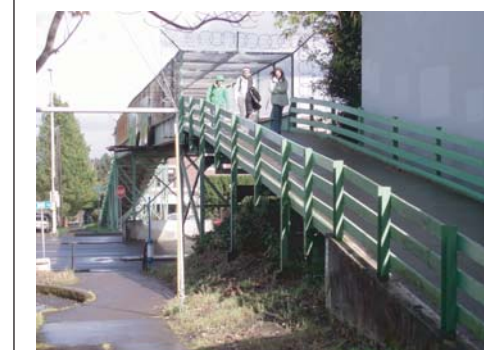
The linear ramps provide direct access between the bridge and points farther east and west, but require additional travel for users accessing TriMet bus stops directly under the bridge

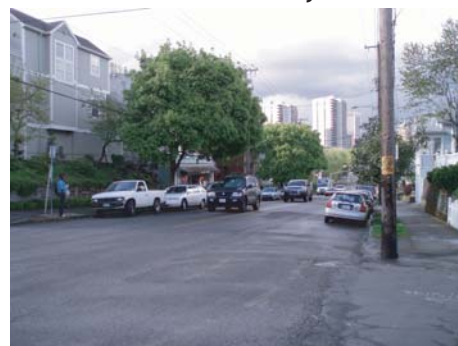
Sidewalks on SW Corbett Ave.

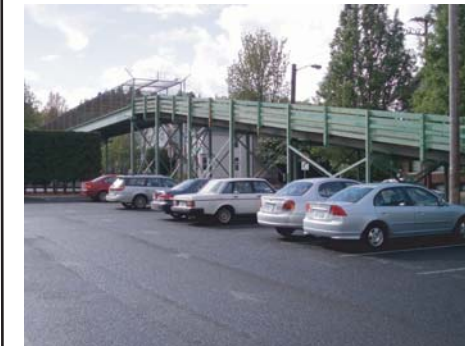
- Linear ramps
- Ramps are somewhat steep and may pose difficulties for wheelchairs or other mobility-impaired users
- No level landings

The east access ramp is fairly steep and lacks level landings

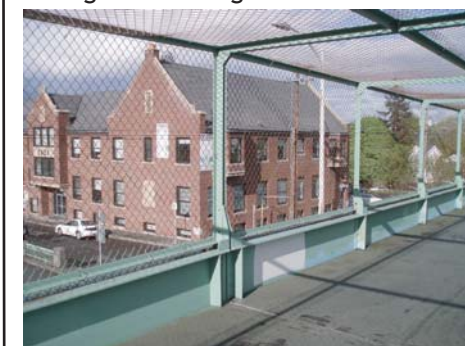
- Access ramps: ~54" railings
- Bridge: No railings

Railings are absent from the bridge structure

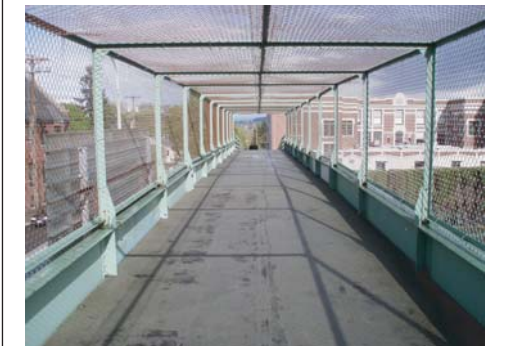
Although the bridge provides a 10' 6" curb-to-curb width, the extruded steel beams reduce the usable width to about 10'

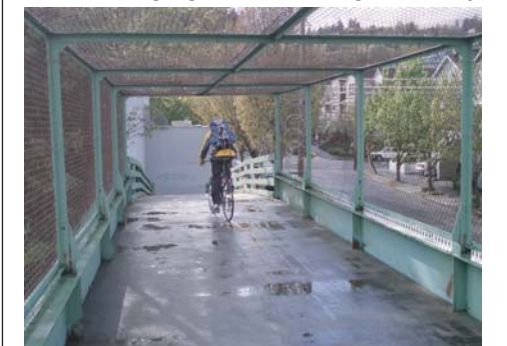
- Bridge: Pavement in generally good condition; water ponding on bridge structure
- Access ramps: Pavement in good condition
- No drainage grates on bridge or ramps

Water ponding on bridge surface

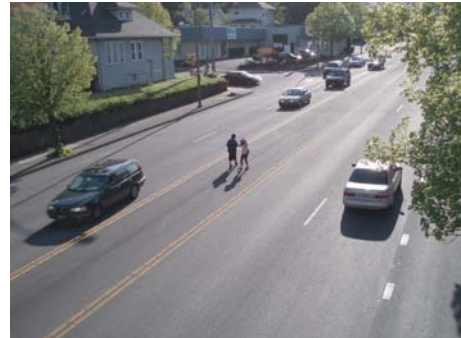
No physical or other elements exist to discourage risky at-grade crossings of SE Powell Blvd.

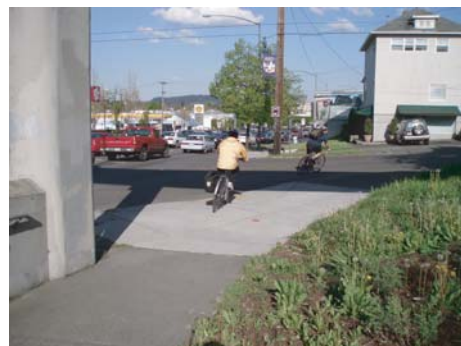
Curb ramps provided where bridge access ramps meet the surrounding street system

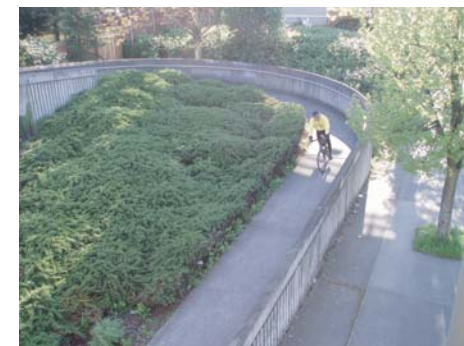
- Vertical rise between bridge and base of access ramps: ~16'
- Bicycle: "Spiral" ramps minimize travel distance to overcome vertical rise, and permit slow but continuous bicycle movement
- Pedestrian: "Spiral" ramps minimize travel distance to overcome vertical rise; pedestrians wishing to access TriMet bus stops directly below the bridge may view the ramps as requiring out-of-direction travel (some at-grade crossing behaviors observed); stairways not provided to reduce travel distance

"Spiral" access ramp on bridge's south side

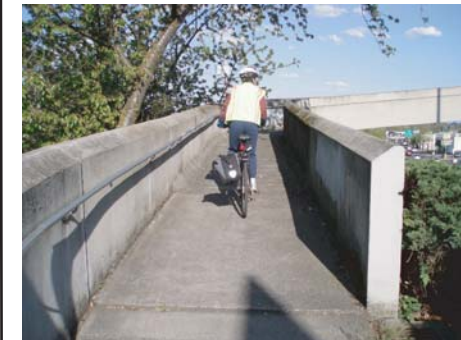
- South ramp: ~175' / ~6' 4"
- North ramp: ~175' / ~6' 4"

Although the bridge and access ramp width provides enough lateral clearance for one bicyclist, it may be difficult for multiple oncoming bicyclists to pass each other

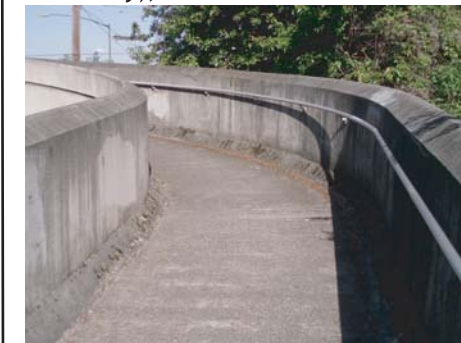
- Access ramps: ~37" railings (railings on one side only), 48" walls
- Bridge: ~33" railings (railings on one side only), 44" walls

Railings are provided on one side of the bridge and access ramps

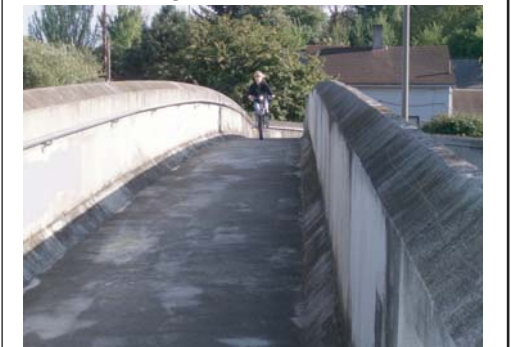
Extruded curbs reduce the bridge's usable width

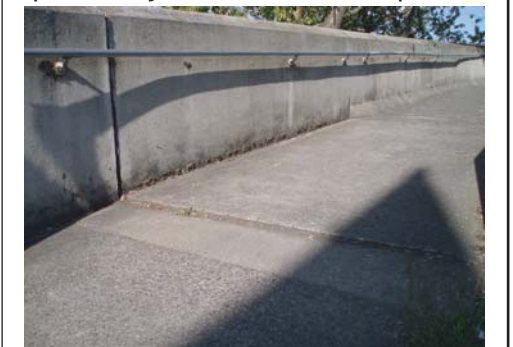
- Bridge: Pavement in good condition
- Access ramps: Pavement in relatively good condition; large "lip" on north and south access ramps; drainage grates placed adjacent to access ramps

"Lip" on north access ramp could pose difficulties for "wheel users"

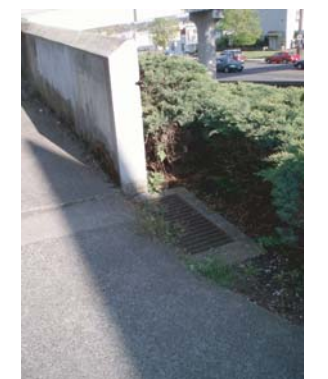
Drainage grate placed outside the bicycle/pedestrian travelway

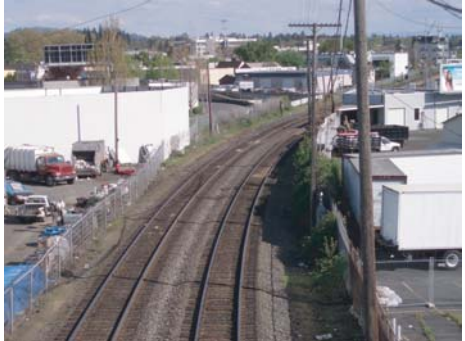
Fencing on both sides of the railroad preclude at-grade crossings

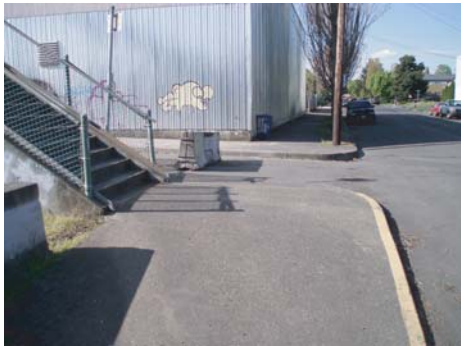
Curb ramps lacking where stairways meet surrounding sidewalks

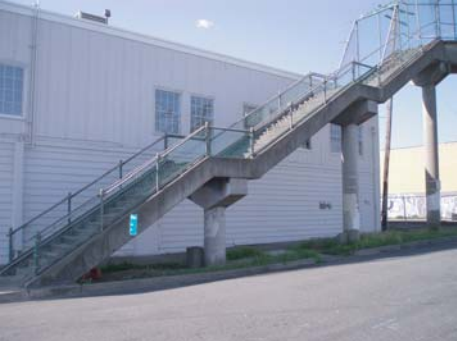
Stairway with landings

Stairway total length/width:  
 - West stairway: ~59' / ~6'  
 - East stairway: ~59' / ~6'

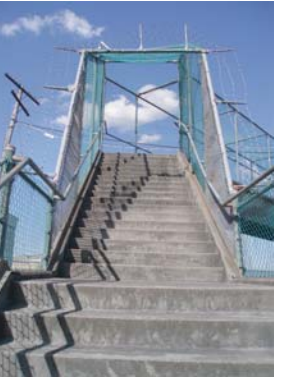
Stairways and landings are approximately 6' wide

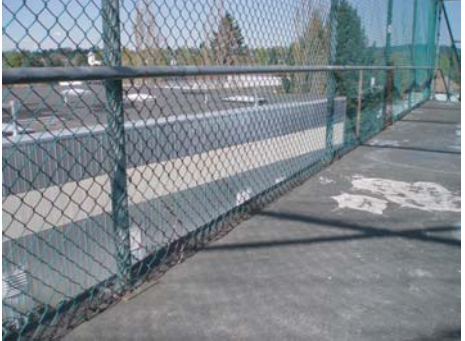
Fence/wall/railing heights:  
 - Stairways: ~34" railings  
 - Bridge: ~34" railings

Railing style on stairways and bridge

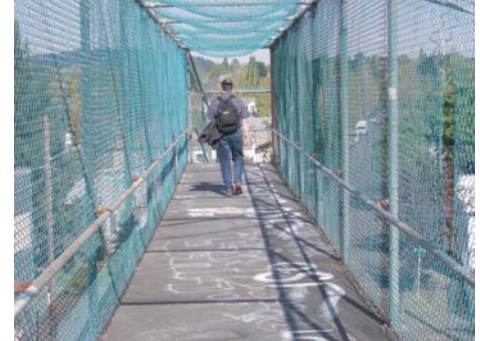
Minimum bridge structure width: ~5' 7"

Bridge cross-section includes a 5' 7" rail-to-rail width

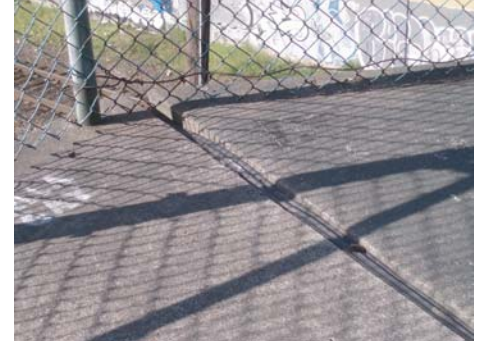
Surface conditions:  
 - Bridge: Pavement in good condition; expansion joint gaps at east and west bridge ends  
 - Stairways: Pavement in good condition

Expansion joint gap at east end of bridge structure

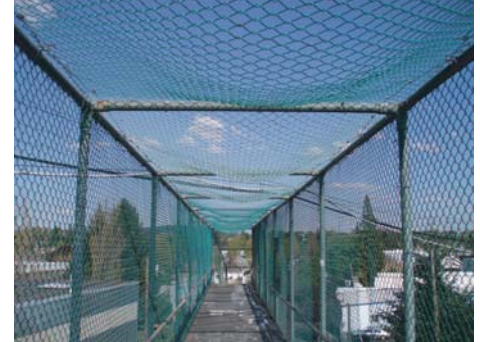
Horizontal/vertical obstructions:  
 Sinking overhead fence on bridge structure

Sinking overhead fence on bridge structure

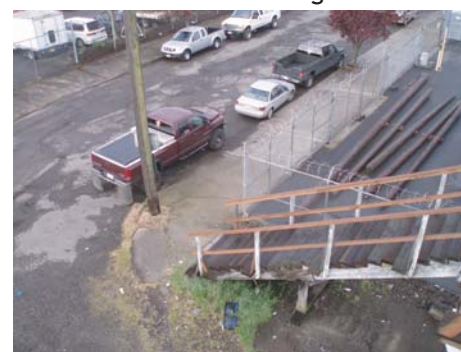
- Curb ramp in poor condition where west stairway meets the street
- Curb ramps in good condition where east stairway meets the street
- Sidewalks on surrounding streets

Curb ramp in poor condition at bottom of west stairway

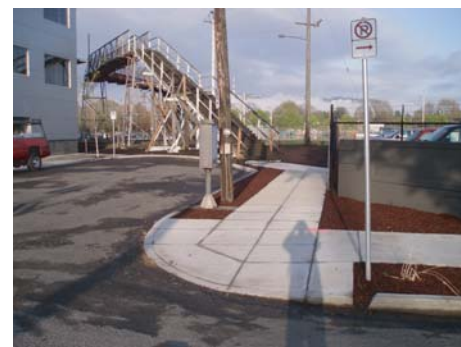
Sidewalk and curb ramp in good condition near east stairway

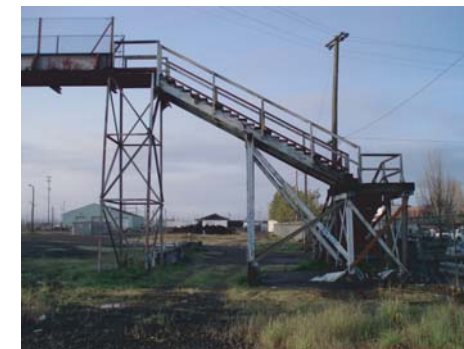
- Vertical rise between bridge and base of access ramps: ~25'
- Bicycle: Bicyclists may equate the lack of access ramps (stairs only) with out-of-direction travel; "bike gutter" not provided on stairways
- Pedestrian: Minimal out-of-direction travel (stairs are oriented along the desired travel route); lack of access ramps renders bridge unusable for wheelchair users

West stairway

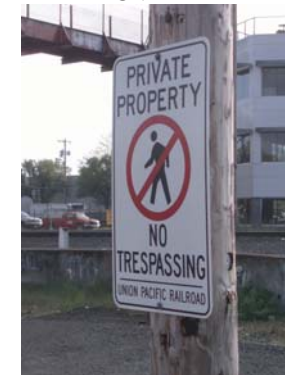
Wayfinding or other signage/pavement markings: "No Trespassing" signs at bridge's west end (to discourage at-grade crossings)

"No Trespassing" sign at bridge's west end

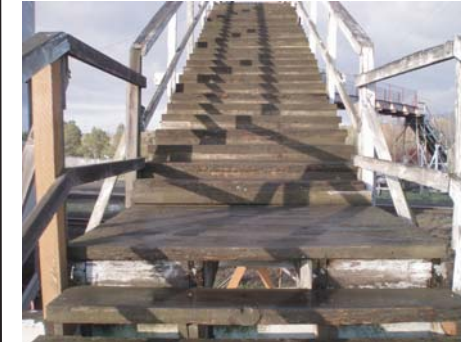
- Wooden stairways with landings
- No access ramps for bicyclists or mobility-impaired users

Wooden stairway with landings

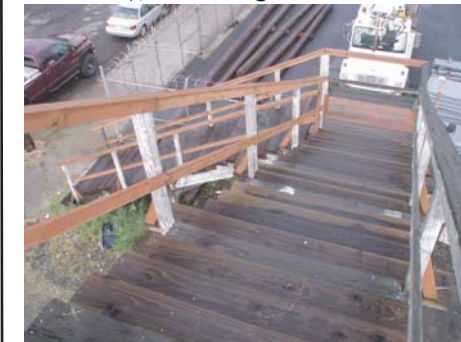
- Stairways: ~42" railings
- Bridge: ~69-79" fence (depending on location); no railings

Railing style on stairways

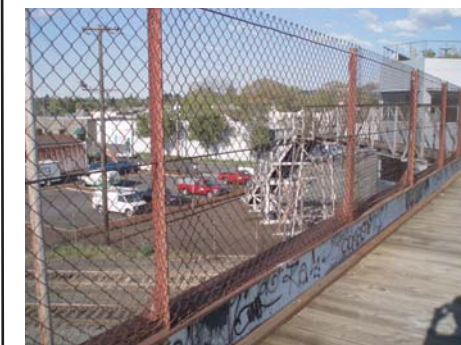
Railings not provided on bridge structure

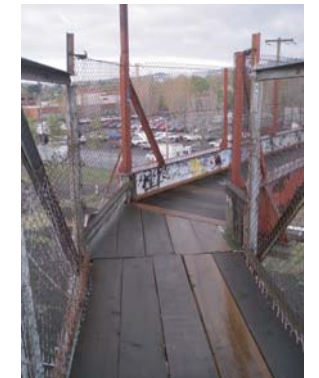
Minimum bridge structure width: ~5' 9" - 6' 4" (depending on location)

An alignment shift midway across the bridge creates two segments with differing widths

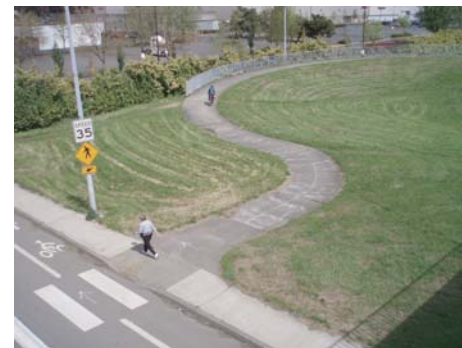
- Curb ramps provided where access ramps meet the street system
- Marked pedestrian crossing where east access ramp meets SE 96th Ave.
- Sidewalks on SE 96th Ave. and SE Main St.
- I-205 Path

Sidewalks and marked pedestrian crossing where east access ramp meets SE 96th Ave.

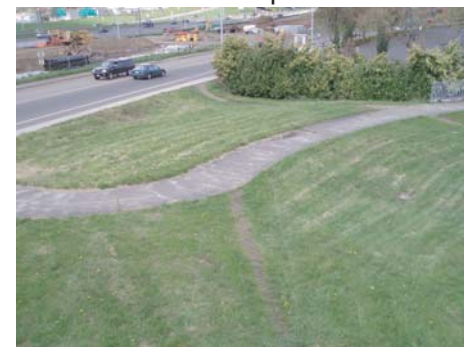
- Vertical rise between bridge and base of access ramps: Data unavailable
- Bicycle: Some out-of-direction travel required at both bridge ends; long circuitous access ramp on east end (informal paths present to reduce travel distance); informal paths on west end have been paved
- Pedestrian: Some out-of-direction travel required at both bridge ends; long circuitous access ramp on east end (informal paths present to reduce travel distance); informal paths on west end have been paved

Informal paths connecting with east access ramp

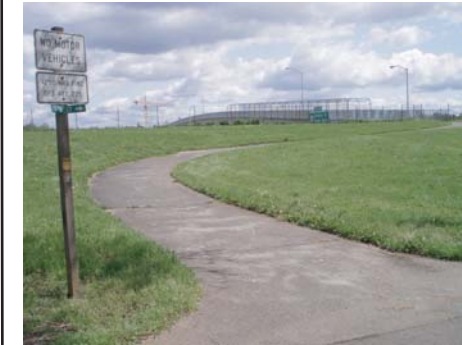
- Circuitous access ramps
- Previously informal paths that have been paved (west end)
- No stairways

West access ramp

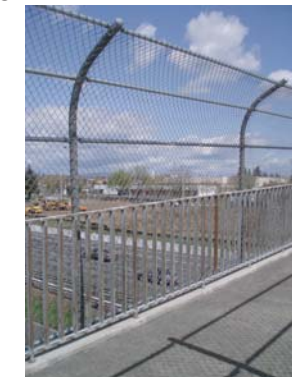
- West ramp: No fences, walls, railings
- East ramp: ~49" railings
- Bridge: ~9' 4" fence, ~49" railings

Fence and railing on bridge structure

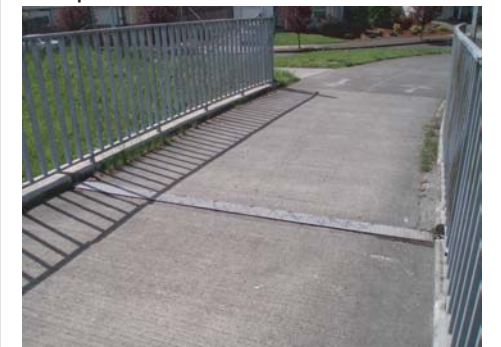
- Bridge: Pavement in good condition; expansion joint gaps at bridge ends (creates issues for "wheel" users)
- Shared use paths: Pavement in generally good condition (minor cracking)
- No drainage grates on bridge or access ramps

Expansion joint gap at bridge's west end

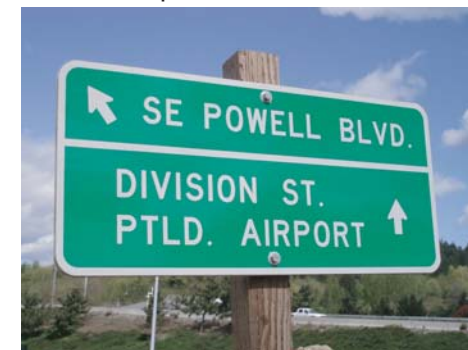
- Wayfinding or other signage/pavement markings:
- Wayfinding signage directing users to/from I-205 path, SE Powell Blvd., and other destinations
  - "Bicyclists Yield to Pedestrians" signs on access ramps
  - Pavement markings separating bi-directional traffic on bridge and access ramps
  - "SLOW" pavement markings on north access ramp

Wayfinding signage on I-205 Path near bridge

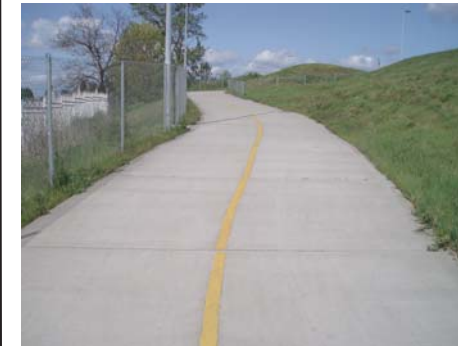
- Bridge access provisions:
- Circuitous access ramps (landings provided on north ramp)
  - No stairways

North access ramp

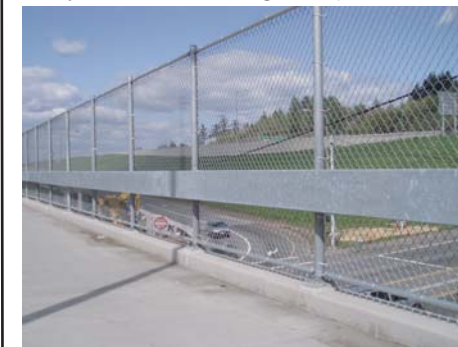
- Fence/wall/railing heights:
- North ramp: No fences, walls, railings
  - South ramp: No fences, walls, railings
  - Bridge: ~95" fence, ~42" railings (railing is ~12" long and serves as a bicycle "handlebar guard")

Bridge railing also serves as a bicycle "handlebar guard"

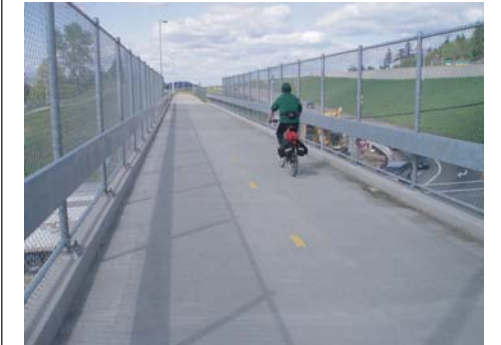
Minimum bridge structure width: ~14'

Bridge cross-section includes a 14' width (curbs and railings are flush with one another)

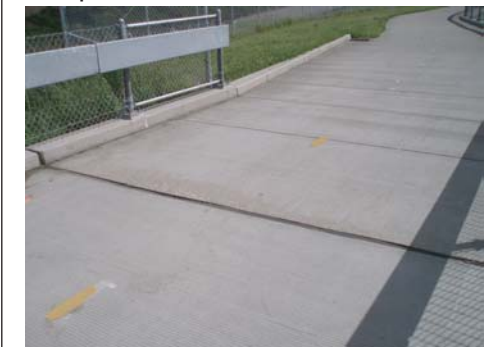
Minor expansion joint gap at bridge's west end

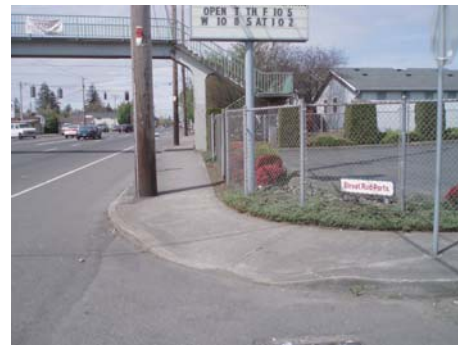
- Bike/ped accommodations immediately adjacent to bridge:
- Curb ramps provided at adjacent intersections
  - Fragmented sidewalks on SE Division St.

Curb ramps are present at adjacent intersections

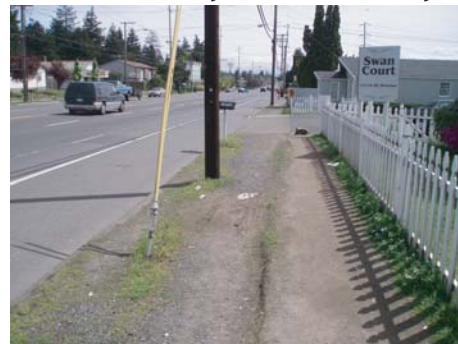
- Surrounding bike/ped network:
- Bicycle lanes and fragmented sidewalks on SE Division St.
  - Low-volume residential streets
  - Sidewalks on most streets
  - Limited street system connectivity

Sidewalk gap on SE Division St. immediately east of the bridge

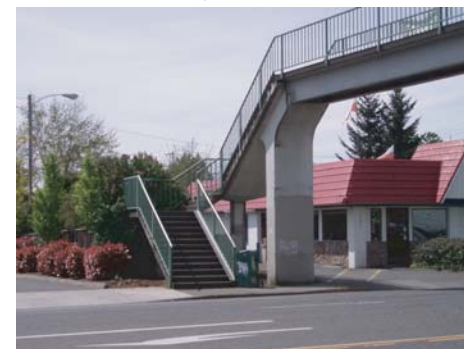
- Degree of out-of-direction travel to overcome any vertical rise to reach the bridge:
- Vertical rise between bridge and base of access ramps: ~16'
  - Bicycle: Bicyclists may equate lack of access ramps (stairs only) with out-of-direction travel; "bike gutters" provided on stairways
  - Pedestrian: Stairways' perpendicular orientation with SE Division St. may minimize perception of out-of-travel, however some pedestrians may chose to cross at-grade (shorter travel distance)

Stairway oriented perpendicular to SE Division St.

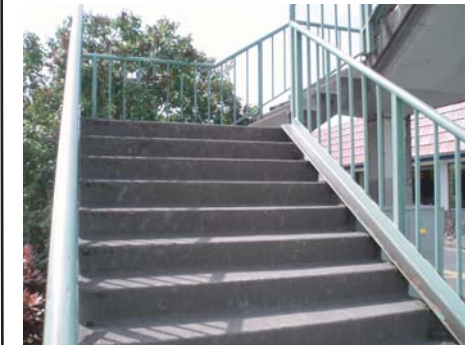
- Bridge access provisions:
- Stairways with level landings and "bike gutters"
  - No access ramps for bicyclists or mobility-impaired users

Stairway with landings and "bike gutter"

- Stairway total length/width:
- North stairway: ~35'/-5' 11"
  - South stairway: ~35'/-5' 11"

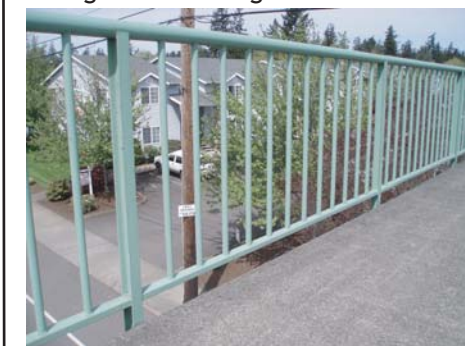
- Fence/wall/railing heights:
- Stairways: ~42" railings
  - Bridge: ~42" railings

Railing style on stairways and bridge

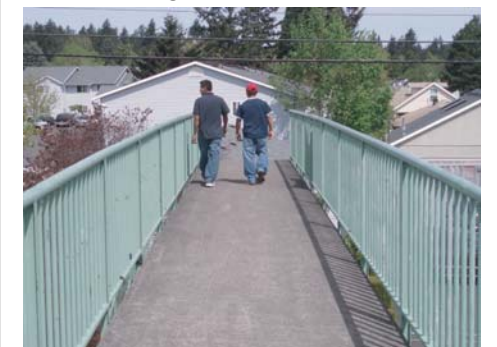
Minimum bridge structure width: ~5' 11"

Bridge cross-section includes a 5' 11" rail-to-rail width

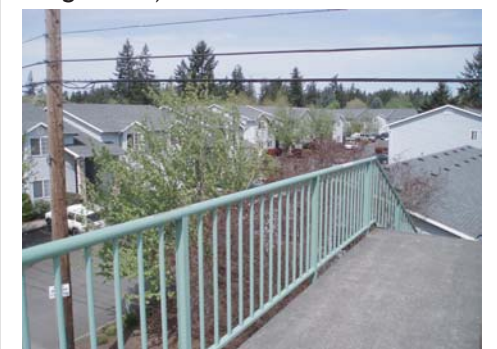
Low-hanging electrical wires above bridge

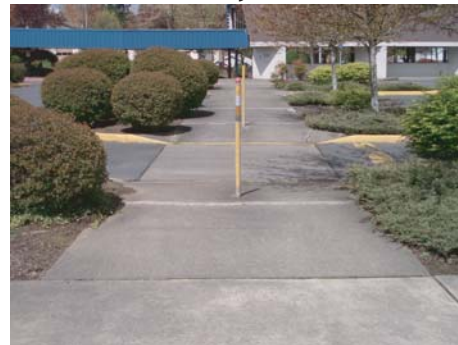
Bike/ped accommodations immediately adjacent to bridge:  
 - Sidewalk leading to Barbur Transit Center  
 - No sidewalks where south access ramp meets the street system

Sidewalk connecting north access ramp with Barbur Transit Center

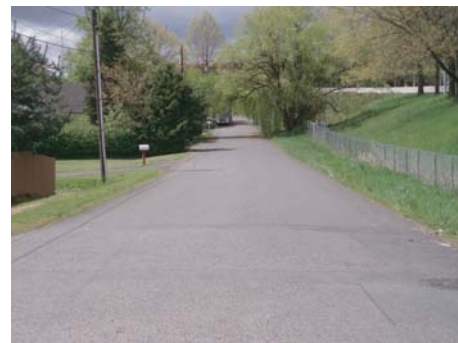
Surrounding bike/ped network:  
 - Bridge is part of "SW Trail #5"  
 - Sidewalks and bicycle lanes on SW Barbur Blvd.  
 - Sidewalks missing on streets south of bridge  
 - Low-volume residential streets

Most streets immediately south of the bridge lack sidewalks

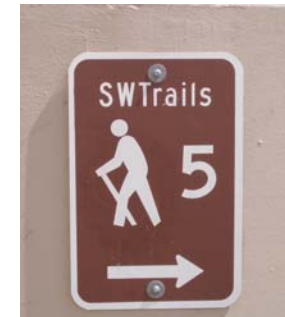
Wayfinding or other signage/pavement markings: Wayfinding signage identifying bridge as part of "SW Trail #5"

Wayfinding signage identifying the bridge as part of "SW Trail #5"

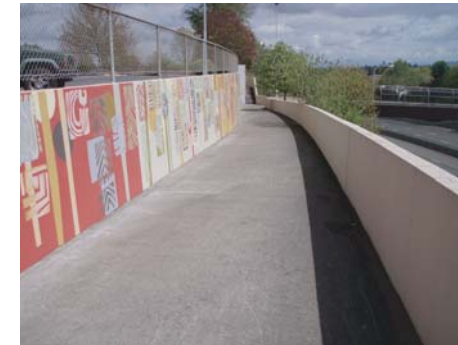
Bridge access provisions:  
 - Linear access ramps on north and south sides  
 - Stairway with landings on north side ("bike gutter" not provided)

North access ramp

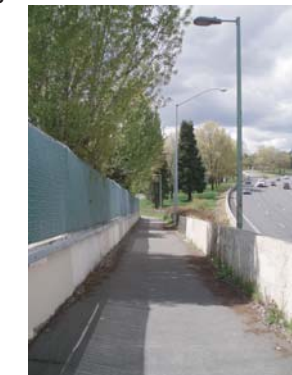
Lighting: Provided on bridge and access ramps

Lighting on south access ramp

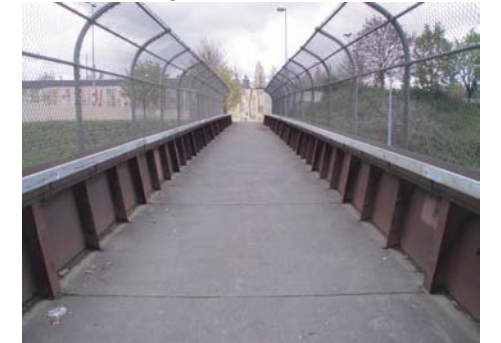
Minimum bridge structure width: ~11'

Bridge cross-section includes an 11' rail-to-rail width

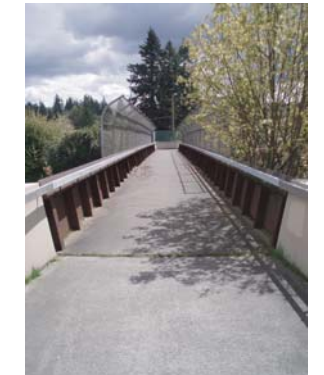
Horizontal/vertical obstructions:  
 - Vegetation encroaching on bridge structure  
 - Vegetation encroaching on south access ramp

Vegetation encroaching on bridge structure

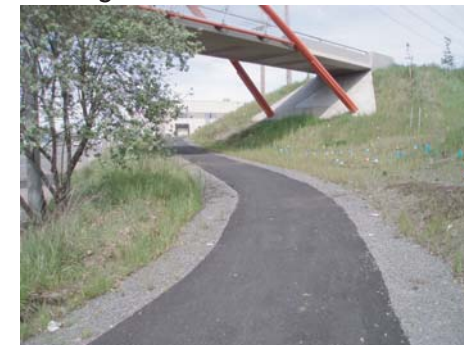
- Degree of out-of-direction travel to overcome any vertical rise to reach the bridge:
- Vertical rise between bridge and base of access ramps: Data unavailable
  - Bicycle: Minimal out-of-direction travel for east-west users (bridge and Springwater Trail are at roughly the same elevation, thereby requiring no circuitous access ramps); some out-of-direction travel between bridge and east side of SE McLoughlin Blvd. (via access ramp); bridge not accessible from west side of SE McLoughlin Blvd.
  - Pedestrian: Minimal out-of-direction travel for east-west users (bridge and Springwater Trail are at roughly the same elevation, thereby requiring no circuitous access ramps); some out-of-direction travel between bridge and east side of SE McLoughlin Blvd. (via access ramp); bridge not accessible from west side of SE McLoughlin Blvd.; stairways not provided for alternative routing

Access ramp connecting bridge with SE McLoughlin Blvd.

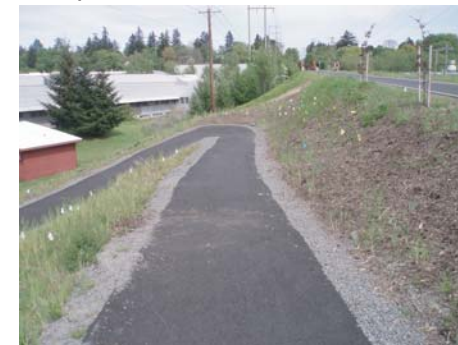
- Bridge access provisions:
- Circuitous access ramp with switchback on bridge's east end (landings not provided)
  - No stairways
  - Bridge is part of a continuous shared use path

Switchback on east access ramp

- Access ramp length/width:
- East ramp: ~465' / ~7'

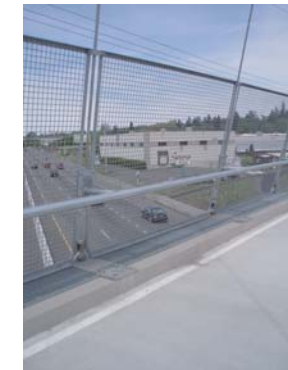
- Fence/wall/railing heights:
- East ramp: No fences, walls, railings
  - Bridge: ~42" railings

Railing style on bridge structure

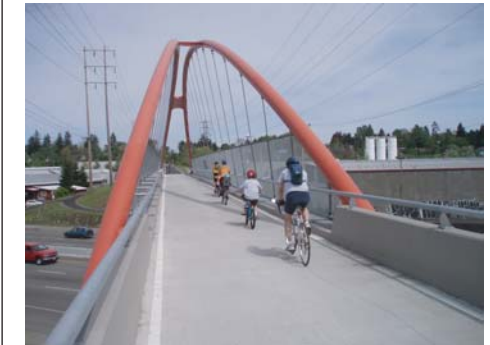
Minimum bridge structure width: ~12'

Bridge cross-section includes a 12' width (curbs and railings are flush with one another)

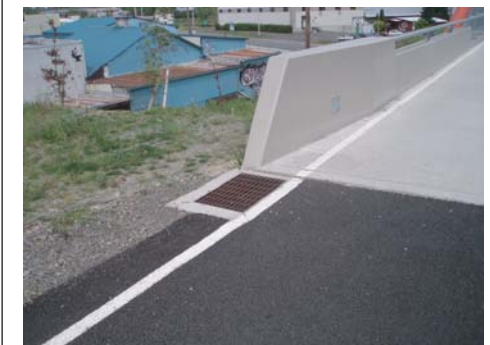
- Surface conditions:
- Bridge: Pavement in good condition; minor expansion joint gaps at bridge ends (creates issues for "wheel" users); drainage grates placed outside the bridge's curb-to-curb width
  - Access ramps: Pavement in good condition

Drainage grates placed outside the bicycle/pedestrian travelway

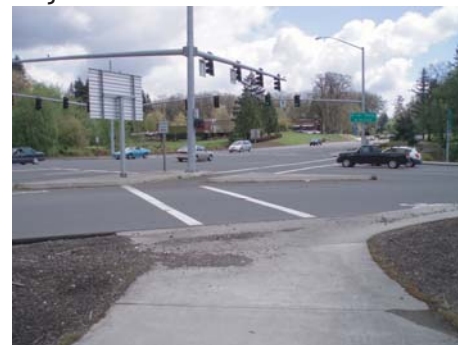
Bike/ped accommodations immediately adjacent to bridge:  
 - Shared use path along Kruse Way and I-5  
 - Sidewalks and curb ramps provided at adjacent intersections

Pedestrian infrastructure present on SW Kruse Way at Bangy Rd., immediately east of the bridge

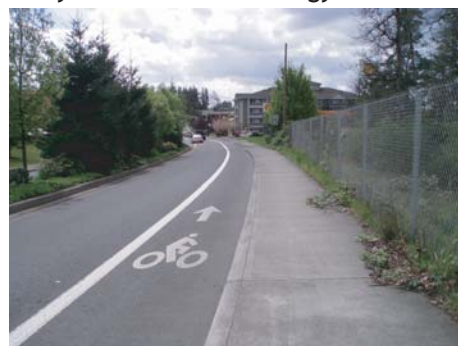
Surrounding bike/ped network:  
 - Shared use paths along SW Kruse Way and I-5  
 - Sidewalks on most nearby streets  
 - Bicycle lanes on SW Bangy Rd.

Bicycle lanes and sidewalks on SW Bangy Rd.
