# **Pedestrian/Bicycle Overcrossings: Lessons Learned**

Prepared by: Rory Renfro  
Portland State University Masters of Urban and Regional Planning  
Field Area Paper  
June 2007

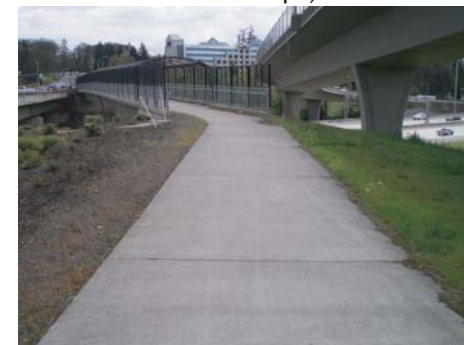
Degree of out-of-direction travel to overcome any vertical rise to reach the bridge:  
 - Vertical rise between bridge and adjacent paths: Data unavailable  
 - Bicycle: No out-of-direction travel (bridge and surrounding streets/paths are at roughly the same elevation, thereby requiring no circuitous access ramps)  
 - Pedestrian: No out-of-direction travel (bridge and surrounding streets/paths are at roughly the same elevation, thereby requiring no stairways or circuitous access ramps)

Bridge and path are at roughly the same elevation, eliminating the need for stairways or circuitous access ramps

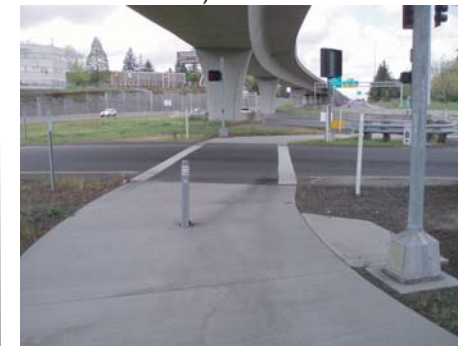
Access ramp length/width:  
 - No specific lengths (bridge is part of a continuous shared use path)  
 - Shared use path width: ~10'  
 - Center bollard at intersection west of bridge (5' horiz. clearance on each side of bollard)

Center bollard present where shared use path meets intersection west of the bridge

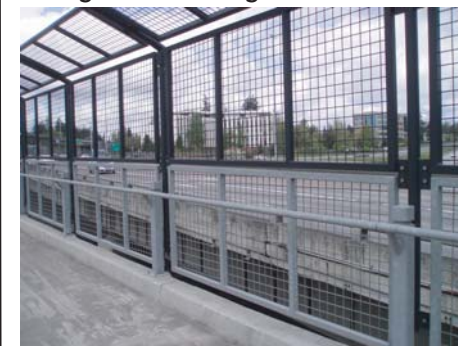
Fence/wall/railing heights:  
 - Shared use paths: No fences, walls, railings  
 - Bridge: ~44" railings

Railing style on bridge structure

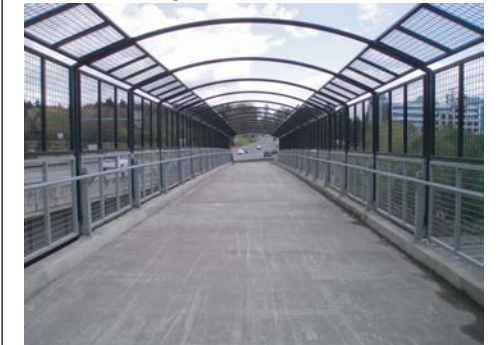
Minimum bridge structure width: ~14' 6"

Bridge cross-section includes a 14' rail-to-rail width

- Bridge: Pavement in good condition; large pavement "lip" at bridge's east end (creates issues for "wheel" users)
- Access ramps: Pavement in good condition
- No drainage grates on bridge or access ramps

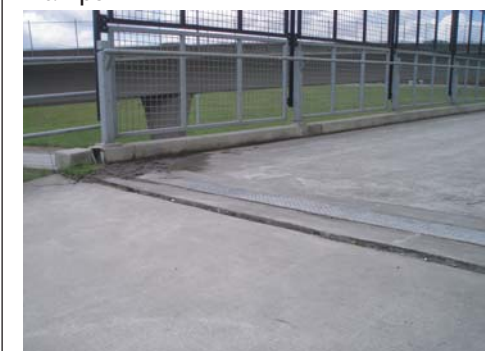
Pavement "lip" at bridge's east end

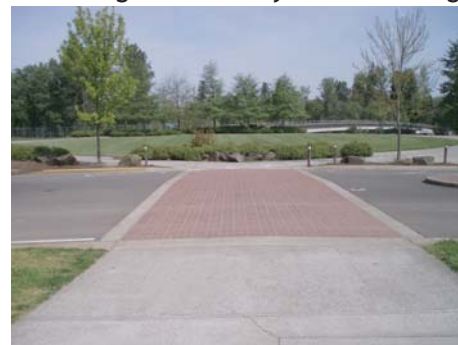
- Shared use paths at both bridge ends
- Raised crosswalk with pavement texturing immediately south of bridge

Raised crosswalk with pavement texturing on Millrace Dr. immediately south of the bridge

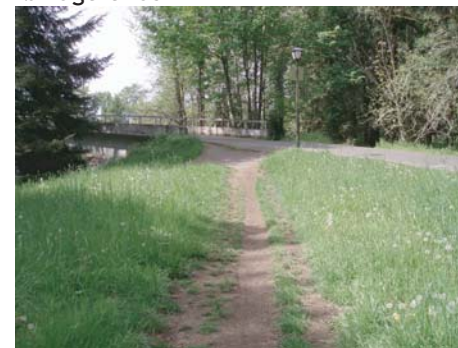
- Vertical rise between bridge and adjacent paths: Data unavailable
- Bicycle: Minimal out-of-direction travel (bridge and surrounding paths are at roughly the same elevation, thereby requiring no circuitous access ramps); however some informal paths exist near both bridge ends
- Pedestrian: Minimal out-of-direction travel (bridge and surrounding paths are at roughly the same elevation, thereby requiring no stairways or circuitous access ramps); however some informal paths exist near both bridge ends

Informal path at bridge's north end

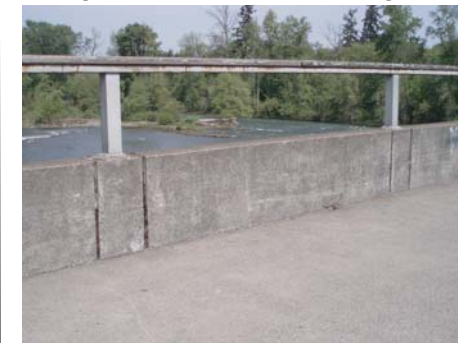
- Shared use paths: No fences, walls, railings
- Bridge: ~20" walls, ~44" railings

Railing style on bridge structure

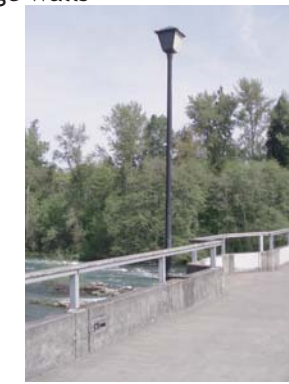
- Provided on bridge and shared use paths
- Several damaged/broken lights on bridge walls

Overhead lighting on bridge

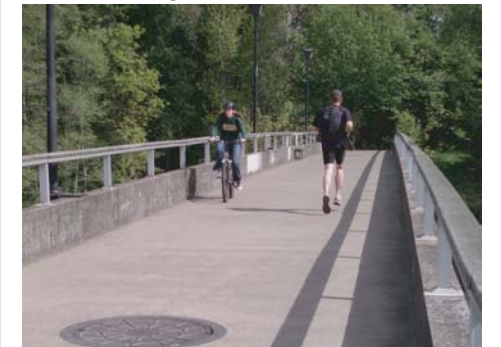
Bridge cross-section includes a 12' width (railings and walls are flush with one another)

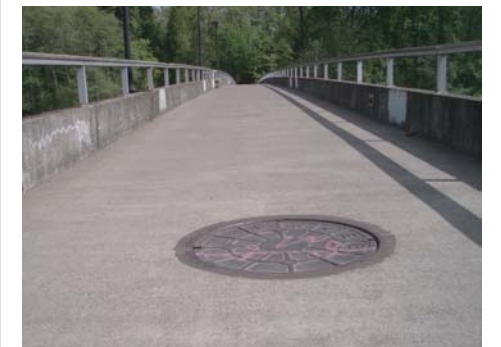
Manhole cover on bridge deck

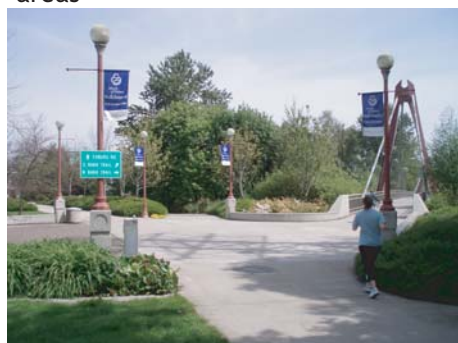
Plaza at bridge's south end serves as a confluence for multiple paths and sidewalks

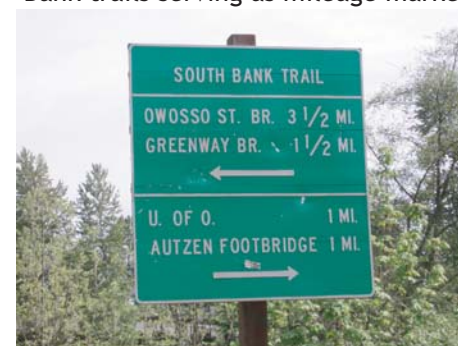
Wayfinding signage near bridge's south end

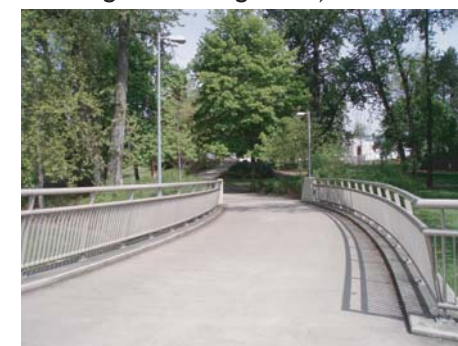
- Linear and curvilinear access ramps
- Stairway on bridge's north end (no landings or "bike gutter")

North access ramp

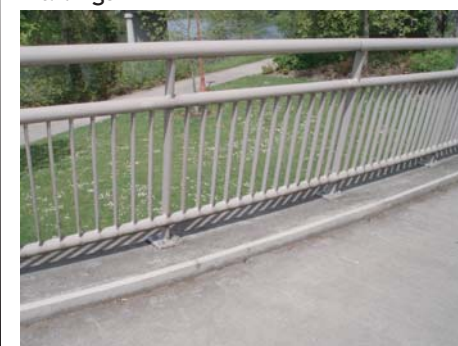
- North ramp: ~43" lower railings, ~55" upper railings
- North stairway: ~43" railings
- Bridge: ~43" lower railings, ~55" upper railings

Railing style on bridge structure and north access ramp

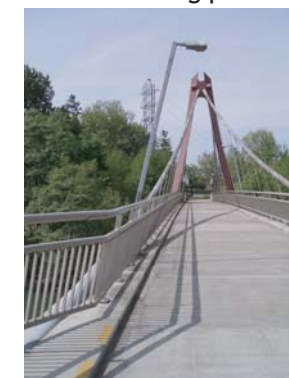
Lighting on bridge structure

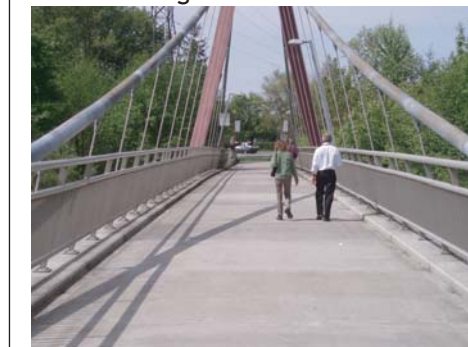
Bridge cross-section includes a 14' width (curbs and railings are flush with one another)

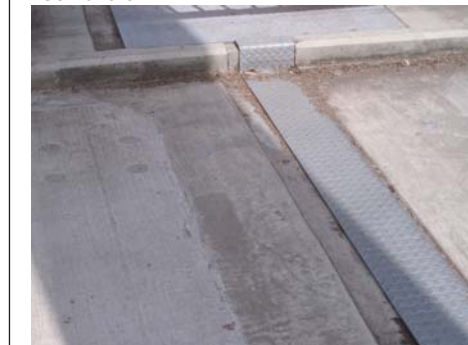
- Bridge: Pavement in good condition; minor expansion joint gaps at bridge ends (creates issues for "wheel" users); small drainage grates placed at bridge edges
- Access ramps: Pavement in good condition

Expansion joint gap at bridge's south end

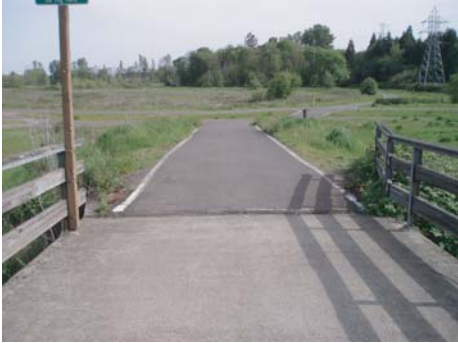
Shared use paths provide direct access to the bridge

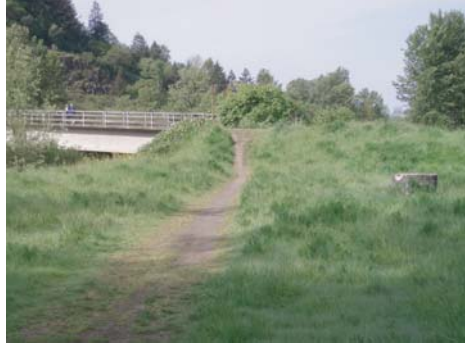
- Vertical rise between bridge and adjacent paths: Data unavailable
- Bicycle: Minimal out-of-direction travel (bridge and surrounding paths are at roughly the same elevation, thereby requiring no circuitous access ramps); however some informal paths exist near the bridge's north end
- Pedestrian: Minimal out-of-direction travel (bridge and surrounding paths are at roughly the same elevation, thereby requiring no stairways or circuitous access ramps); however some informal paths exist near the bridge's north end

Informal path at bridge's north end

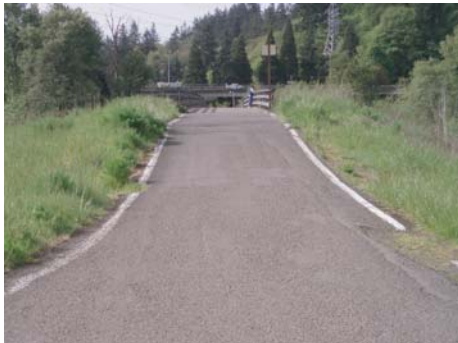
Bridge access provisions: Bridge is part of a continuous shared use path network (north access path is somewhat steep, which could complicate travel for wheelchair users)

The north access path includes a short but steep grade, which can pose difficulties for wheelchairs and other users

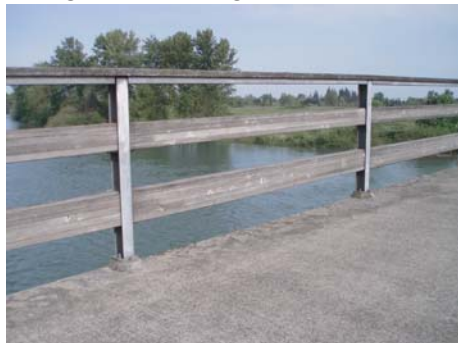
- Shared use paths: No fences, walls, railings
- Bridge: ~43" railings

Railing style on bridge structure

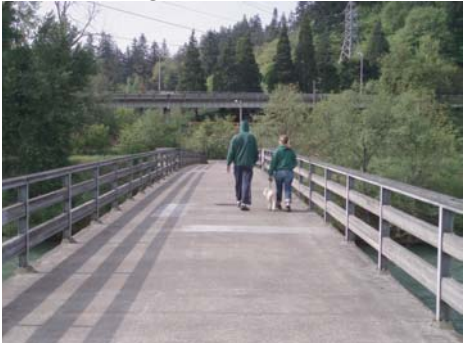
Bridge cross-section includes a 13' rail-to-rail width

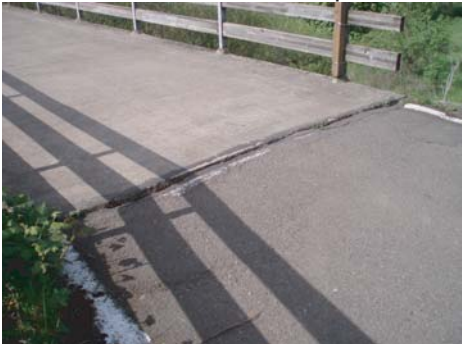
- Bridge: Pavement in generally good condition; large pavement "lips" at both bridge ends; manhole covers on bridge deck might be difficult for some "wheel" users
- Shared use paths: Rough pavement conditions on north access path

Pavement "lip" at bridge's north end

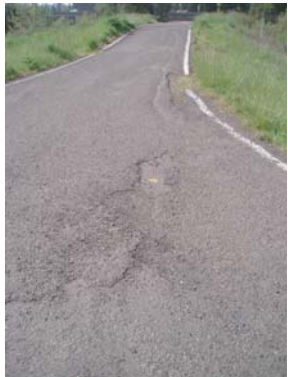
Rough pavement conditions on north access path

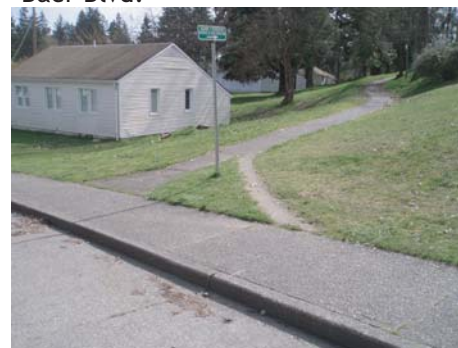
- Curb ramps lacking where access paths meet the street system
- Sidewalks present on Searle St. and Baer Blvd.

Curb ramps lacking where access paths meet surrounding streets

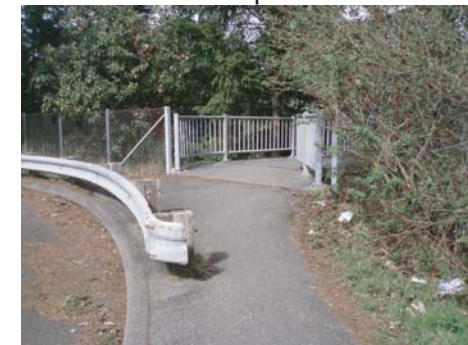
- Vertical rise between bridge and base of access ramps: Data unavailable
- Bicycle: Minimal out-of-direction travel (bridge and surrounding streets/paths are at roughly the same elevation); lack of curb ramps complicates bicycle transitions to/from access paths
- Pedestrian: Minimal out-of-direction travel (bridge and surrounding streets/paths are at roughly the same elevation); out-of-direction travel required for mobility-impaired users to access curb ramps

The lack of curb ramps complicates bridge access for some users

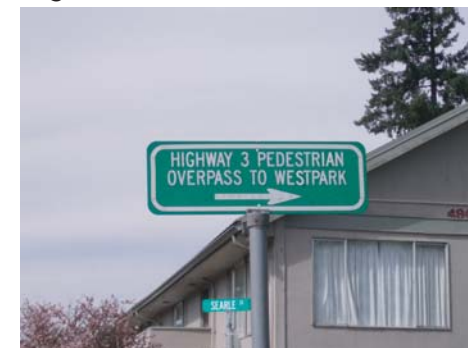
Wayfinding signage west of bridge

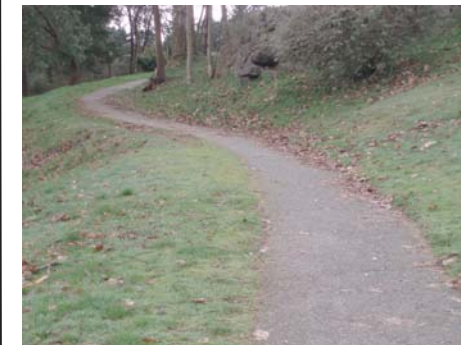
East access path

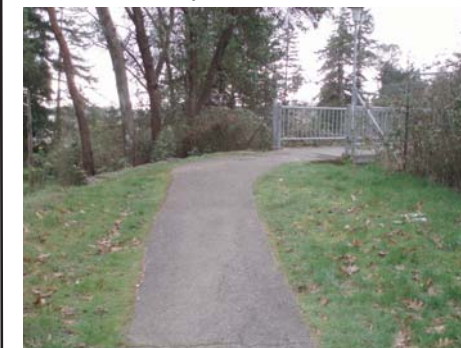
- East path: No specific length (part of a continuous path); ~4' 6" width

East access path is about 4' 6" wide

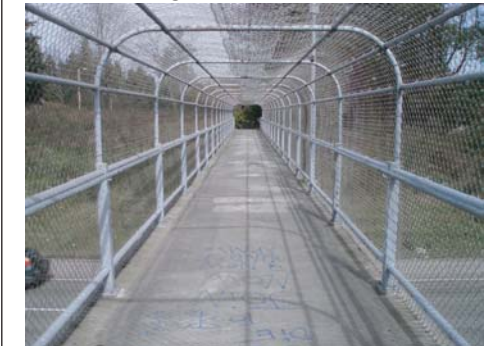
Bridge cross-section includes a 7' 6" rail-to-rail width and a 7' 6" vertical clearance

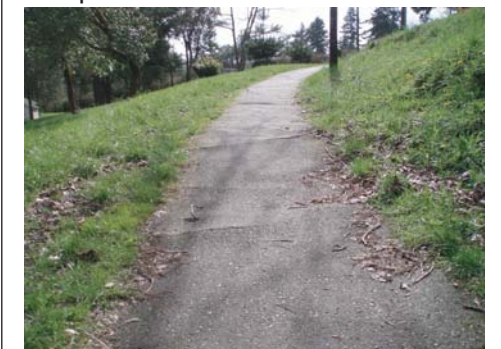
Pavement cracking/heaving on east access path
