Camp Arrowhead Location

Methodology

Landslide Hazard Risk

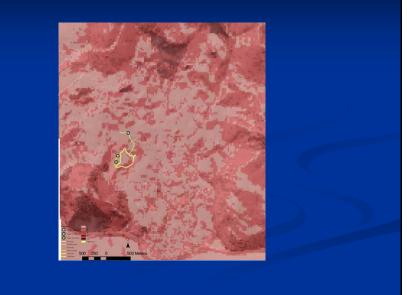
- The model within the Camp Arrowhead site gave higher landslide hazard risk ratings at three of the four observer landslide indicator areas.
- Without a finer resolution DEM (LiDAR), site specific recommendations are very limited.
