Changes in Tree Canopy on Fanno Creek:

Englewood and Greenway Parks

8 December 2002

Geography 410U/510, Professor Heejun Chang

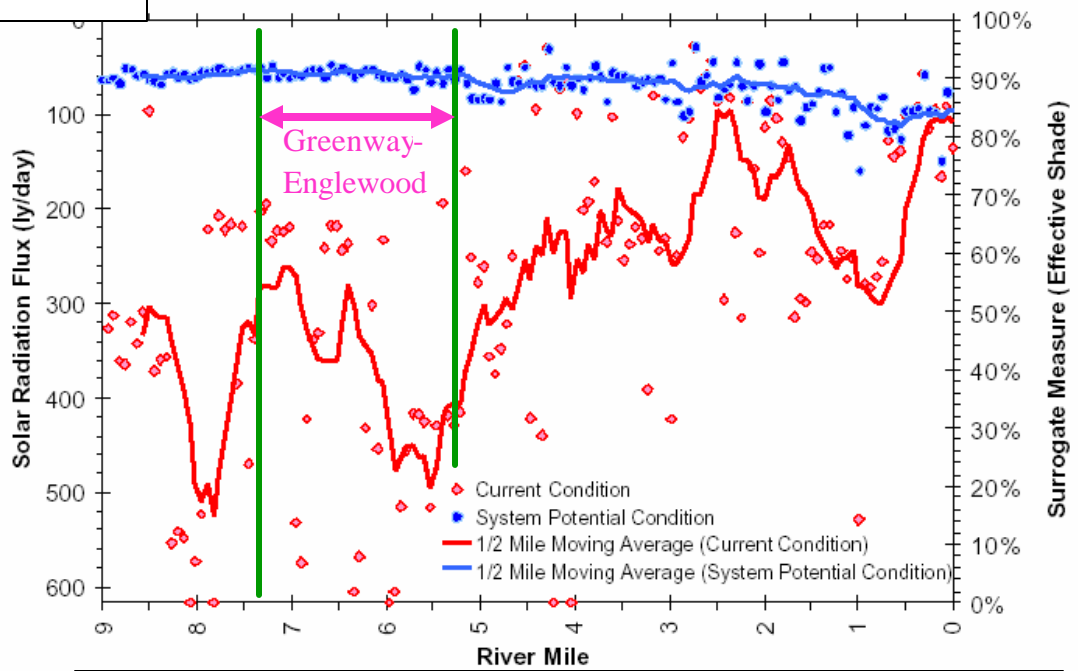
Figure 5.

Figure 5 graphs both current and system potential effective shade against river mileage on Fanno Creek. The end-points of the combined Greenway-Englewood reach are marked. Individual data points represent current and system potential conditions per 100 meter reach. System potential for non-point sources “reflects a riparian vegetation condition without human disturbance.”

Fanno Creek Surrogate Measure for Non Point Sources – *Effective Shade*

Source: Oregon Department of Environmental Quality, 2001, *Tualatin Subbasin Total Maximum Daily Load (TMDL)*, Appendix A, "Temperature Technical Analysis" (annotated)

We deduce opportunities for riparian vegetation enhancement directly from the effective shade graph, by estimating overall averages of effective shade and counting data points with effective shade no greater than 20%.

The Oregon DEQ effective shade data clearly shows gaps representing opportunities to reduce solar stream heating. Gaps in tree canopy are corroborated by inspection of the 2001 aerial mosaics, by our data determined from those mosaics, and by the DEQ data on vegetation height and buffer widths. The difference between the system potential for effective shade and the current condition is large. System potential for effective shade is at least 90% in the Greenway-Englewood reaches. Current conditions for Greenway average less than 55% effective shade while those for Englewood are less than 30%. Nine data points in the combined reaches show 100 meter sub-reaches with effective shade no more than 20%, including five sub-reaches less than 10%. These results support hypothesis 3: Reaches with low effective shade and high system potential are an opportunity to reduce stream heating by enhancing tree canopy.

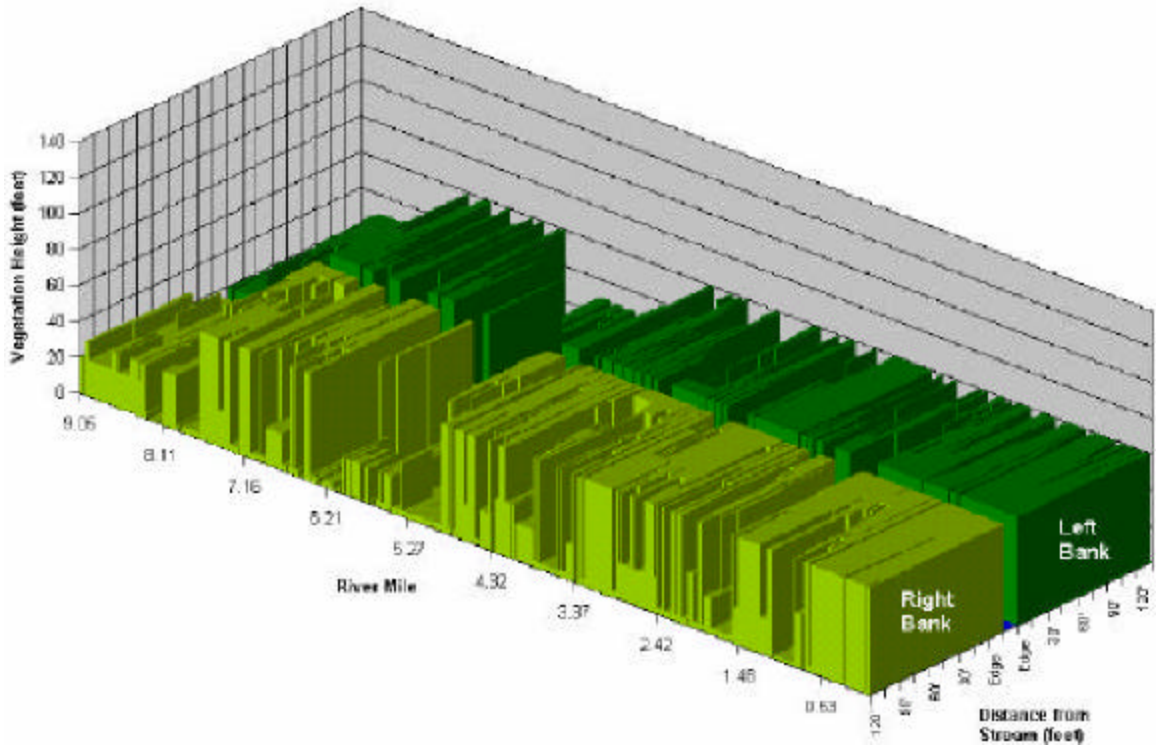
Figure 6.

Fanno Creek Existing Vegetation Heights and Buffer Widths at Each 100-foot Model Reach.

Figure 6 graphs vegetation heights and buffer widths along Fanno Creek. We have no comparable data from 1963.

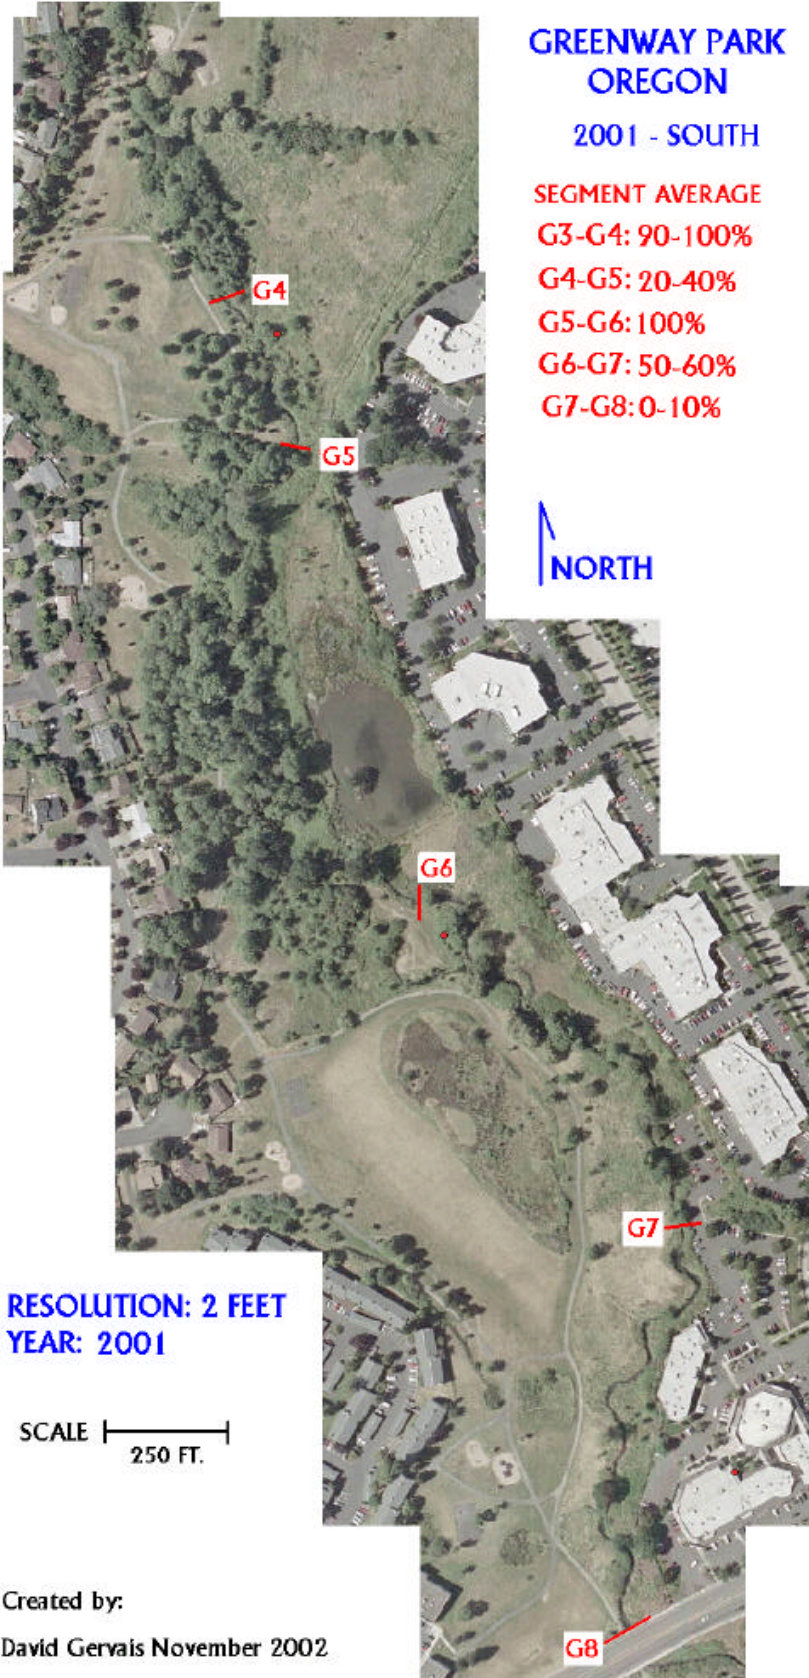
**GREENWAY PARK
OREGON**

2001 - SOUTH

SEGMENT AVERAGE

G3-G4: 90-100%

G4-G5: 20-40%

G5-G6: 100%

G6-G7: 50-60%

G7-G8: 0-10%

**RESOLUTION: 2 FEET
YEAR: 2001**

Reach	Photo Distance (cm)	Scale (ft/cm)	Ground Distance (ft)	%Shade	Product
G1-G2	8.7	116	1009	100%	1009
G2-G3	7.0	116	812	5%	41
G3-Ref3	2.6	116	302	95%	287
Ref3-G4	4.2	125	525	95%	499
G4-G5	2.7	125	338	30%	101
G5-G6	7.5	125	938	100%	938
G6-G7	6.7	125	838	55%	461
G7-G8	6.5	125	813	5%	41
Totals			5573	60%	3334

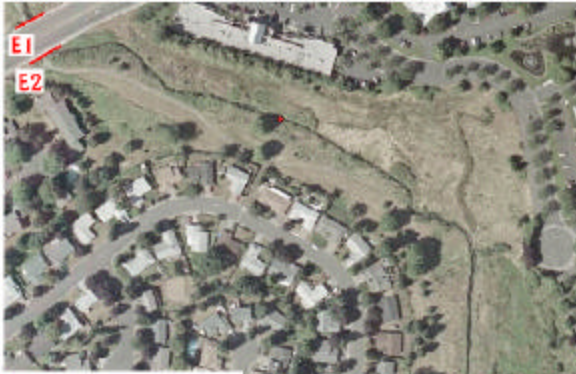
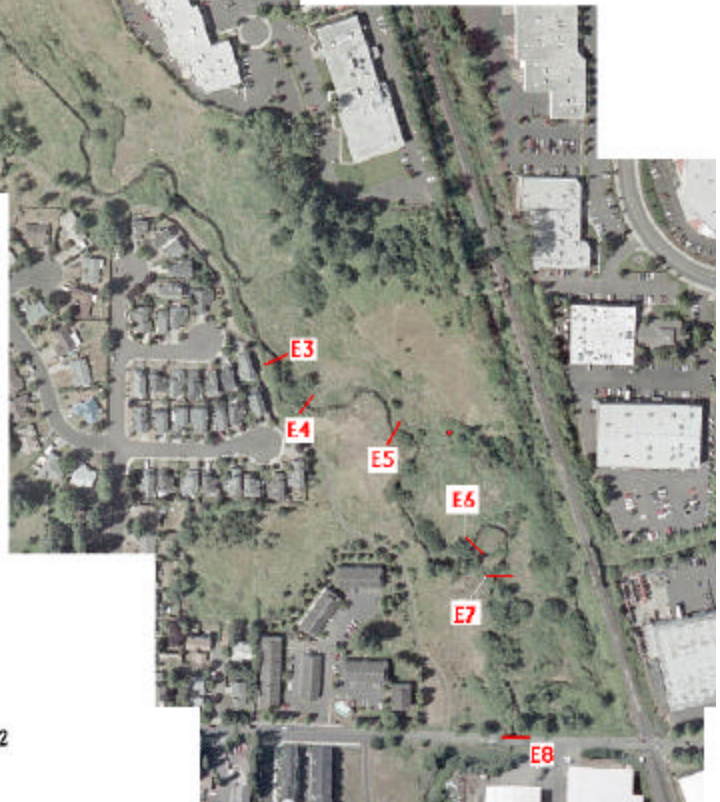
ENGLEWOOD PARK OREGON

RESOLUTION: 2 FEET
YEAR: 2000

TREE CANOPY COVER

- E1-E2 (Bridge)
- E2-E3: 0%
- E3-E4: 10-20%
- E4-E5: 0%
- E5-E6: 10-20%
- E6-E7: 0%
- E7-E8: 50%

Reach	Photo Distance (cm)	Scale (ft/cm)	Ground Distance (ft)	%Shade	Product
E2-E3	18.0	139	2502	0%	0
E3-E4	0.9	139	125	15%	19
E4-E5	1.6	139	222	0%	0
E5-E6	2.3	139	320	15%	48
E6-E7	0.8	139	111	0%	0
E7-E8	2.7	139	375	50%	188
Totals			3656	7%	254
