Reservoir Evolution Following the Removal of  
Marmot Dam on the Sandy River, Oregon

A thesis submitted in partial fulfillment of the  
requirements for the degree of

Master of Science  
in  
Geology

Portland State University  
©2012

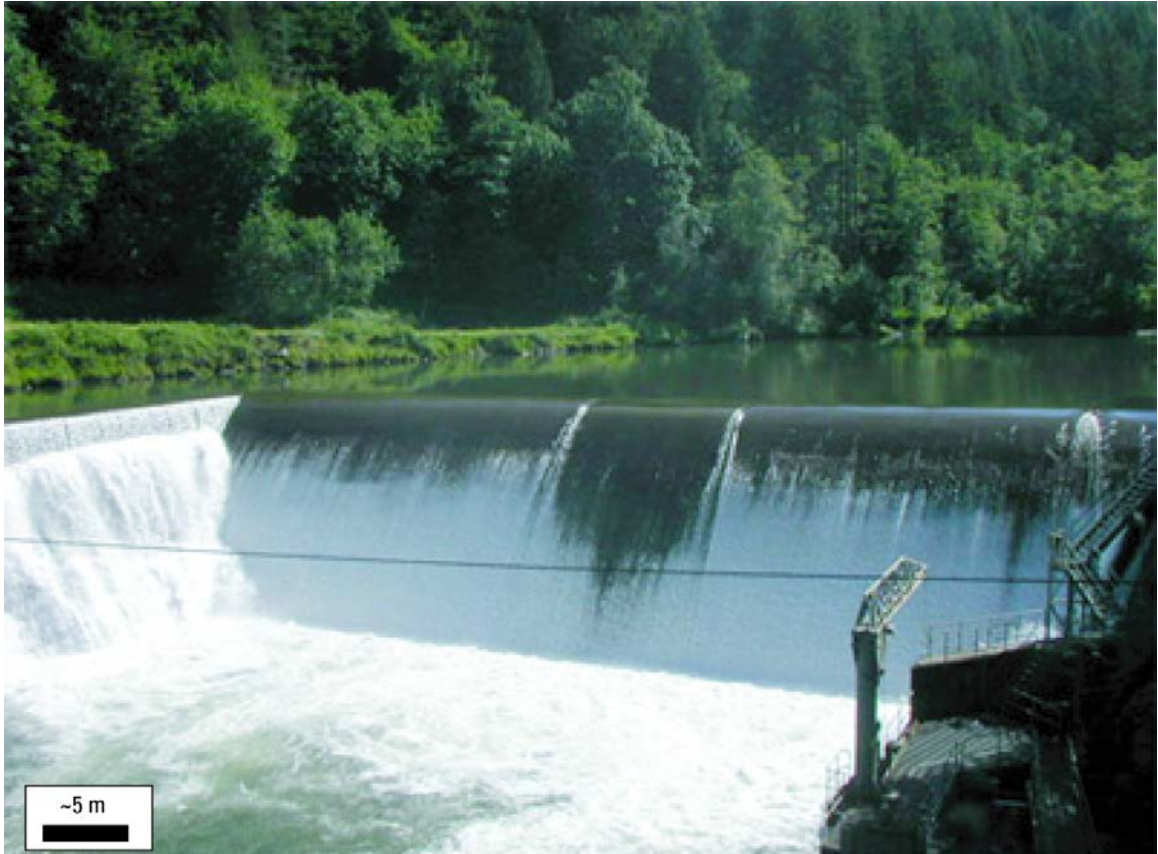
**Figure 1. Photograph of Marmot Dam, Sandy River, Oregon (courtesy of Portland General Electric, circa 1996).**

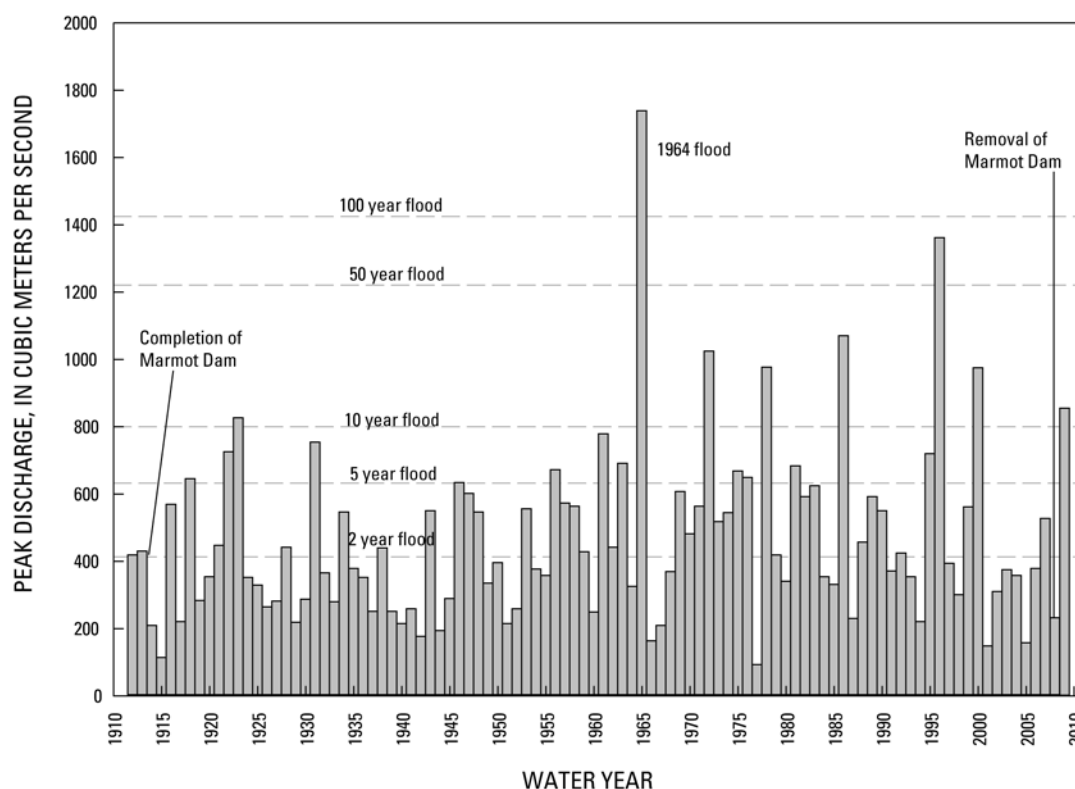
**Figure 3. Peak discharge record at USGS streamflow-gaging station 14137000 Sandy River near Marmot, Oregon, and flood frequency data (Cooper, 2005).**

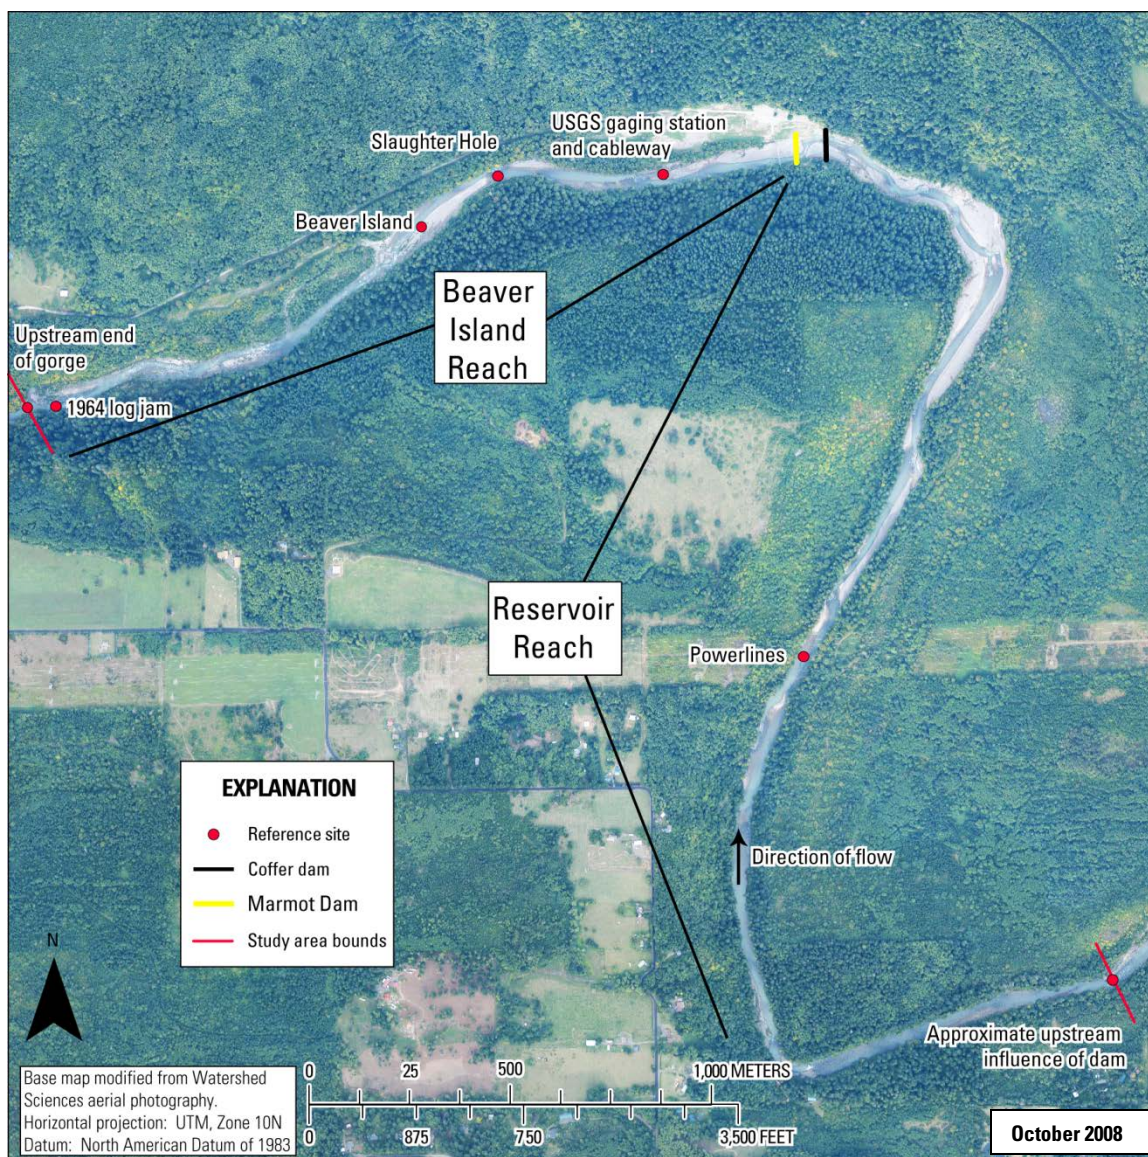
Figure 4. Aerial photograph of study area in the vicinity of Marmot Dam, Sandy River, Oregon.

This project's focus is on the changes occurring within the 3.5 km Reservoir Reach upstream of the Marmot Dam and the Beaver Island Reach extending 2 km below the dam site (Table 3; Figure 4). Prior to the removal of Marmot Dam, the Reservoir Reach had a gradient of 0.0020 m/m measured from LiDAR topography acquired in September 2007. Construction of the dam altered local base level of this reach, which is confined by steep, bedrock walls, and caused abundant sediment deposition. As a result, the reach changed from one that was steep and continual to one having alluvial morphology subject to backwater. Prior to dam removal, the long and narrow reservoir was bordered by intermittent bedrock outcrops and small local gravel bars in the upper

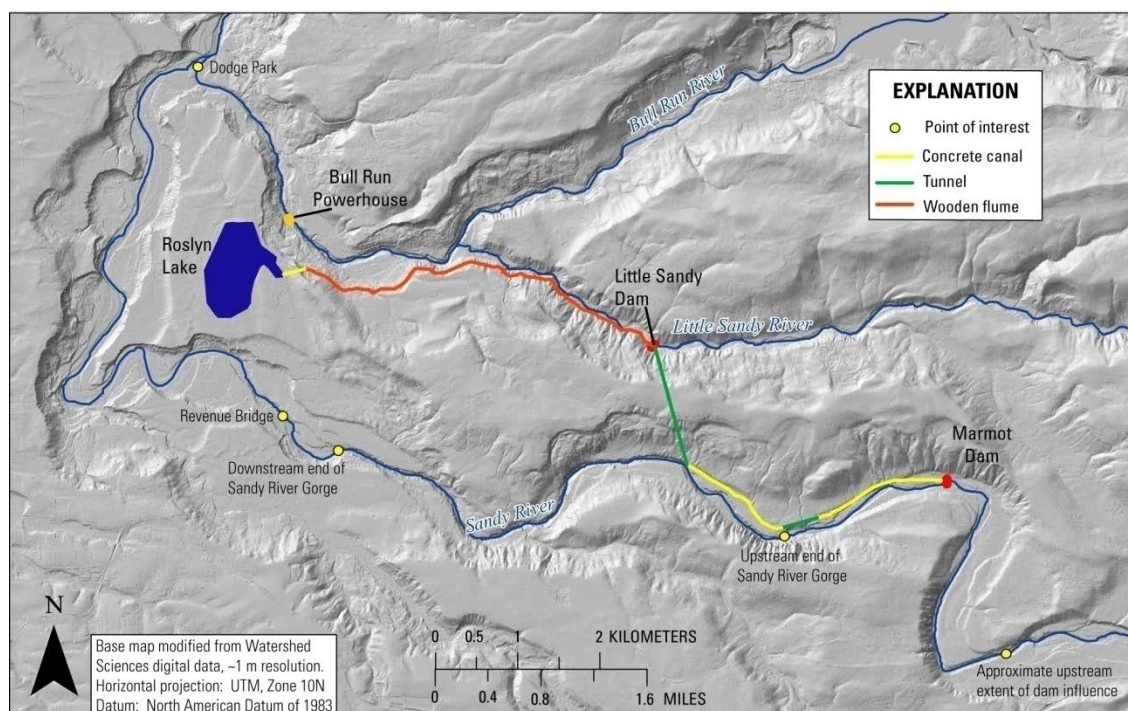
**Figure 5. Major components of the Bull Run Hydroelectric Project operated by Portland General Electric. The project was decommissioned and Roslyn Lake was drained by 2008.**

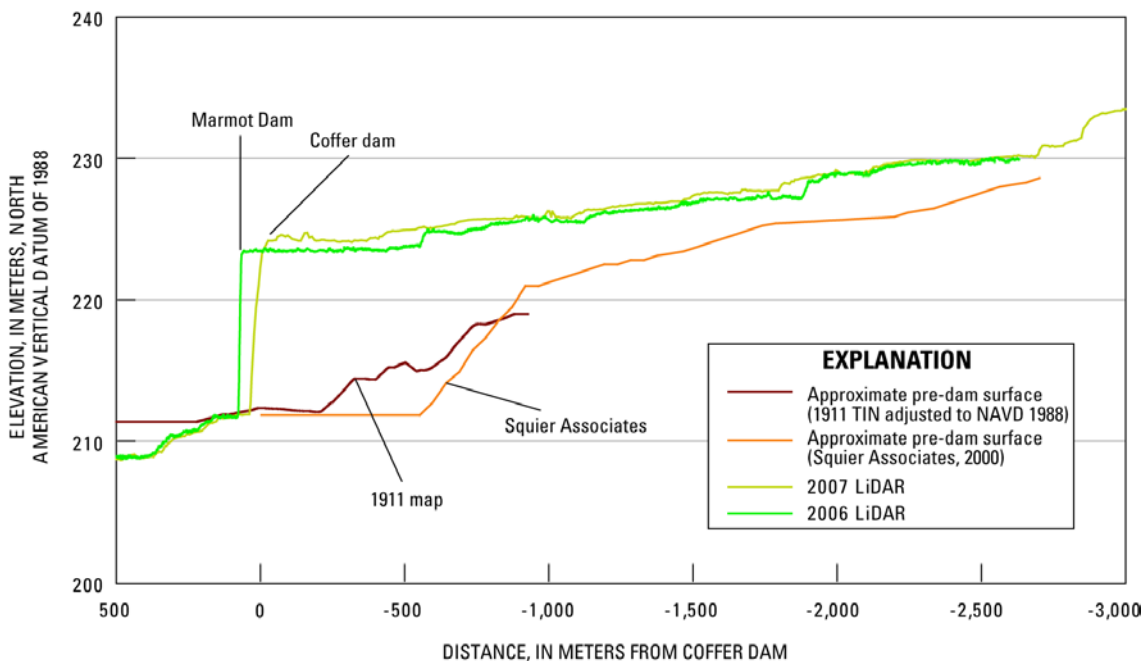
**Figure 9. Longitudinal profiles extracted from 1911 interpolated TIN surface, the top of Squier Associates' (2000) Unit 3 (pre-dam bed surface), and the 2007 and 2008 LiDAR digital elevation models of the Sandy River reservoir area.**

Channel gradient varies within reaches according to local topography. Pre-dam longitudinal profiles (Figure 8, Figure 9) yield a Reservoir Reach gradient of 0.006 m/m

Discrepancies between the 1911 pre-dam profile and the Squier Associates (2000) pre-dam bed-surface profile (Figure 9) may be due to sparse data collection of Squier Associates within the Reservoir Reach. An anomalously flat stretch directly downstream of the dam site, and extending 0.8 km through the upstream end of the Beaver Island Reach, may be due to limited historical topographic information.

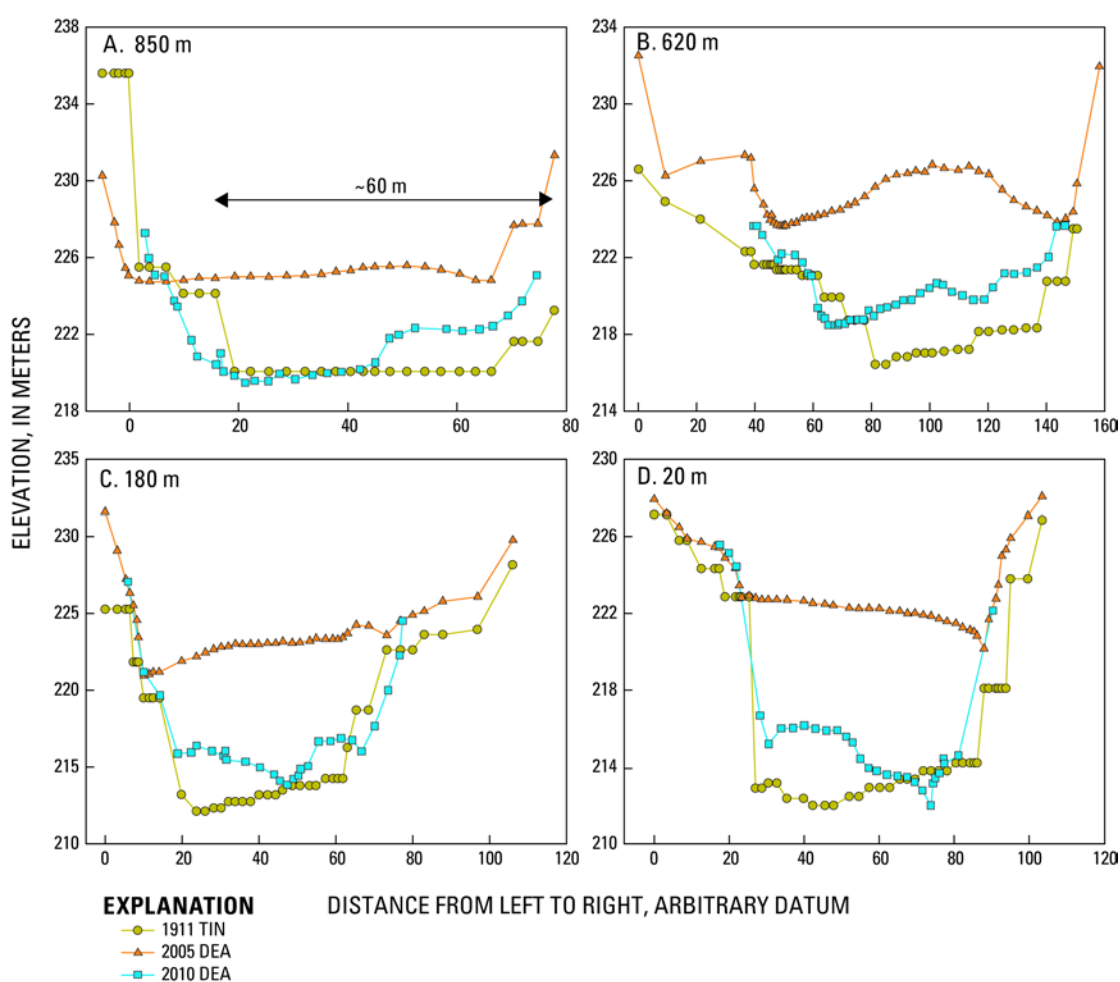
**Figure 10. Comparison of 1911 pre-dam surface cross-sections with those of pre- and post-removal cross sections within the reservoir surveyed by David Evans and Associates. Locations at A) 850 m, B) 620 m, C) 180 m, and D) 20 m upstream of the coffer dam location.**

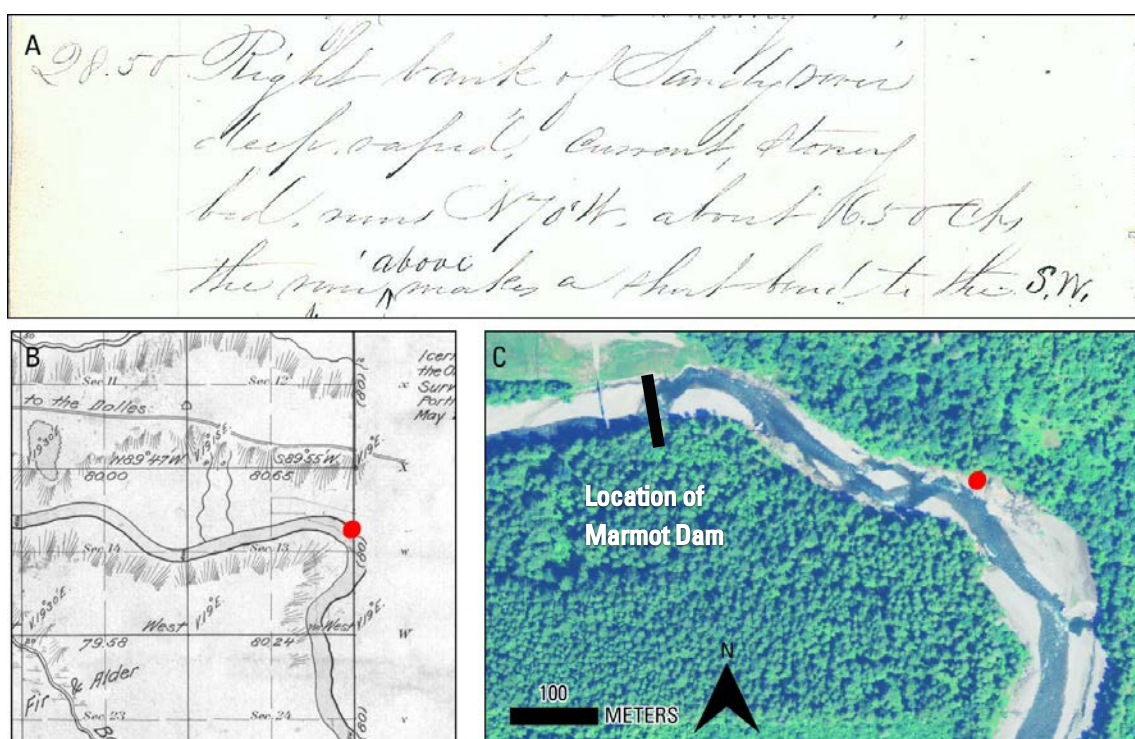
**Figure 11.** Notes (A) and map (B) from a General Land Office survey conducted in 1860 and (C) a 2009 aerial photograph with red dot denoting the location referred to in the notes.

Burnett's (1860) historical survey notes from a General Land Office (GLO) cadastral survey upstream of the dam location describe the Sandy River as "Right bank of Sandy River deep, rapid, current, stony bed, runs N<sup>70</sup>W, about 16.50 ch, the river above makes a short bend to the S.W."

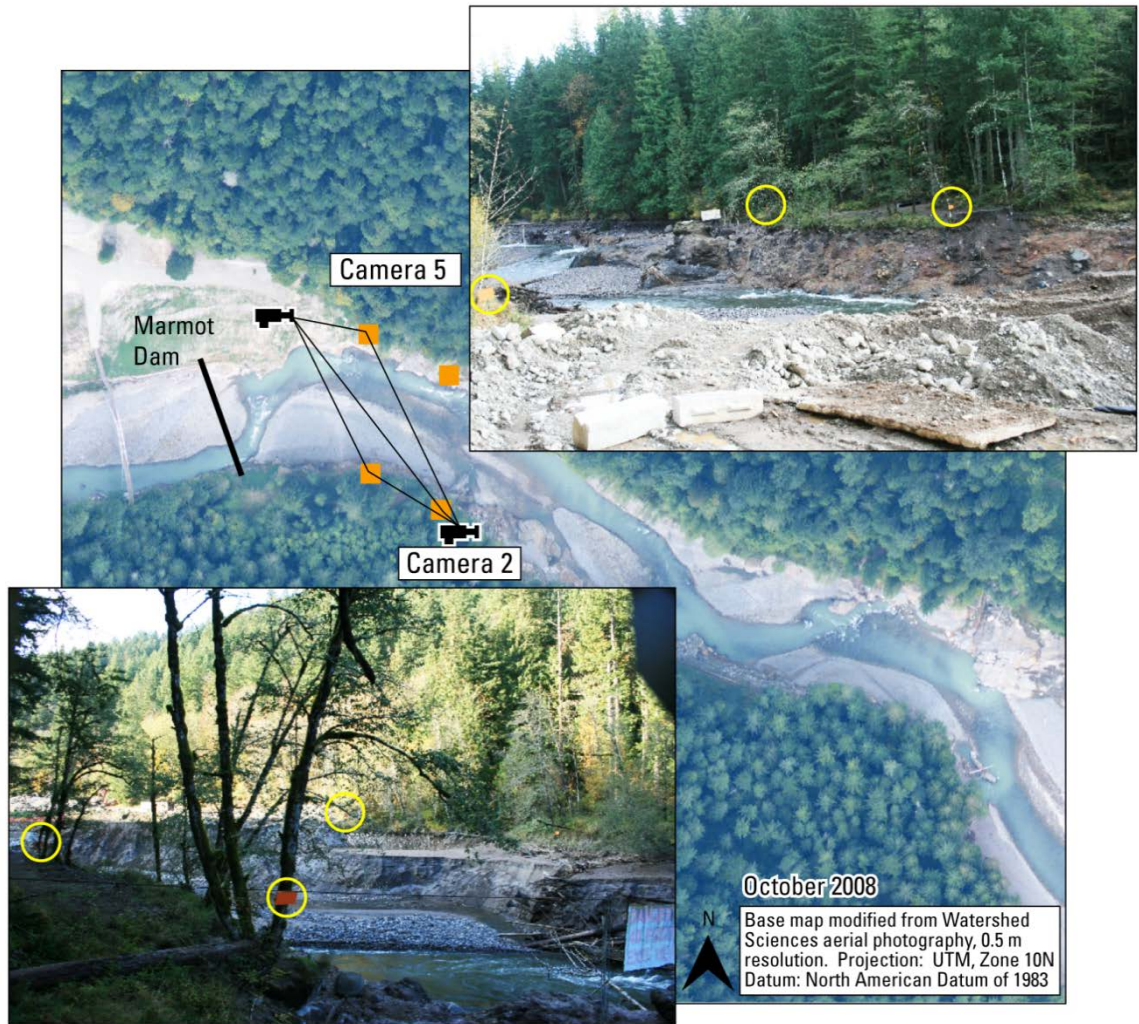
**Figure 13. PhotoModeler creates a model based on coincident points between photographs. This example shows where rays from cameras 2 and 5 would intersect the orange photograph targets. Yellow circles indicate the location of targets within the terrestrial photographs.**

The control points were used to spatially register each photograph within the PhotoModeler software. Three to five photographs with overlapping, but not stereoscopic, imagery were chosen for each time interval (Table B1) on the basis of photograph clarity and identifiable control points in multiple images. A minimum of six tie points between each set of photographs were assigned to match photographs. Tie points could consist of any object visible in multiple photographs. Tie points are important in construction of the three-dimensional model and are best utilized by the software when distributed across photographs with about 60 percent overlap, although, some of the photograph sets used had less overlap. In some instances, weather obscured the control and tie points and thus, other identifiable features were used to register the photographs, such as bedrock outcrops, stumps, and construction equipment.

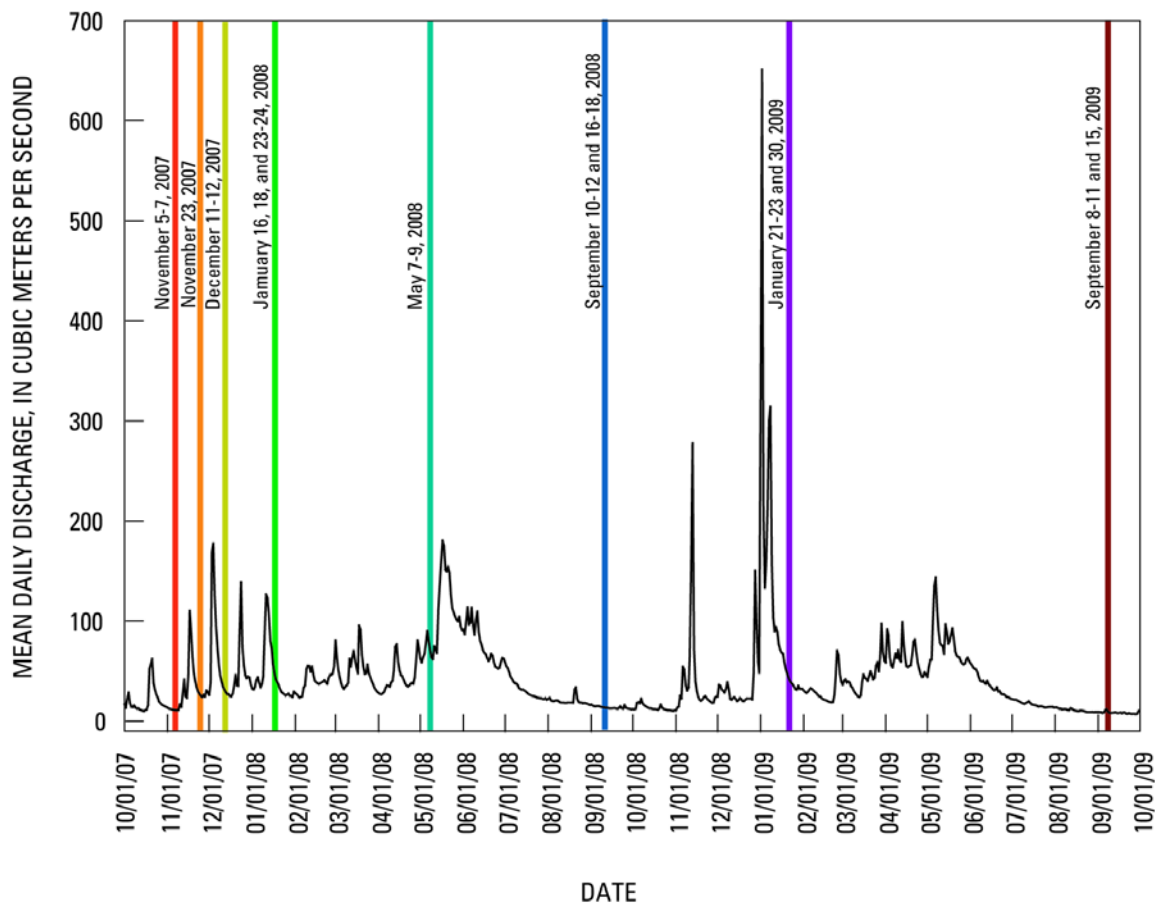
**Figure 14. Mean daily discharge from USGS streamflow-gaging station 14137000, Sandy River near Marmot, Oregon and timing of USGS topographic surveys over the two-year period following the removal of Marmot Dam on 19 October, 2007.**

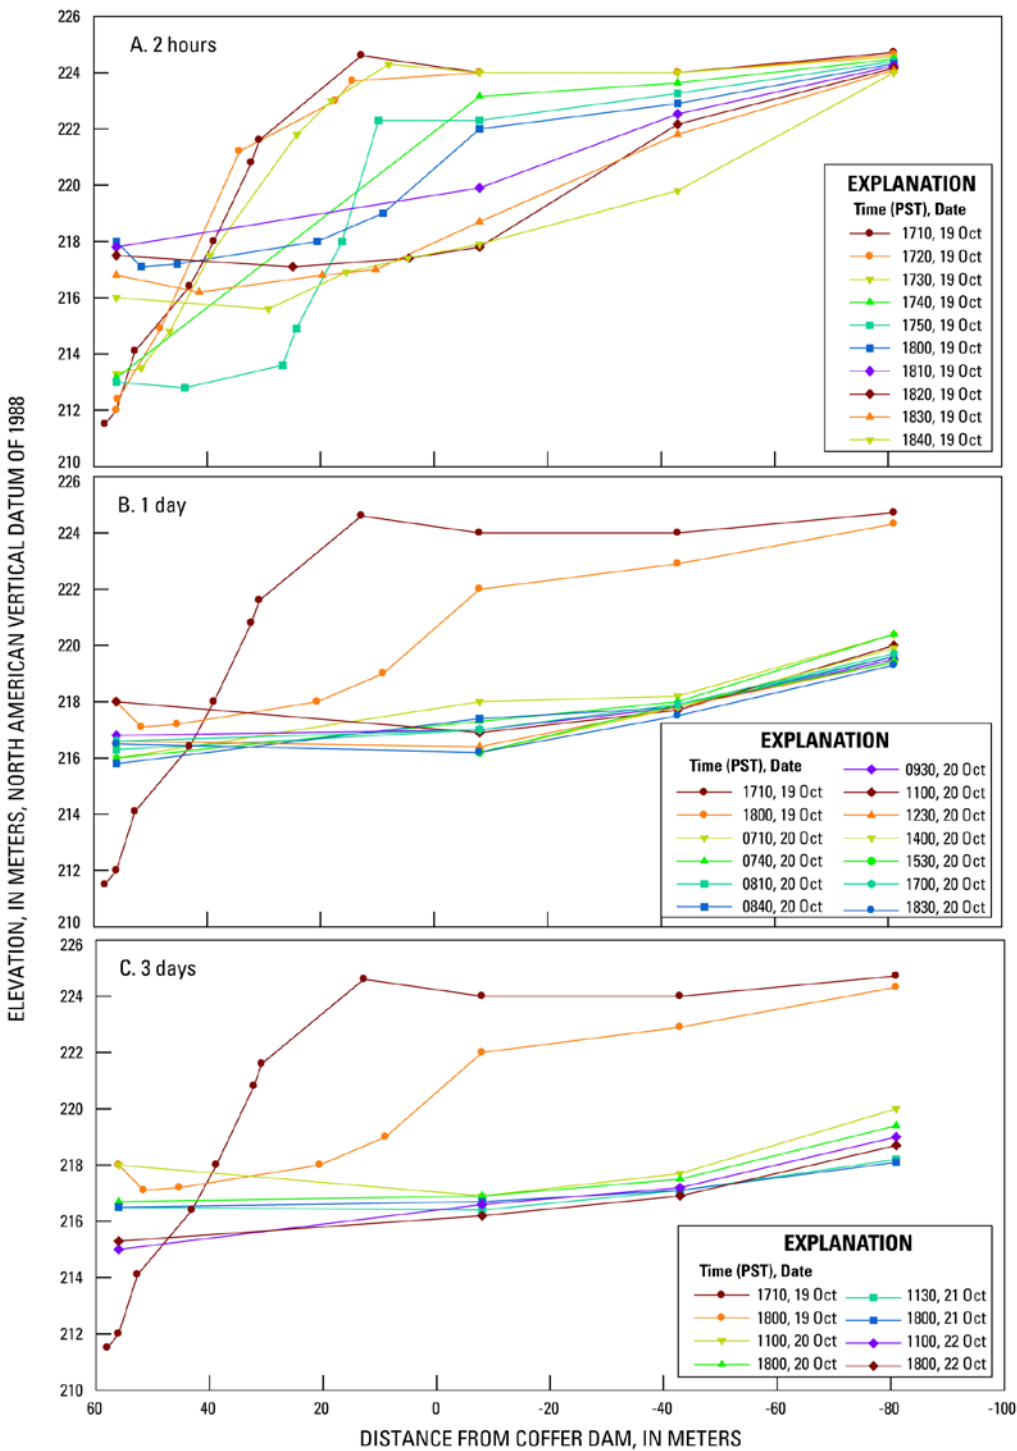
Figure 15. Sandy River water-surface profiles for the lower reservoir derived from photogrammetry for about A) 2 hours, B) 1 day, and C) 3 days following coffer dam breaching which occurred at 1700 PST on 19 October 2007.

Early stages of post-dam-removal channel evolution reveal rapid incision through the reservoir deposit and subsequent widening in the lower reservoir within the first few hours and days following breaching of the coffer dam (Figure 15). Rates of initial incision through the unconsolidated impounded sediment ranged from 1.8 m/hr to 12.6 m/hr over the first hours. Rates within the lower 100 m of the Reservoir Reach slowed to an average daily rate of 0.2 m/hr on 20 October, the day after the breach, but still attained rates of up to 4.8 m/hr at a distance 8 m upstream of the coffer dam. Incision continued to slow throughout the first 3 days following breaching of the coffer dam. The slowing incision rate coincides with increasing river discharge and is followed by a period, after 22 October, with decreasing discharge (Figure 16) when changes became undetectable from photogrammetry (Figure 17). Two weeks following breaching, bed elevation 8 m upstream of the coffer dam site had lowered by 7.7 m, and at 49 and 81 m upstream, it lowered 7.5 and 6.8 m, respectively (Figure 15; Figure 17).

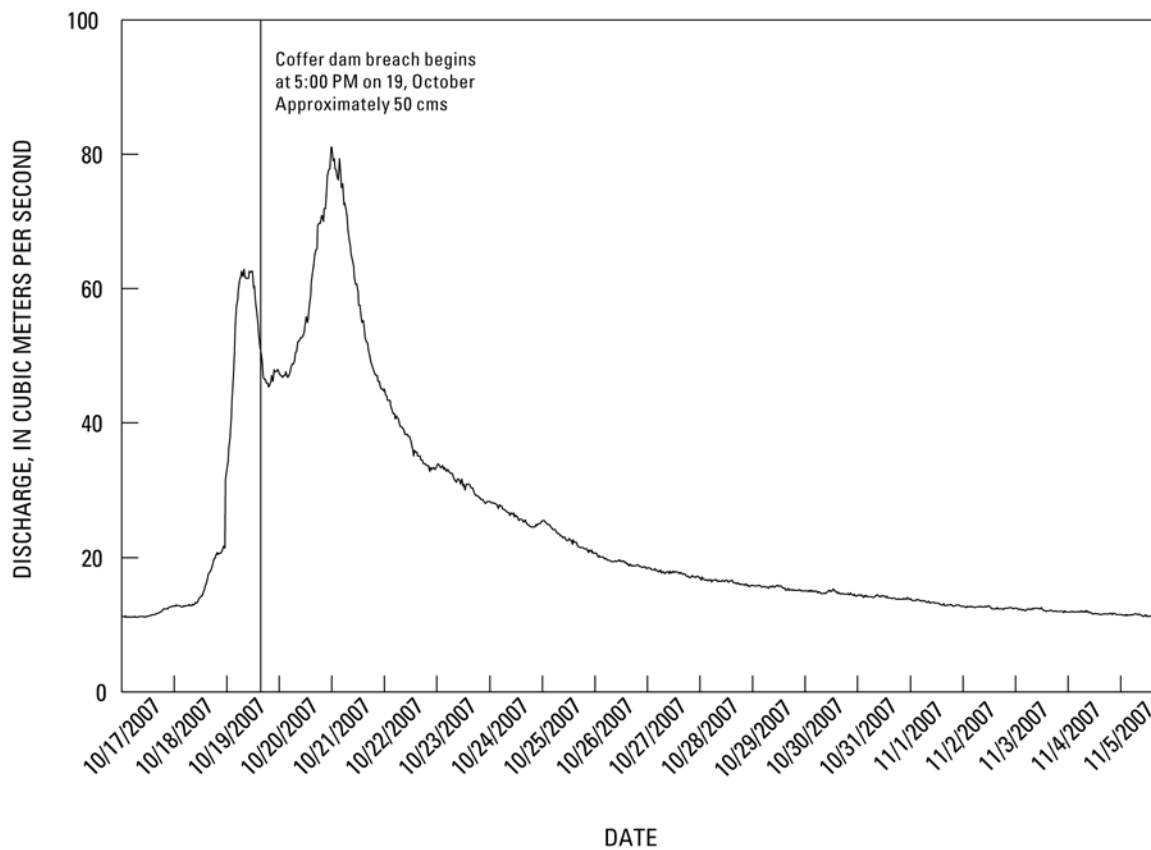
**Figure 16. Hydrograph at USGS streamflow-gaging station 14137000 following coffer dam breaching on the Sandy River, Oregon (USGS, 2009b).**

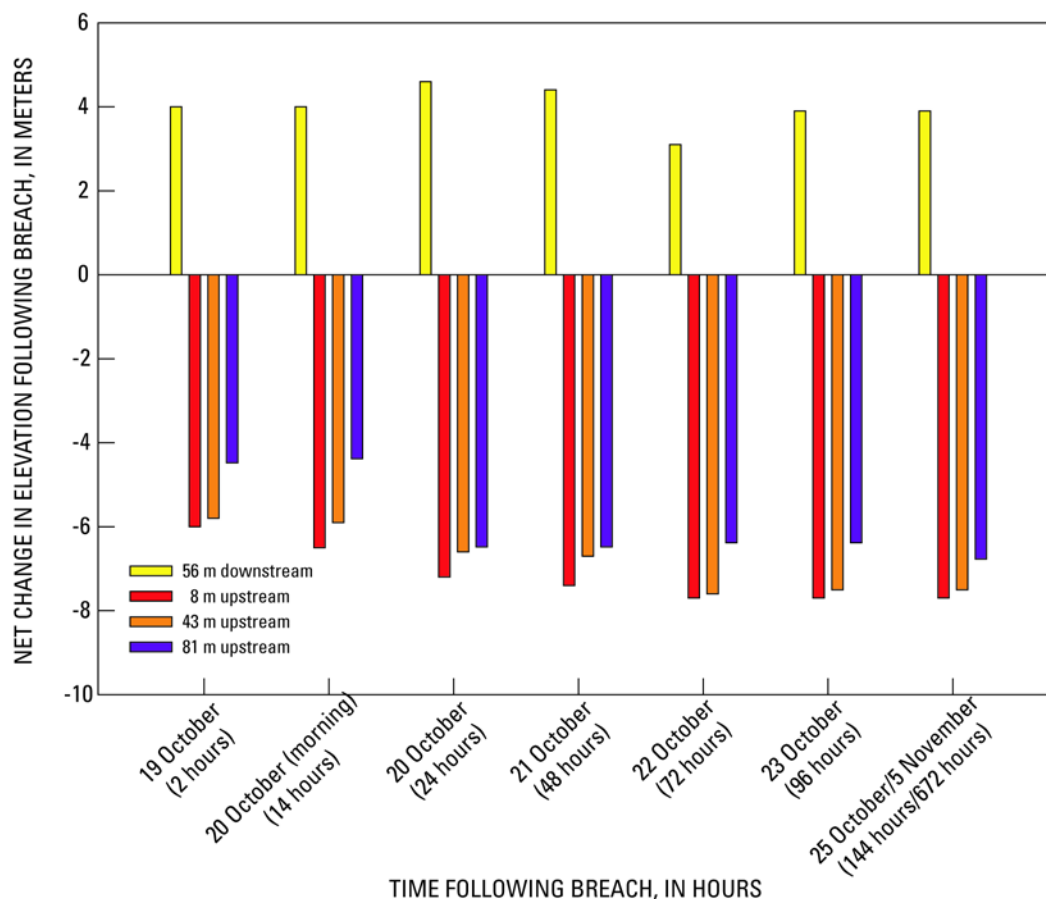
**Figure 17. Net change in elevation at four locations measured from time lapse photography following the removal of Marmot Dam on the Sandy River, Oregon. Dates represent the end of the day unless noted. Due to camera station moves, the stations 56 m downstream and 8 m upstream of the dam site were only measured through 25 October, 2007, while those at 43 m and 81 m upstream of the dam site were monitored through 5 November.**

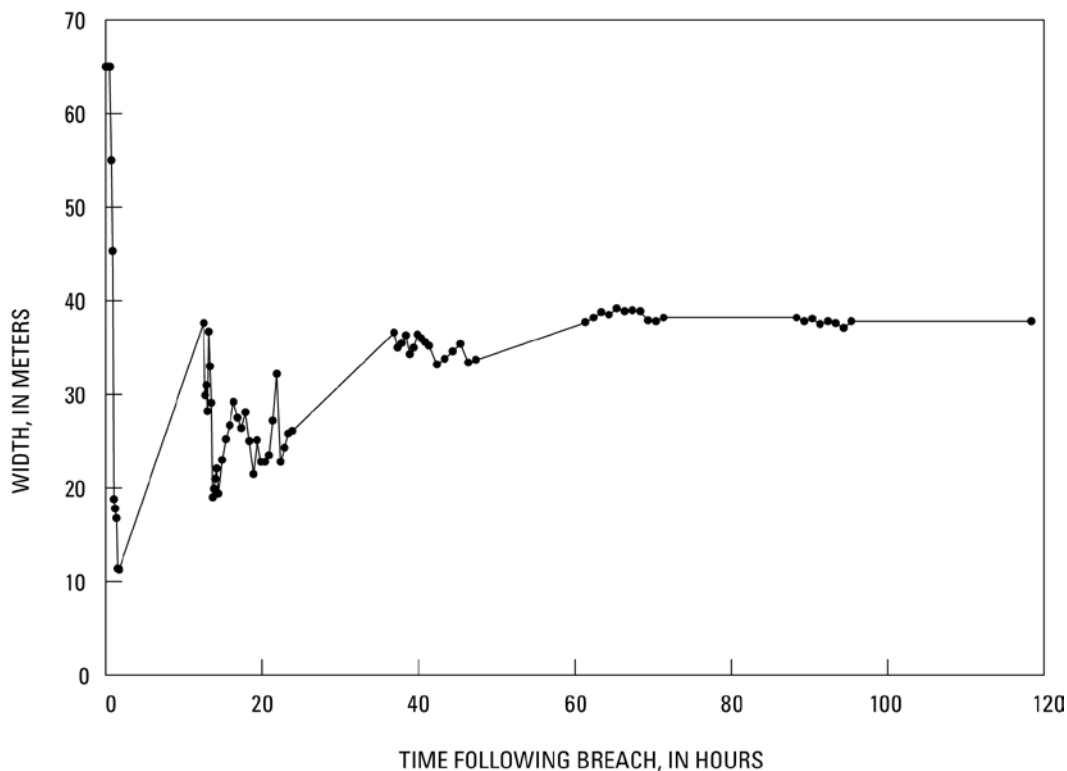
**Figure 18. Channel width measured photogrammetrically following breaching of the coffer dam 8 m upstream the dam site. The initial width is the un-channeled, wetted width prior to coffer dam breaching.**

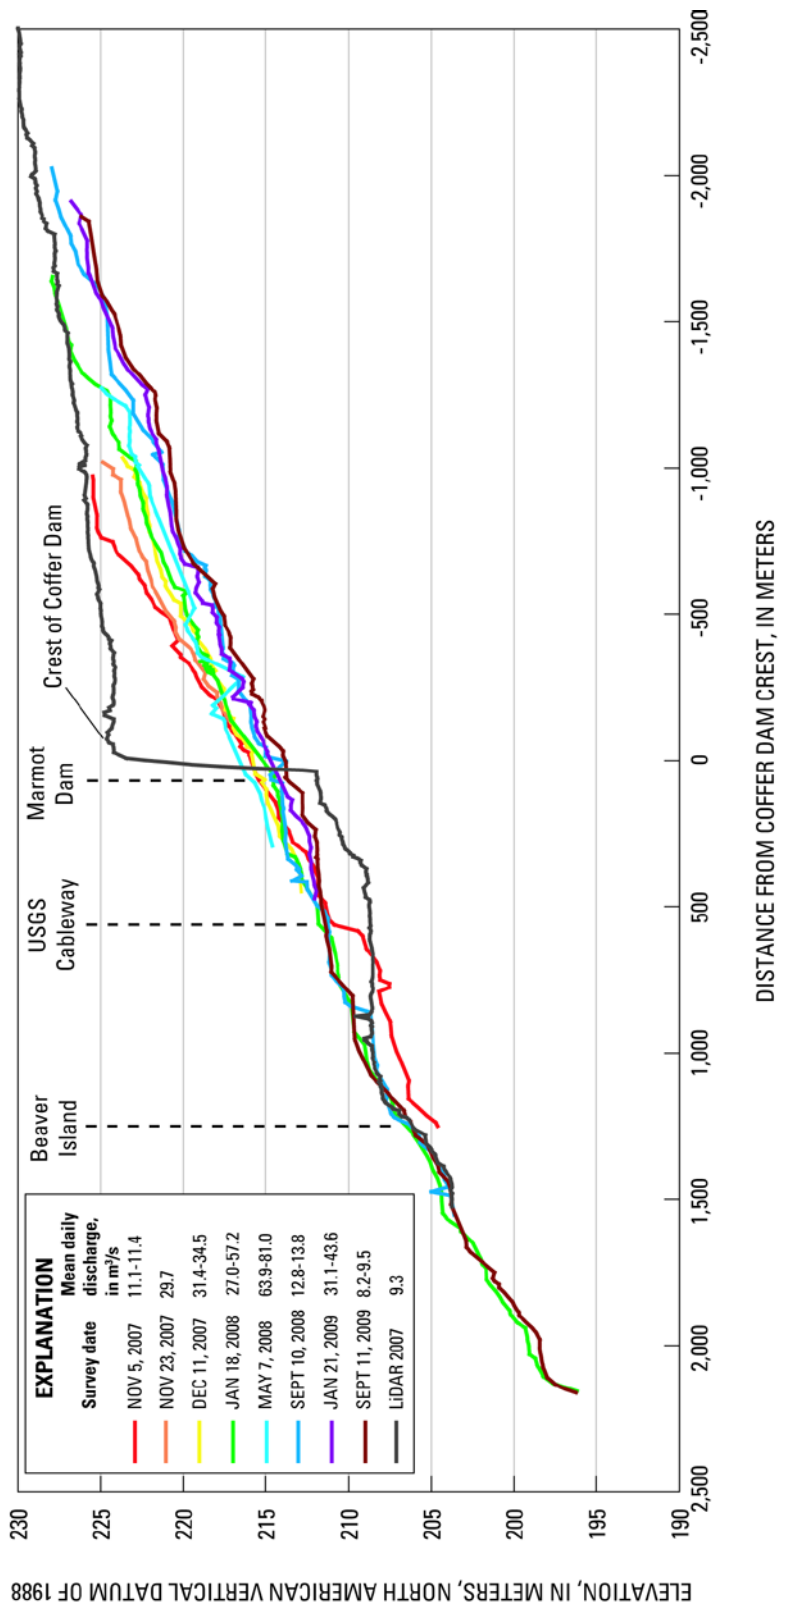
Figure 19. Longitudinal profiles of water-surface elevation in the vicinity of the former Marmot Dam on the Sandy River, Oregon, as measured from LiDAR and field surveys.

years after breaching, a September 2009 survey indicates a Reservoir Reach gradient remaining at about 0.006 m/m (Figure 19), and incision between 800 m and 1,000 m upstream of the dam site exceeding 4.6 m since the first November 2007 survey. As much as 1.9 m of incision occurred in the upper Reservoir Reach during the second year at a location 1,800 m upstream (Figure 20).

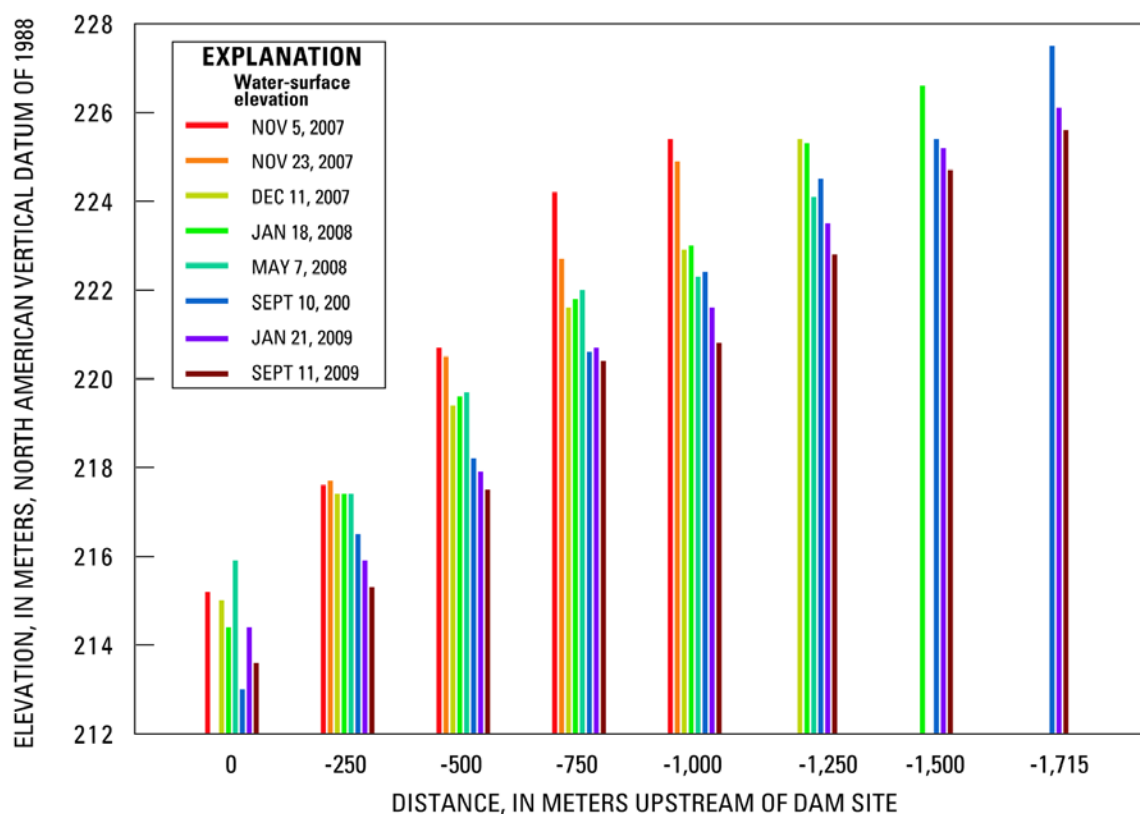
**Figure 20. Water-surface elevation during the 2 years following the removal of Marmot Dam on the Sandy River, Oregon.**

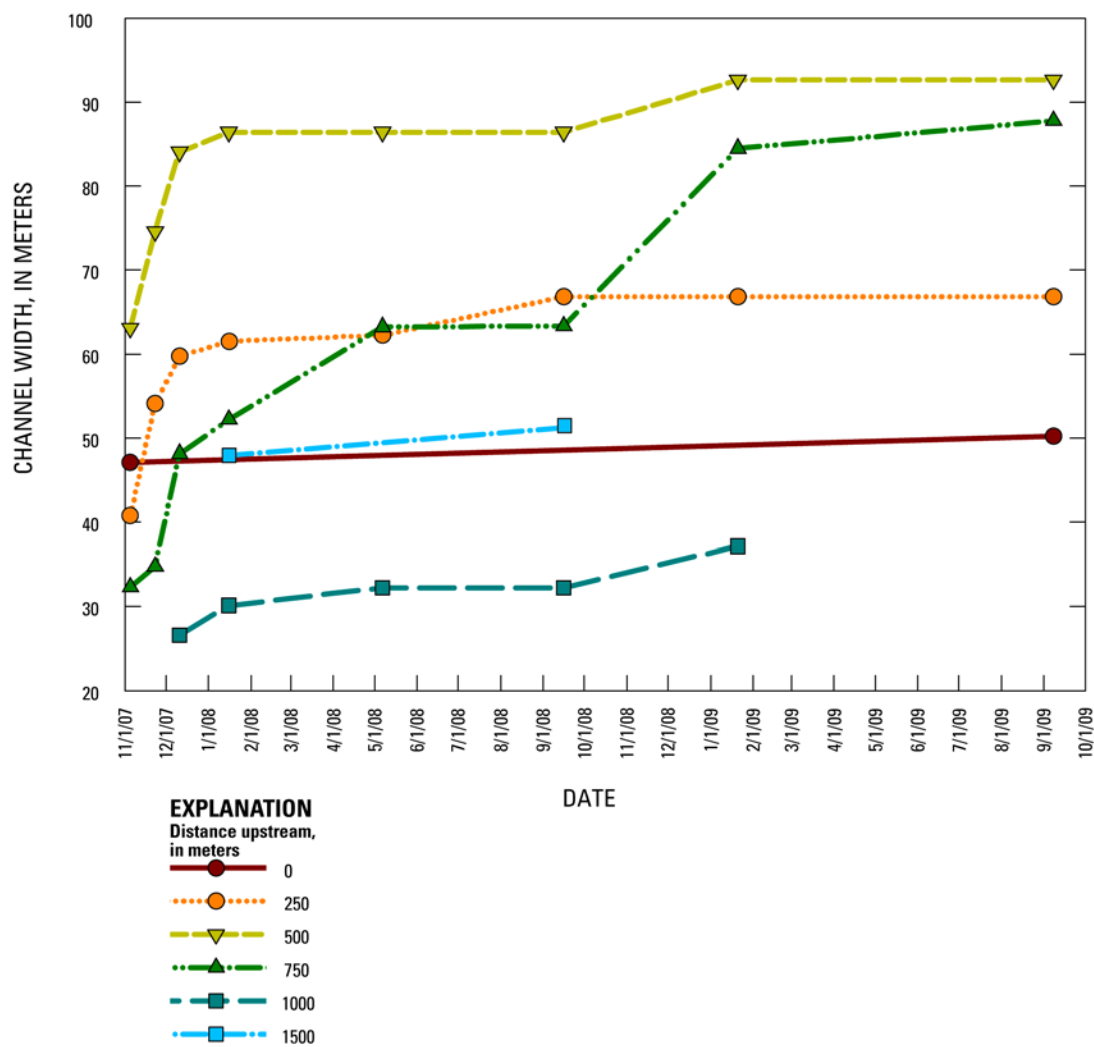
Figure 21. Active channel width within the Reservoir Reach following the removal of Marmot Dam.

followed by diminishing rates of widening. The greatest change in channel width was measured between the two November surveys, with increases in width varying from 13.4 m at a location 250 m upstream of the dam site to 2.5 m at a location 750 m upstream (Figure 21). Overall, rates of channel widening remained high through the winter as runoff increased. Minimum daily average rates varied up from 0.74 m/day through December 2007 to 0.11 m/day through January 2008. Continual failure of over-steepened banks in the Reservoir Reach contributed to extensive channel widening. By May 2008, the channel had increased in width by more than 30 m since 5 November 2007 at a location 750 m upstream of the dam site. Channel-width adjustments were still evident in summer 2008, but to a far less degree likely due to decreased discharges and depletion of reservoir sediment. The Sandy River channel widened through the lower 1 km of the Reservoir Reach by as much as 31 m in the year following removal, but only about 5 m of that width increase occurred after May 2008 (Figure 21). Channel width increased slightly with the onset of high river discharges at the beginning of water year 2009 (1 October, 2008 through 30 September, 2009), in the middle Reservoir Reach and widened by as much as 21 m after a 5-year flood event in January 2009 at locations 500 m to 750 m upstream of the dam site (Figure 3). Following the January 2009 flood, channel width in the Reservoir Reach remained relatively stable. Approximately 2 years following the removal of Marmot Dam, widths of the Reservoir Reach widths averaged 50 m to 90 m (Figure 21), as compared to 30 to 60 m measured two weeks after breaching of the coffer dam.

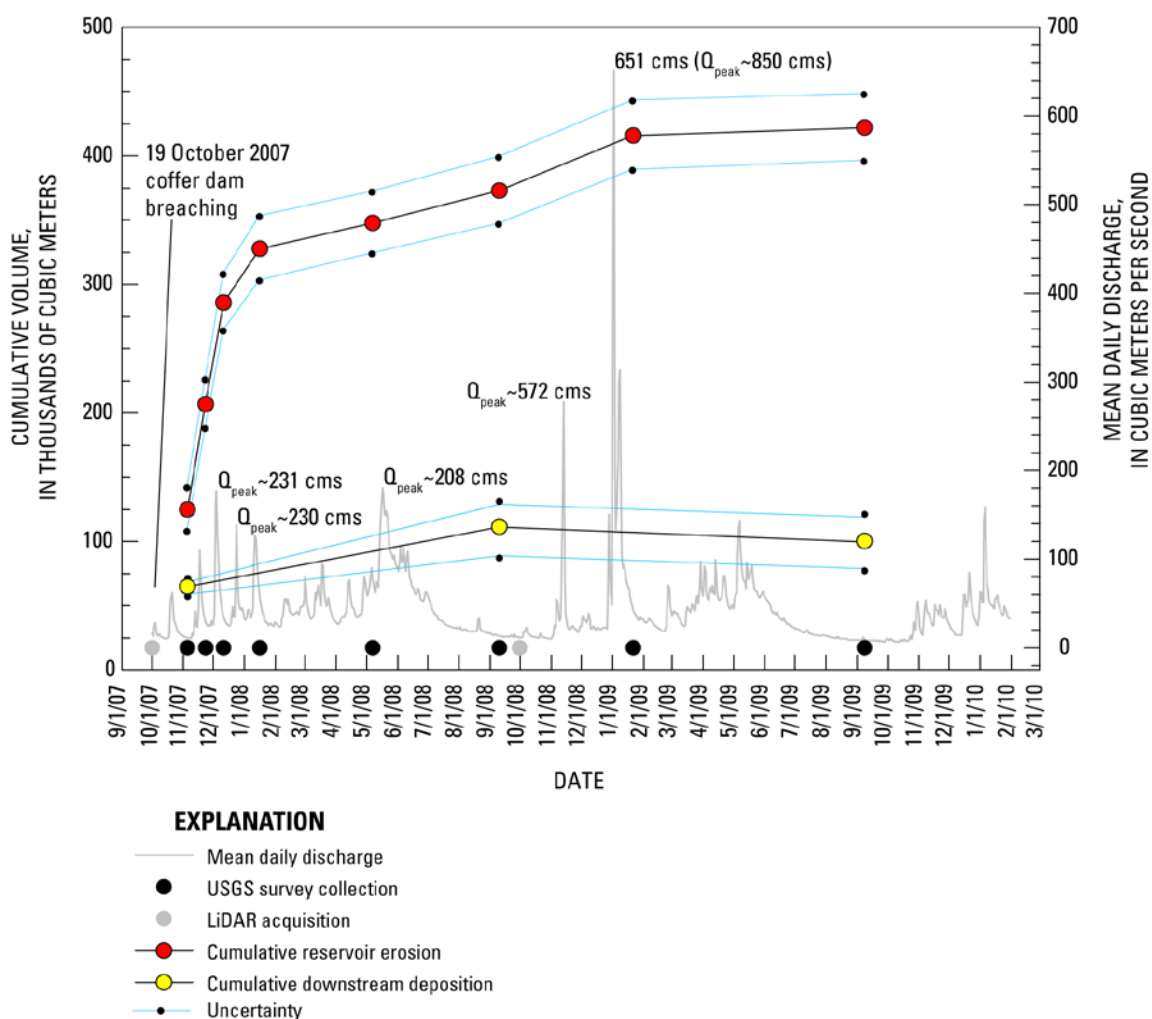
**Figure 22. Cumulative reservoir erosion and downstream deposition two years following the removal of Marmot Dam including variation in discharge and collection dates for USGS and LiDAR surveys used to measure the change in volume.**

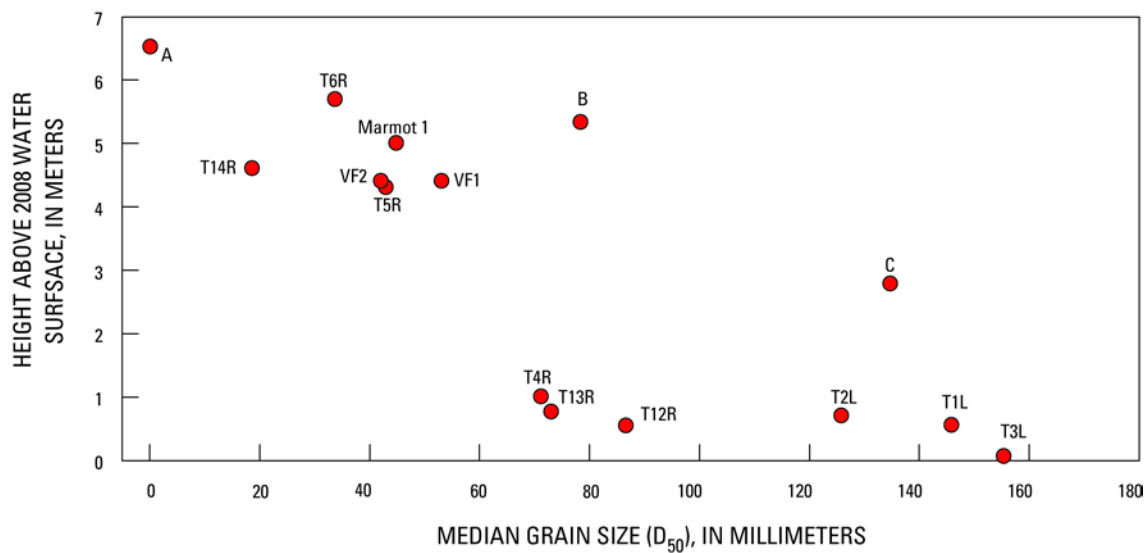
**Figure 25. Median grain size of bed-material samples collected in the Reservoir Reach relative to height above the 2008 LiDAR water surface in the Reservoir Reach of the Sandy River. See appendix C for sample location.**

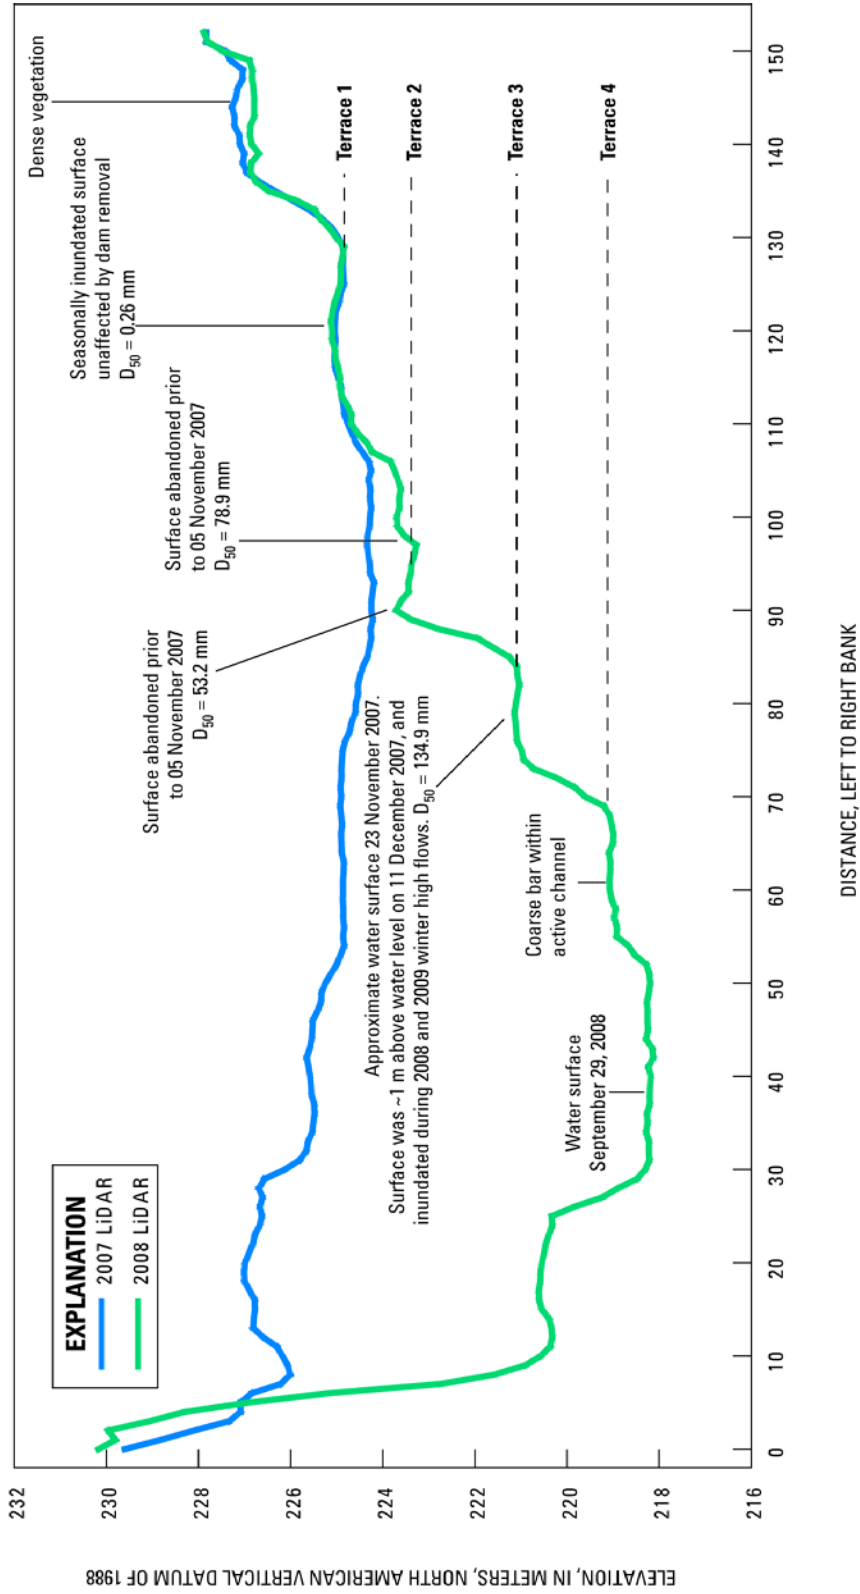
Figure 26. Pre- and post-removal LiDAR cross sections in the Reservoir Reach at about 250 m upstream of the dam site. These sections illustrate terrace development and bed-material coarsening following dam removal. Terraces are also labeled on Figure 27.
