Reservoir Evolution Following the Removal of  
Marmot Dam on the Sandy River, Oregon

A thesis submitted in partial fulfillment of the  
requirements for the degree of

Master of Science  
in  
Geology

Portland State University  
©2012

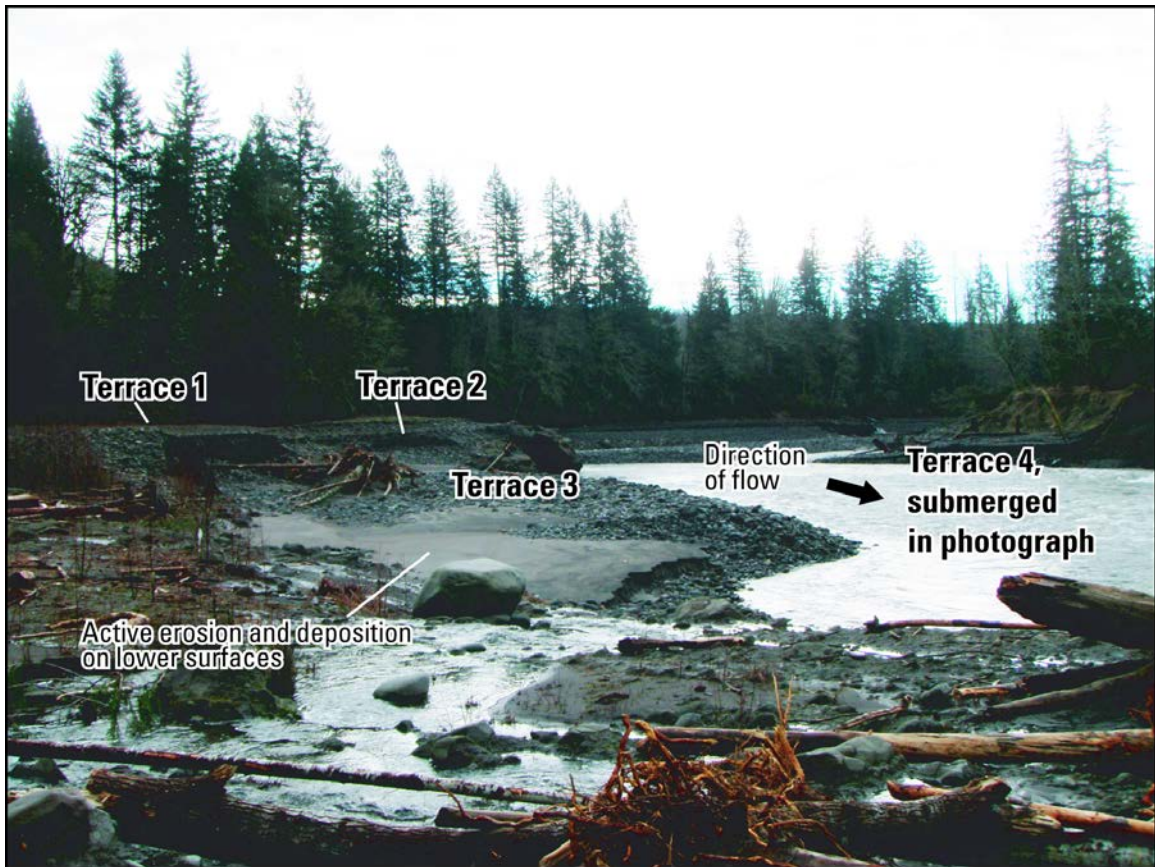
Figure 27. Photograph of bedrock and remaining sediment relative to channel position in the Reservoir Reach of the Sandy River following dam removal. Terrace locations denoted on Figure 26.

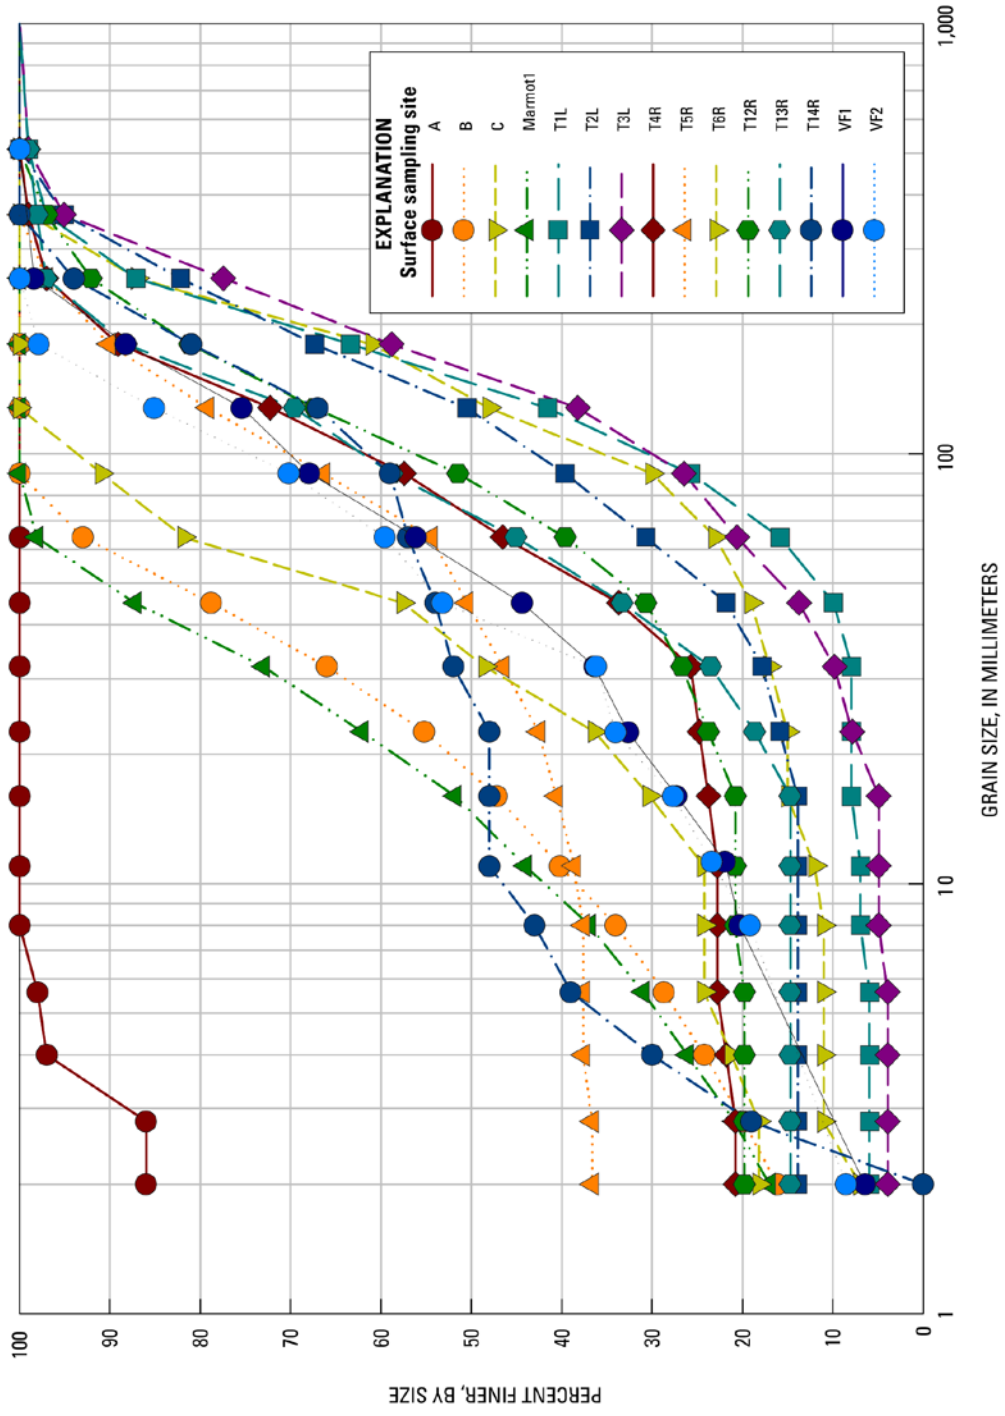
Figure 28. Particle-size distributions of bed-material samples collected in the Reservoir Reach of the Sandy River following removal of Marmot Dam. See appendix C for sample location.
