# Initial Reservoir Evolution Following the Removal of Marmot Dam on the Sandy River, Oregon

Mackenzie Keith  
Geography 593  
Digital Terrain Analysis  
December 8, 2011

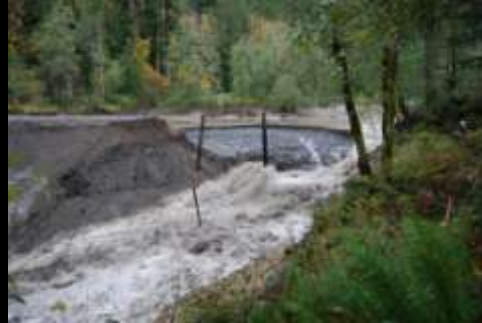
- Constructed in 1913
- 14.3 m-tall dam
- 3 km-long reservoir
- Removed October 2007
- “Blow and Go”
- Few other studies monitoring reservoir response
- 125,000 m<sup>3</sup> of sediment eroded in the 1<sup>st</sup> two weeks

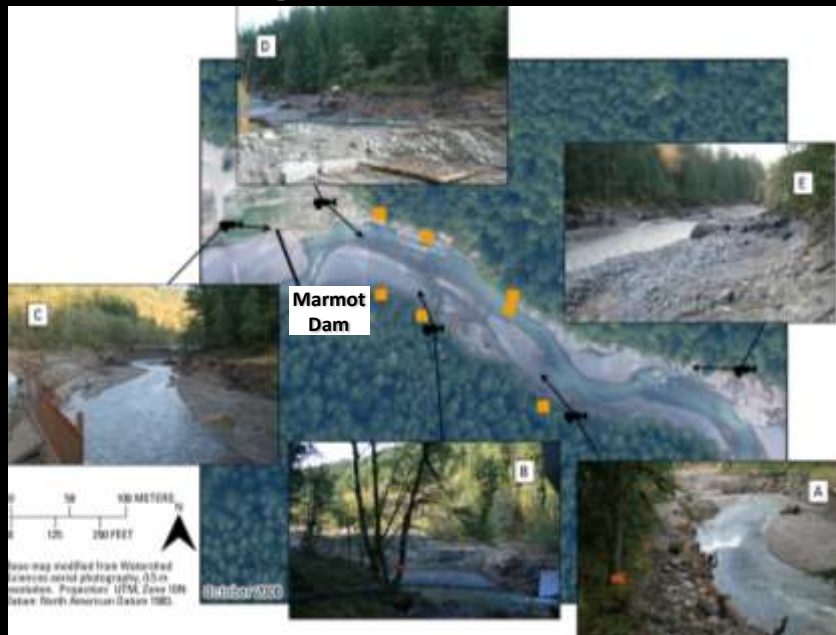
## Photogrammetric Methods

- Time-lapse photography
- PhotoModeler 5.2 software
  - Uses collinear equations to solve the intersection of light rays for a 3D point
  - Outputs coordinates
- Internal controls
  - Focal length, lens distortion, principal point
- External controls
- Tie points
- Point tagging

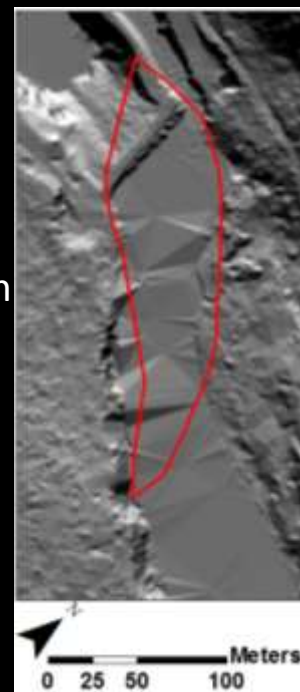
## Surface Creation Methods

- 2007 LiDAR collected pre-removal
- Converted to common projection and vertical units
- All surfaces covered different spatial extents
- Re-sampled to similar cell size, clipped to coincident area (10 % of 2 week erosion area), and snapped to LiDAR surface
