FRACTURES ALONG PART OF THE EMERSON FAULT ZONE PRODUCED BY THE 28 JUNE 1992 LANDERS, CALIFORNIA, EARTHQUAKE

by
Robert W. Fleming, Arvid M. Johnson, Kenneth M. Cruikshank and Sumaryanto Y. Martosudarmo
1997

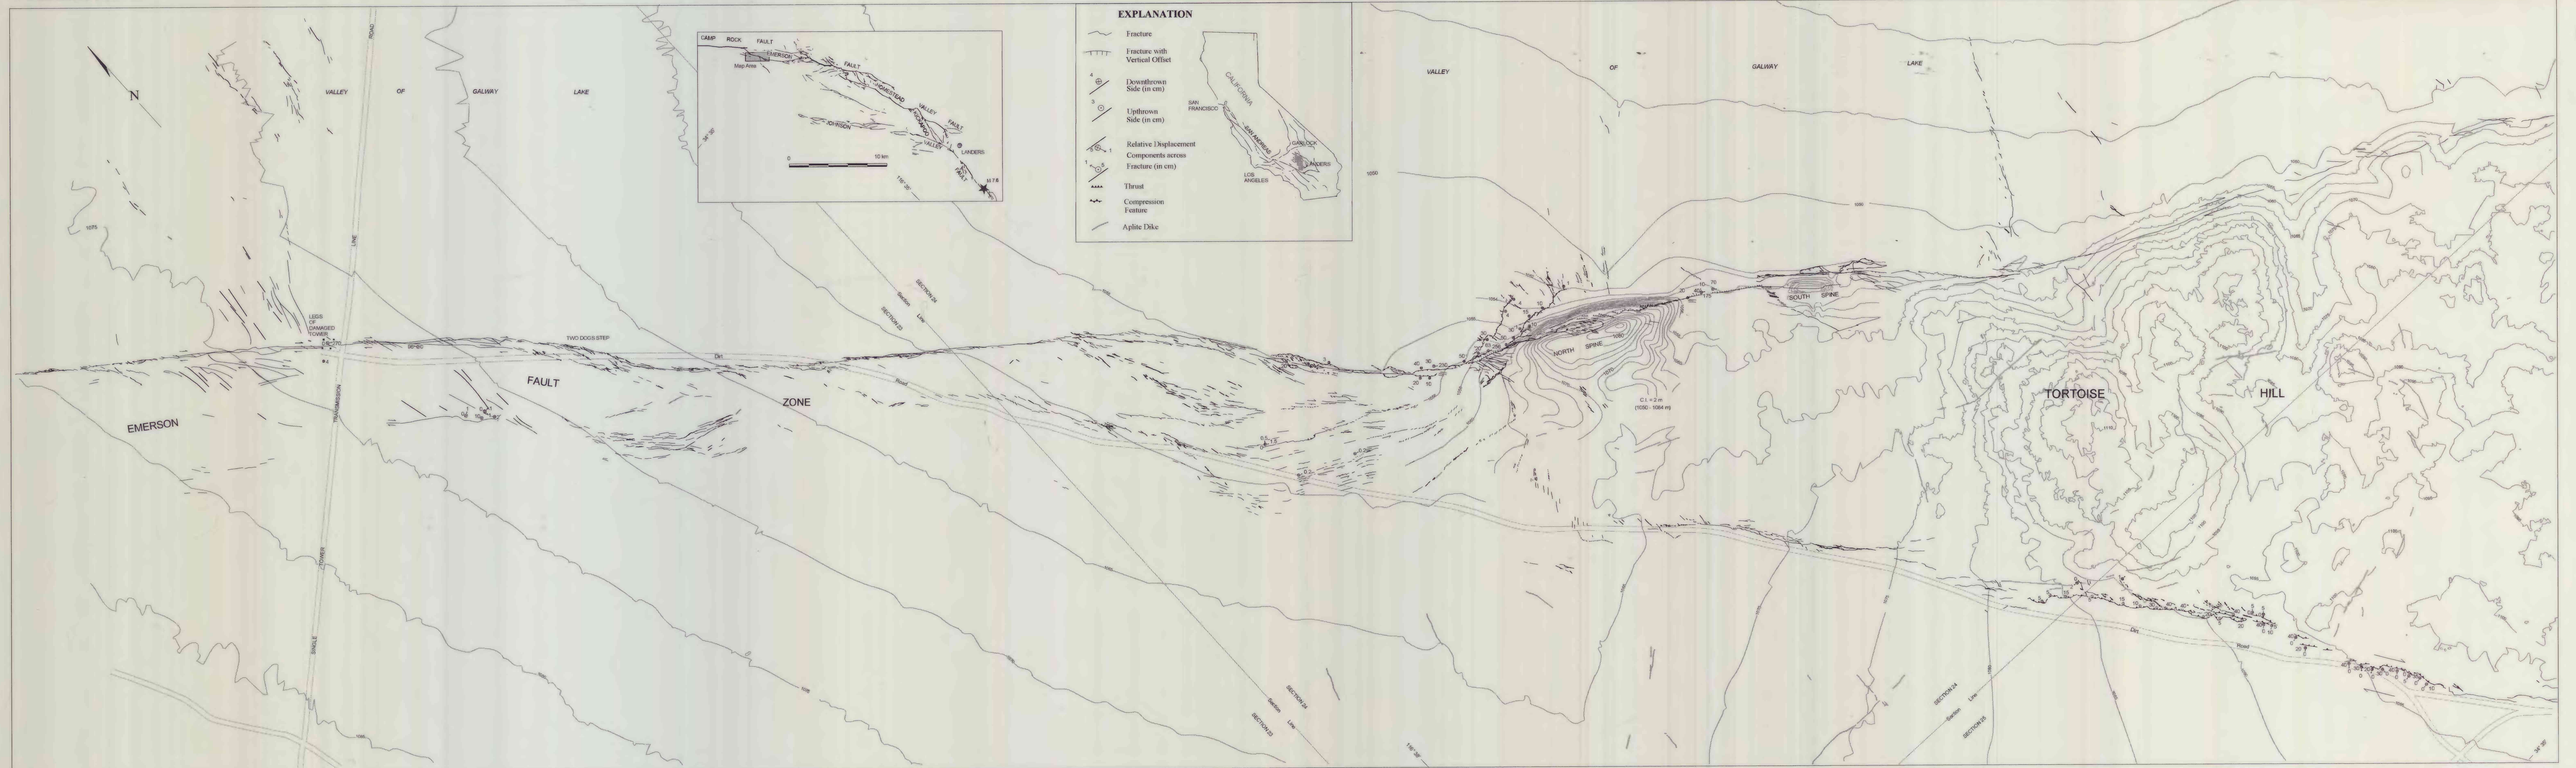
Base map constructed photogrammetrically by James Messerich
Rupture map compiled by Nils A. Johnson, 1995
